December 20, 2019
 ACS Project No. 18-096

- NO ACM
- LBP on yellow striping paint
Clack Canyon Road
- LBP on drainage grate West
Kingman TI EB
- OSHA lead at multiple locations

Re: Asbestos and Lead-based Paint Sampling and Analysis
 NH-NHFP-040-A(212)S
 040 MO 048 H7993 01C
 I-40/US 93 West Kingman System Traffic Interchange

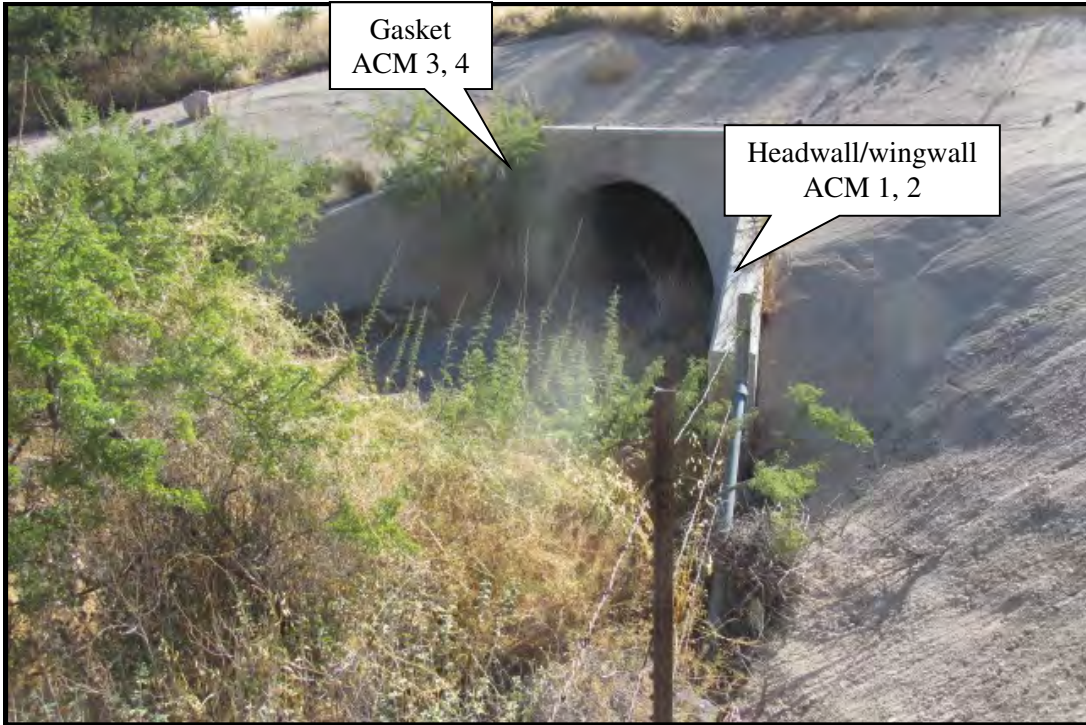
Photograph 1. View northeast of reinforced corrugated metal pipe (RCMP) along Interstate 40 (I-40), near milepost (MP) 48.3.
 Photograph date: October 2, 2019.

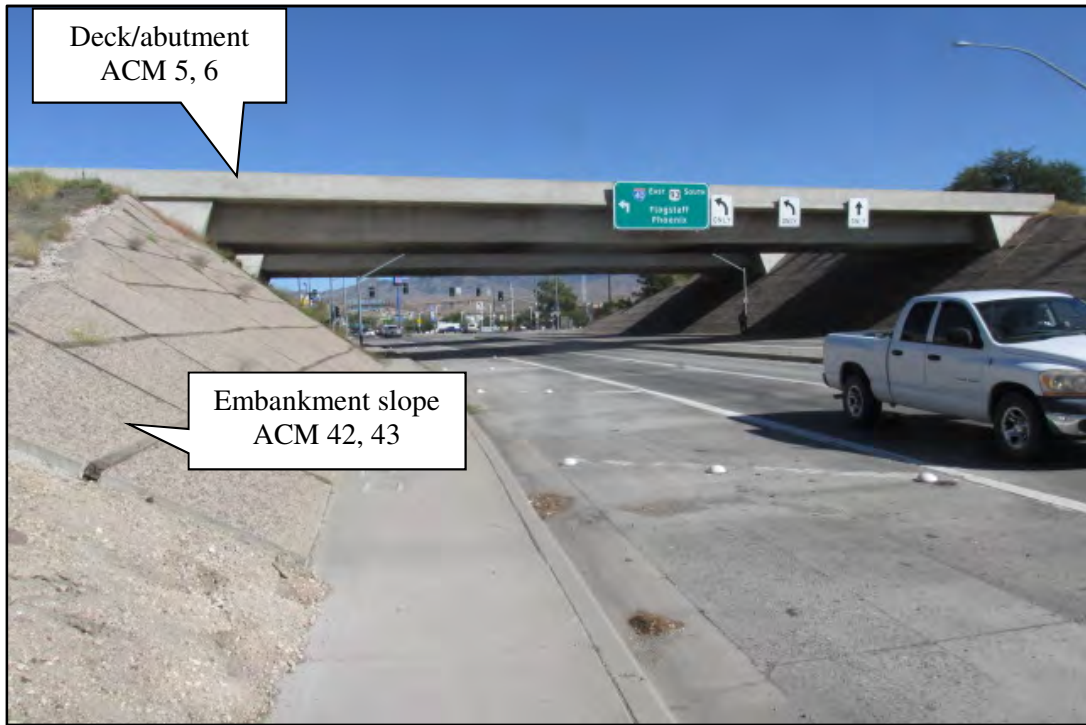
Photograph 2. View east of West Kingman traffic interchange (TI) overpass (OP) westbound (WB), Structure #1836, MP 48.84.
 Photograph date: October 1, 2019.

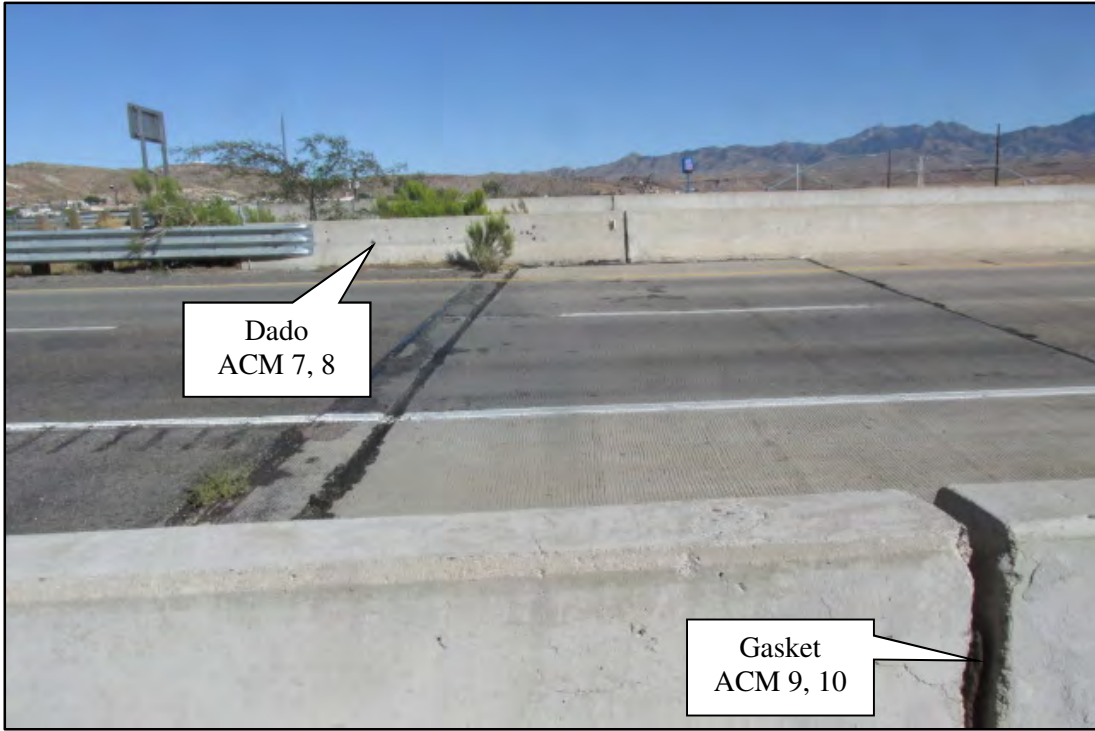
Photograph 3. Detail view of the dado/deck gasket on the West Kingman TI OP WB.
Photograph date: October 1, 2019.

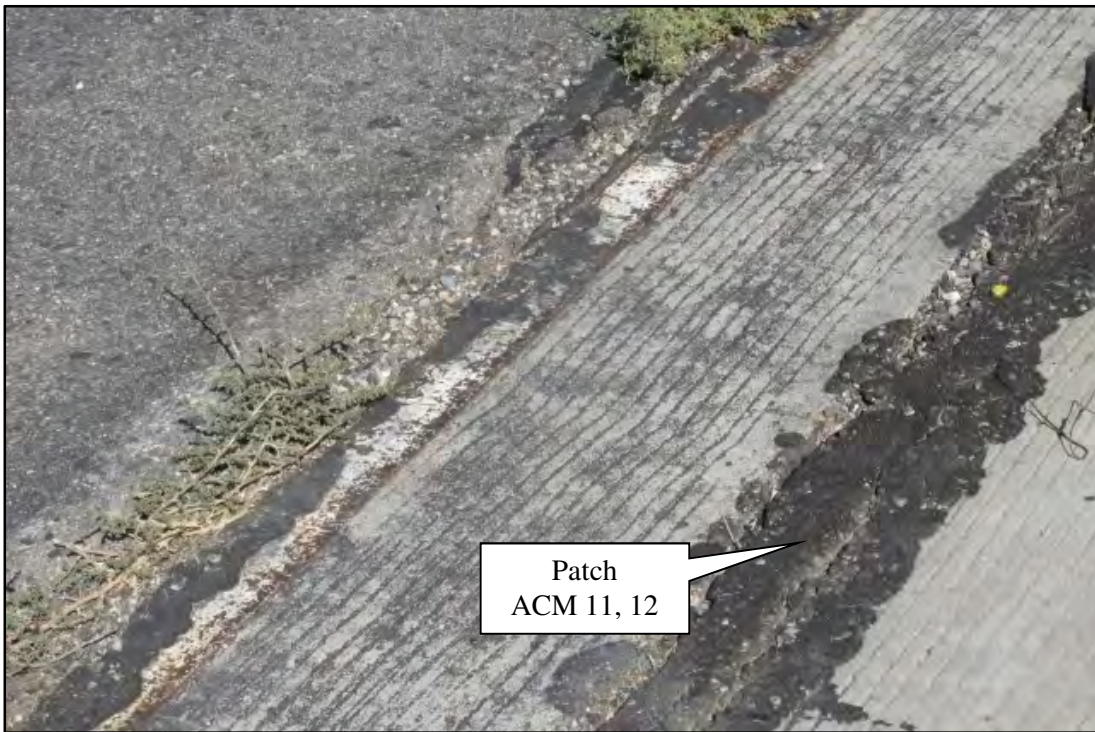
Photograph 4. Detail view of the West Kingman TI OP WB expansion joint patch.
Photograph date: October 1, 2019.

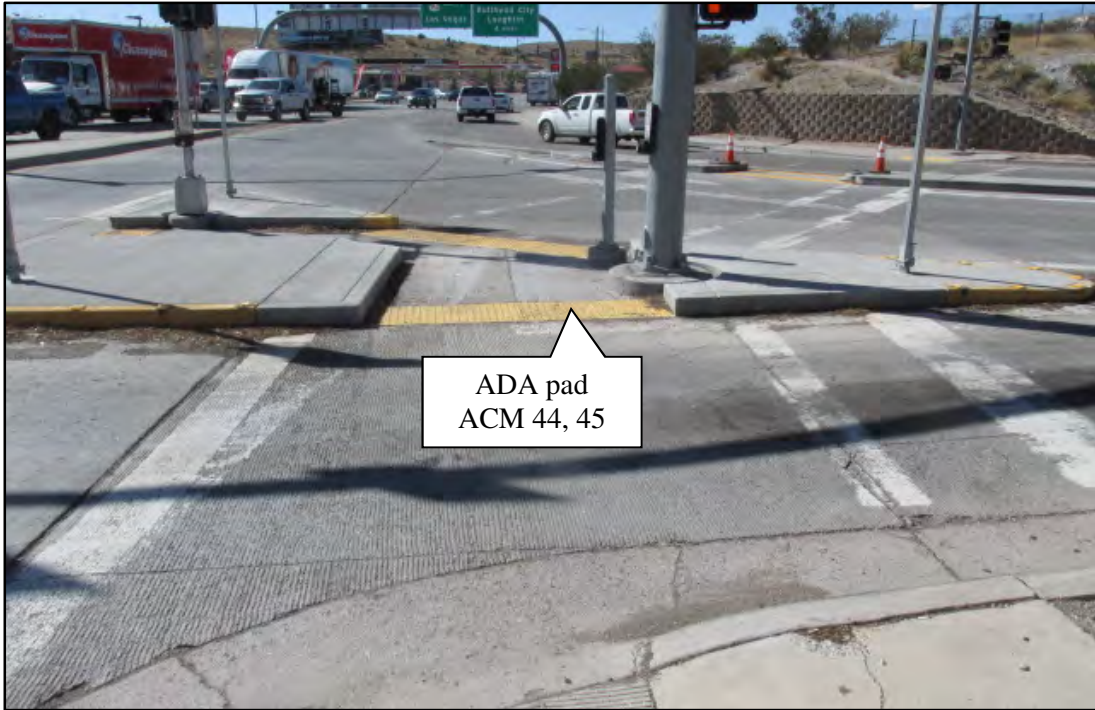
Photograph 5. View south of the West Kingman TI eastbound (EB)/WB Americans with Disabilities Act (ADA) yellow fiberglass pad.
Photograph date: October 1, 2019.

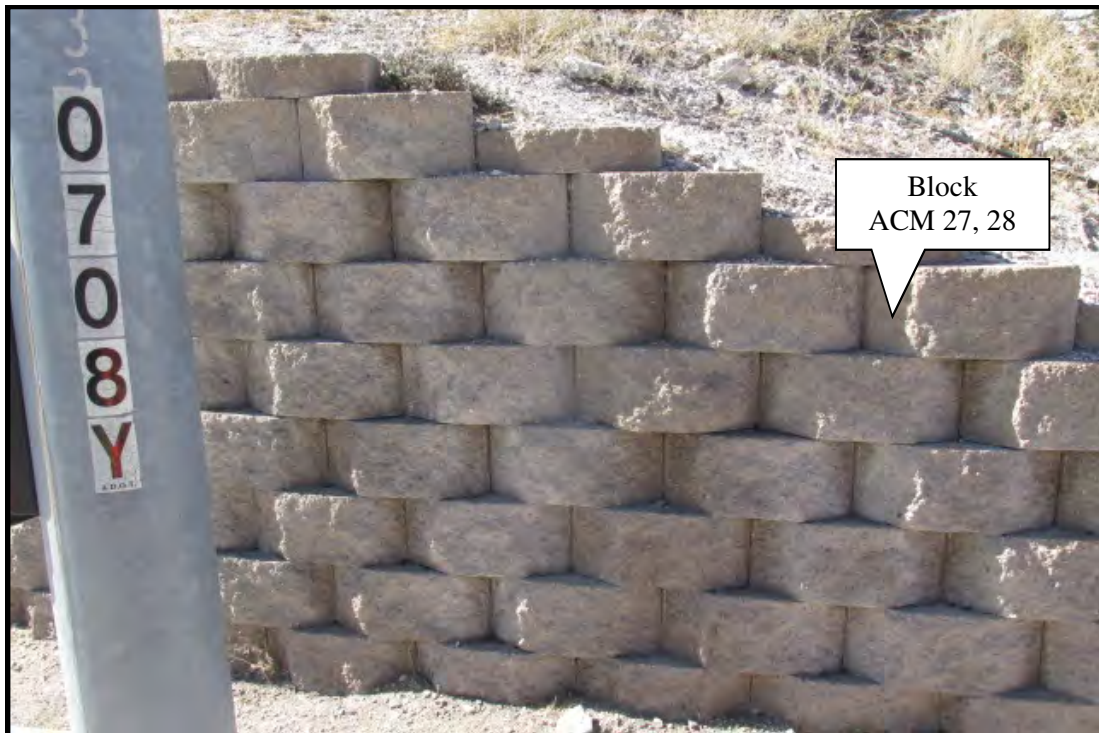
Photograph 6. Detail view of West Kingman TI OP WB off-ramp block retaining wall.
Photograph date: October 1, 2019.

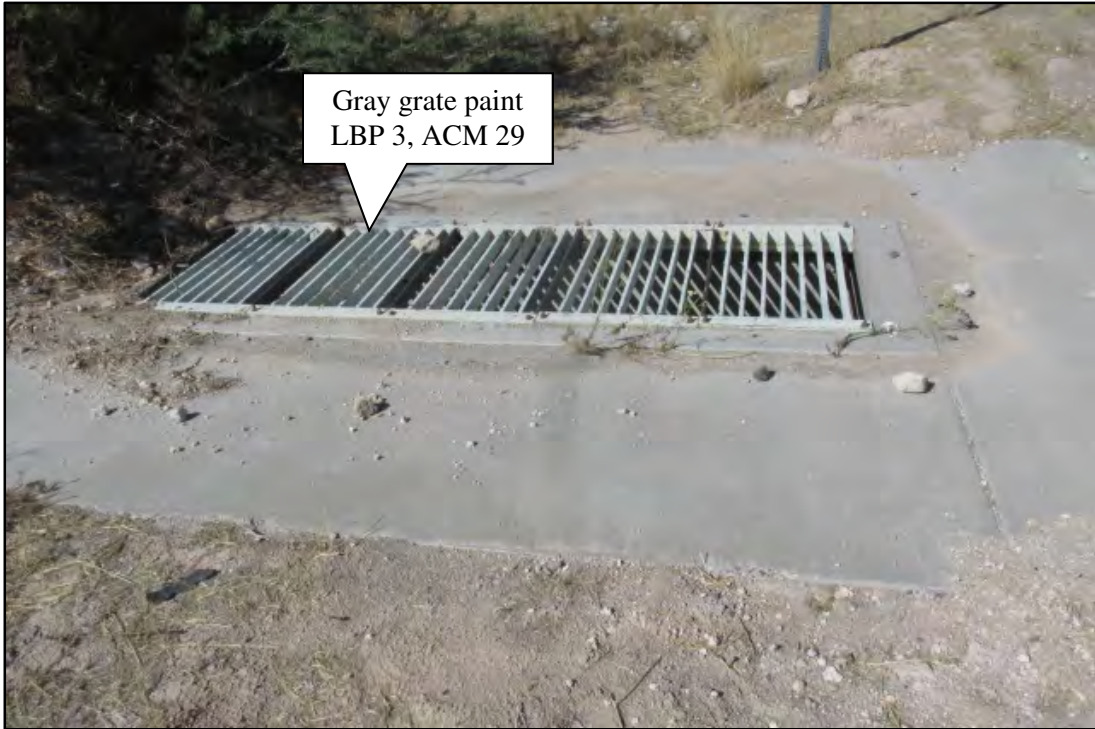
Photograph 7. Detail view West Kingman TI OP WB off-ramp catch basin.
Photograph date: October 1, 2019.

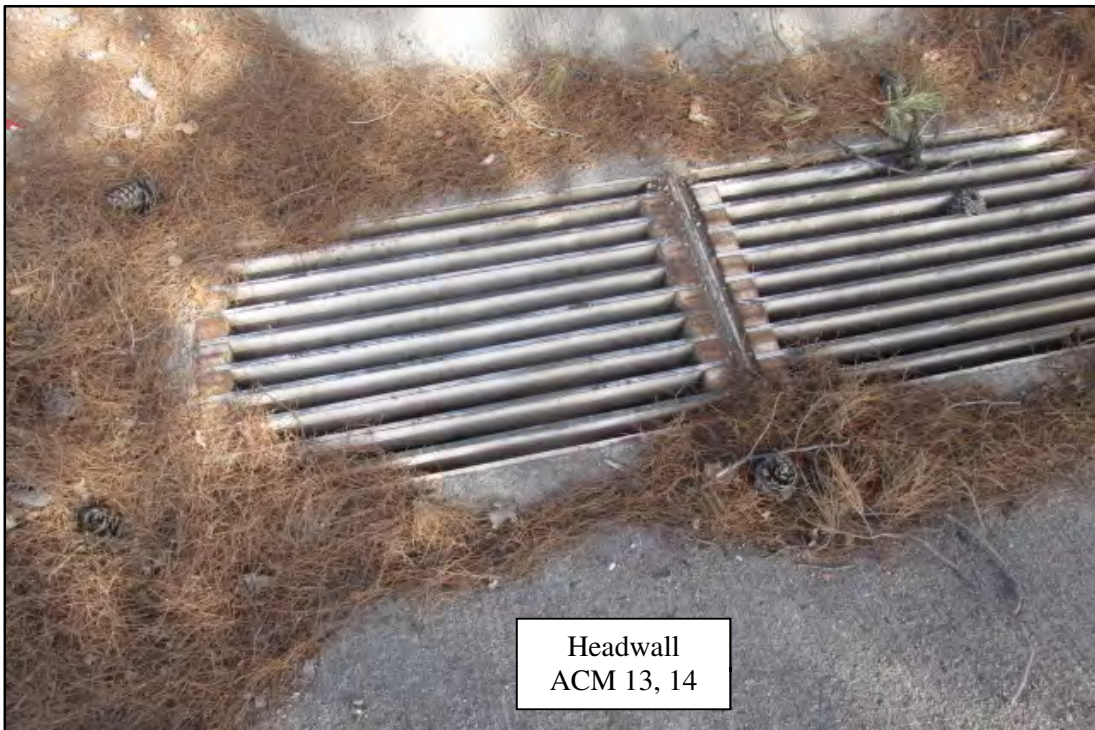
Photograph 8. Detail view of the West Kingman TI OP WB southwest corner (SWC) catch basin.
Photograph date: October 16, 2019.

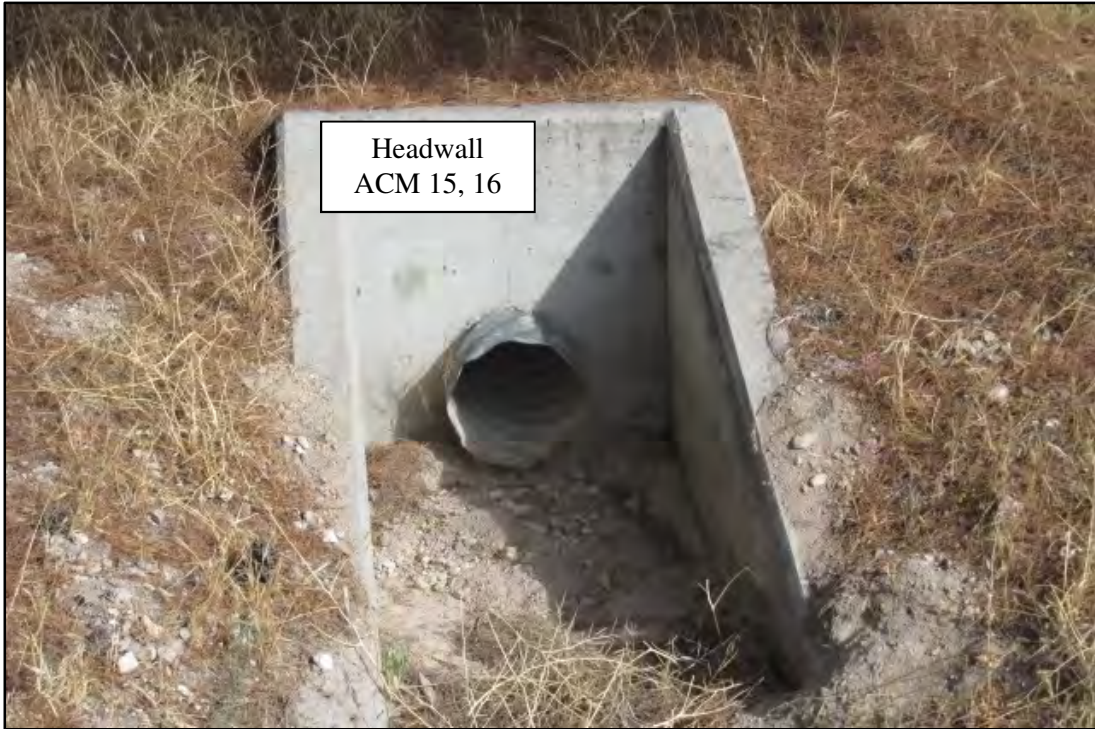
Photograph 9. Detail view of the RCMP at the SWC of the WB West Kingman TI OP.
Photograph date: October 16, 2019.

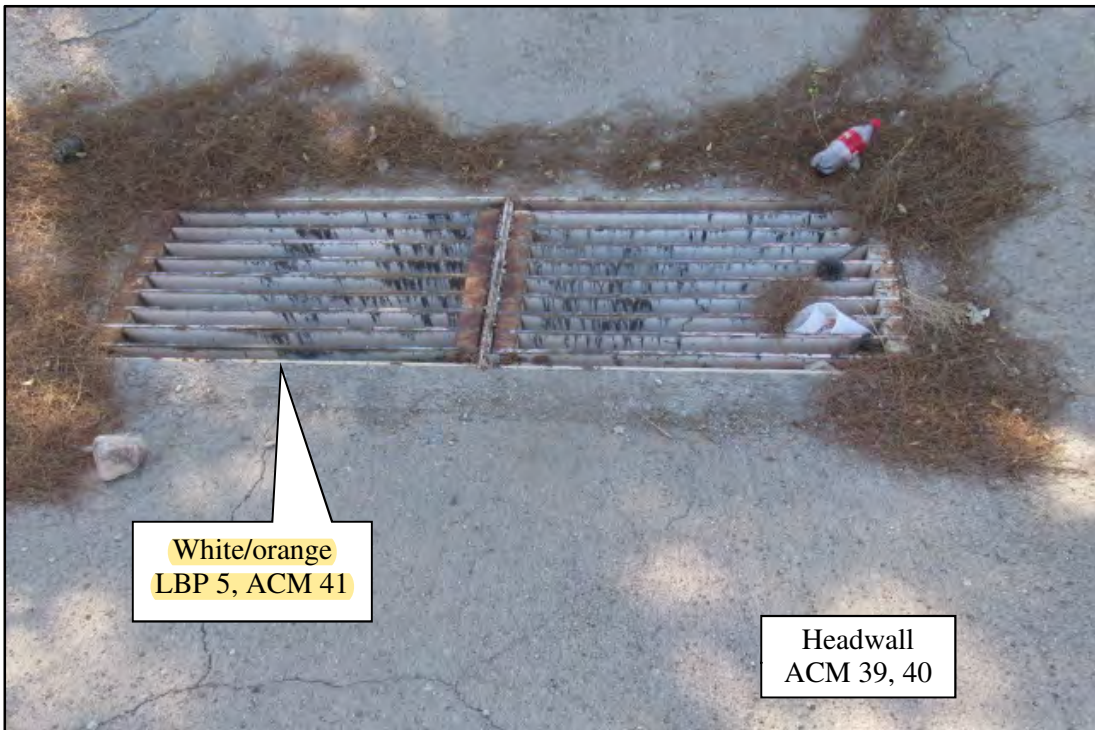
Photograph 10. Detail view of the West Kingman TI OP EB southeast corner (SEC) catch basin.
Photograph date: October 16, 2019.

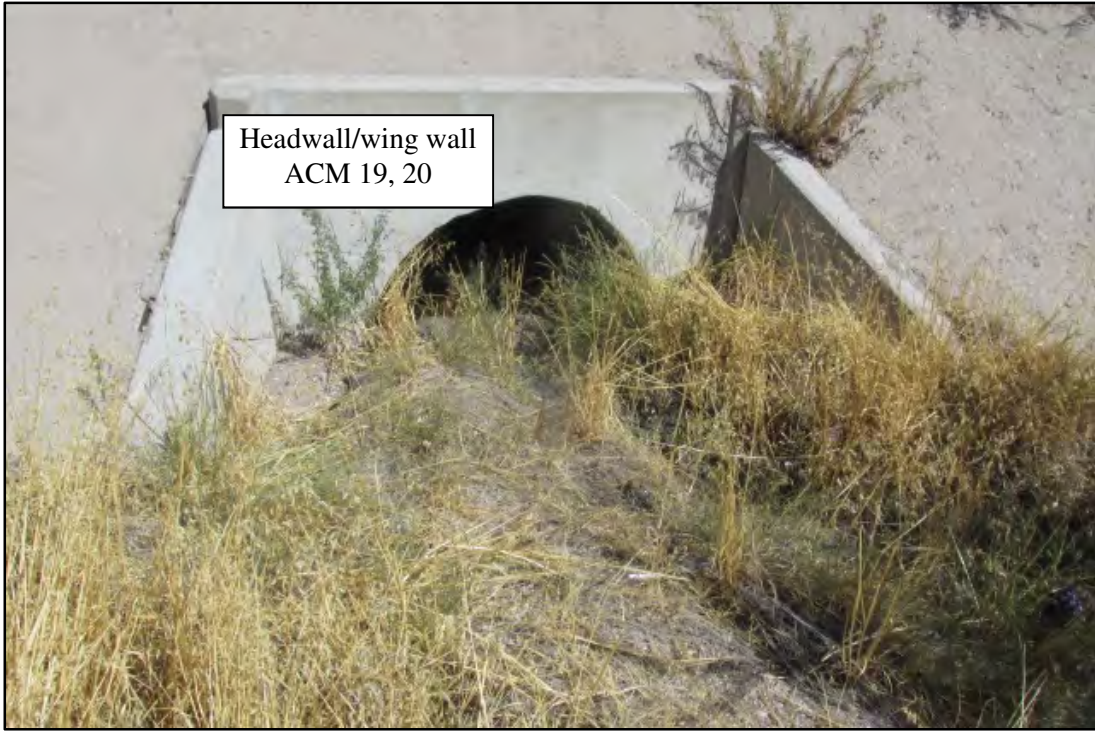
Photograph 11. Detail view of the West Kingman TI WB on-ramp SWC RCMP.
Photograph date: October 2, 2019.

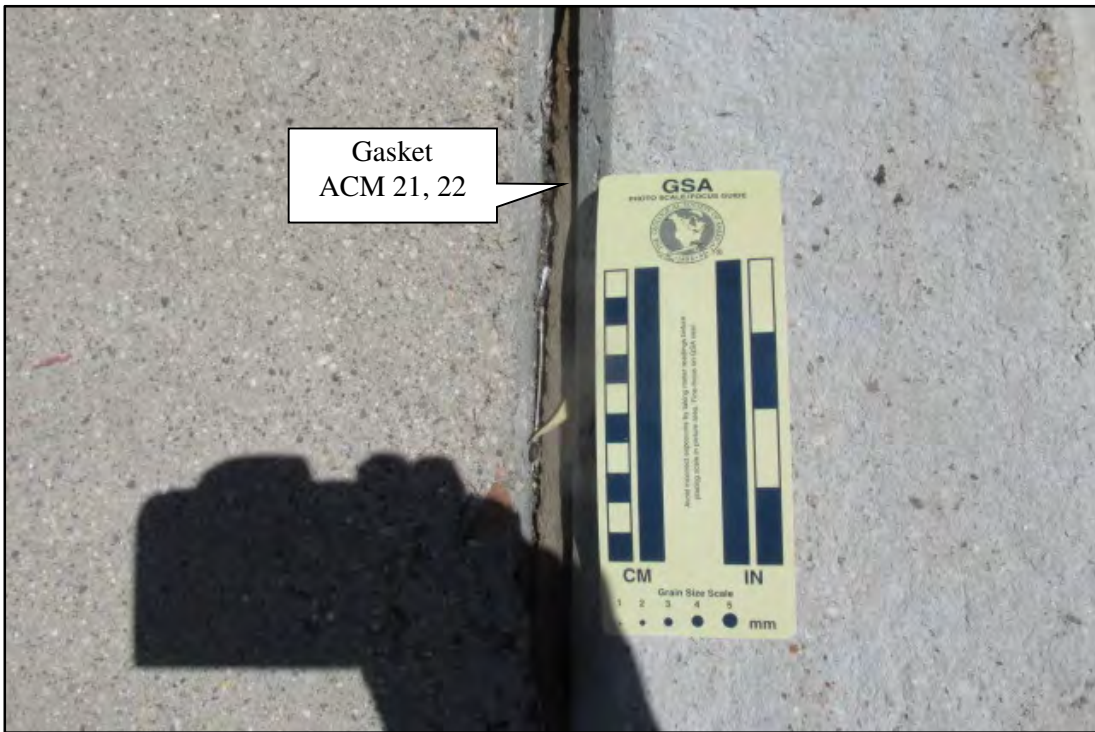
Photograph 12. Detail view of the West Kingman TI WB on-ramp SWC RCMP gasket.
Photograph date: October 2, 2019.

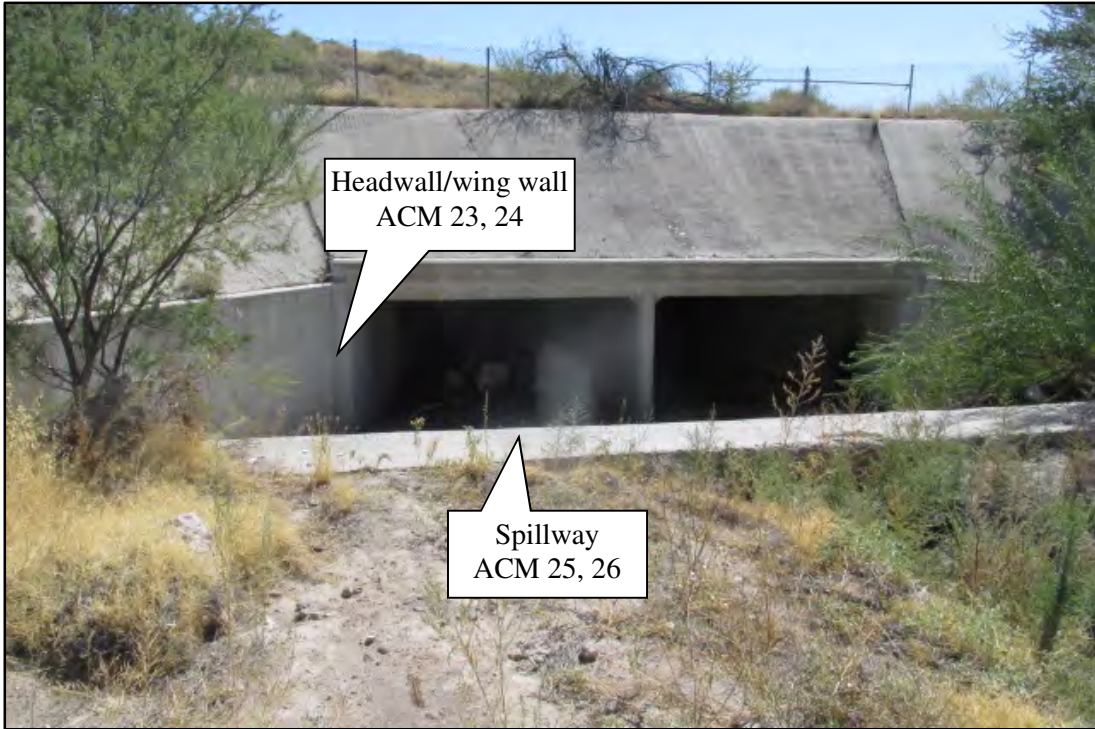
Photograph 13. Detail view of the West Kingman TI WB on-ramp reinforced concrete box culvert (RCB) and spillway.
Photograph date: October 2, 2019.

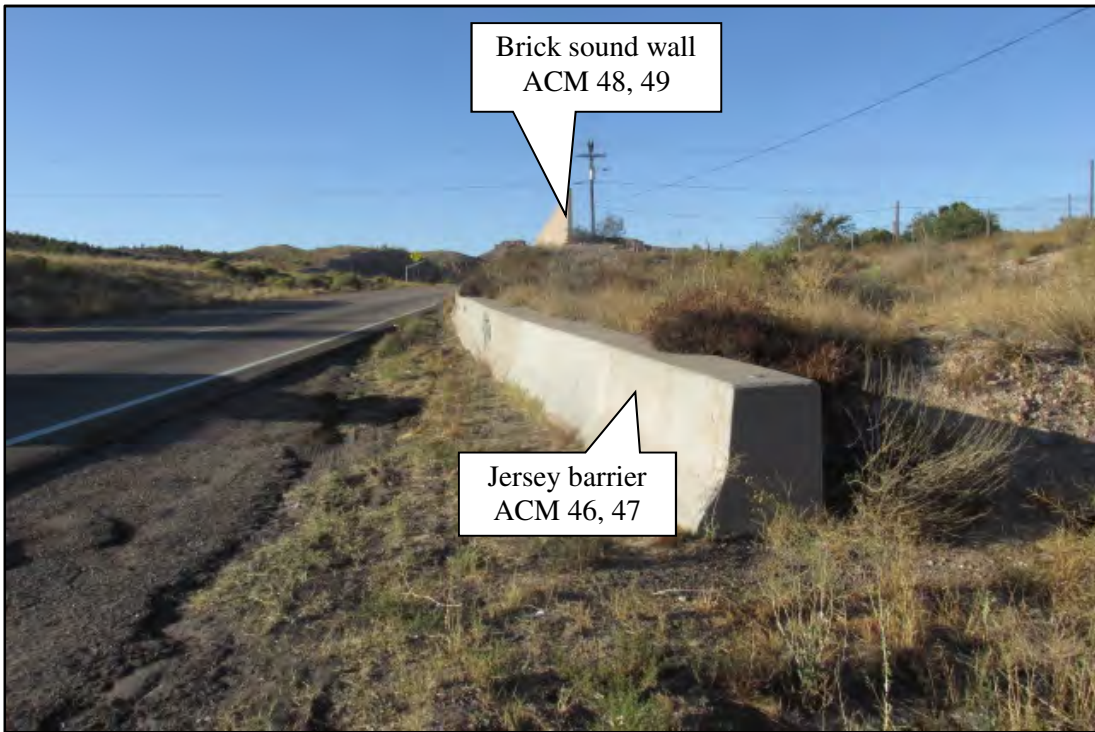
Photograph 14. View east of the I-40 EB Jersey barrier and brick sound wall at MP 49.
Photograph date: October 2, 2019.

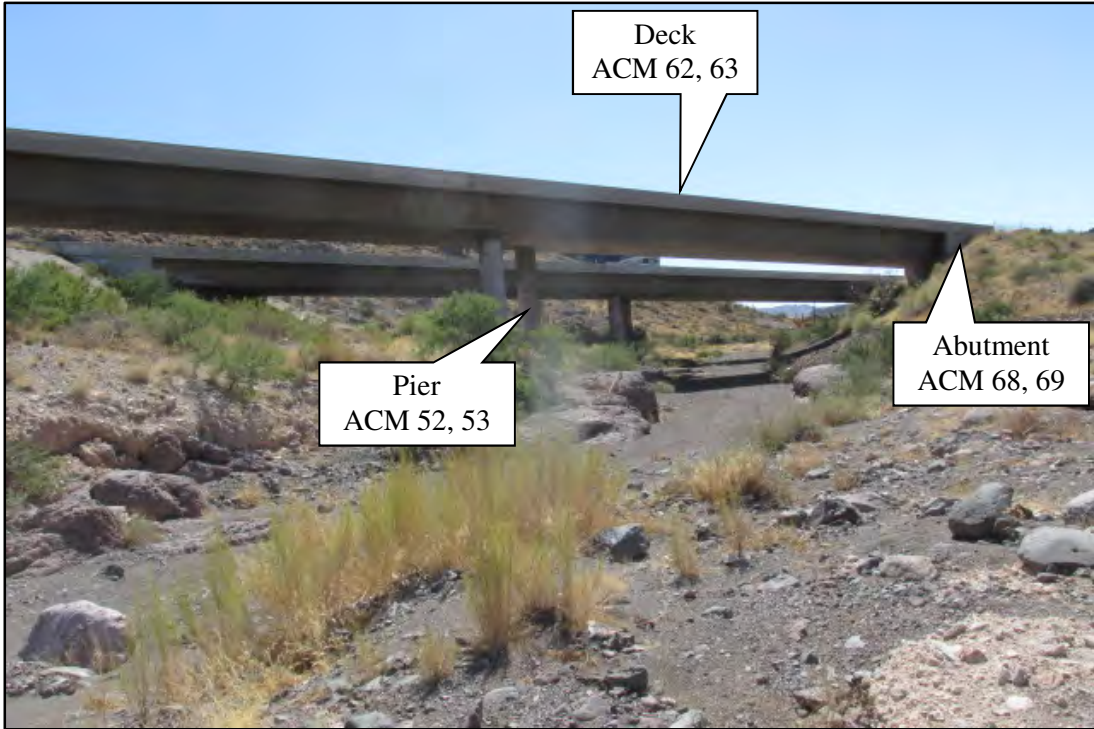
Photograph 15. View south of the Clack Canyon Wash OP WB, Structure # 1838, MP 49.7 (foreground) and Clack Canyon Wash OP EB Structure # 1837, MP 49.7 (background).
Photograph date: October 1, 2019.

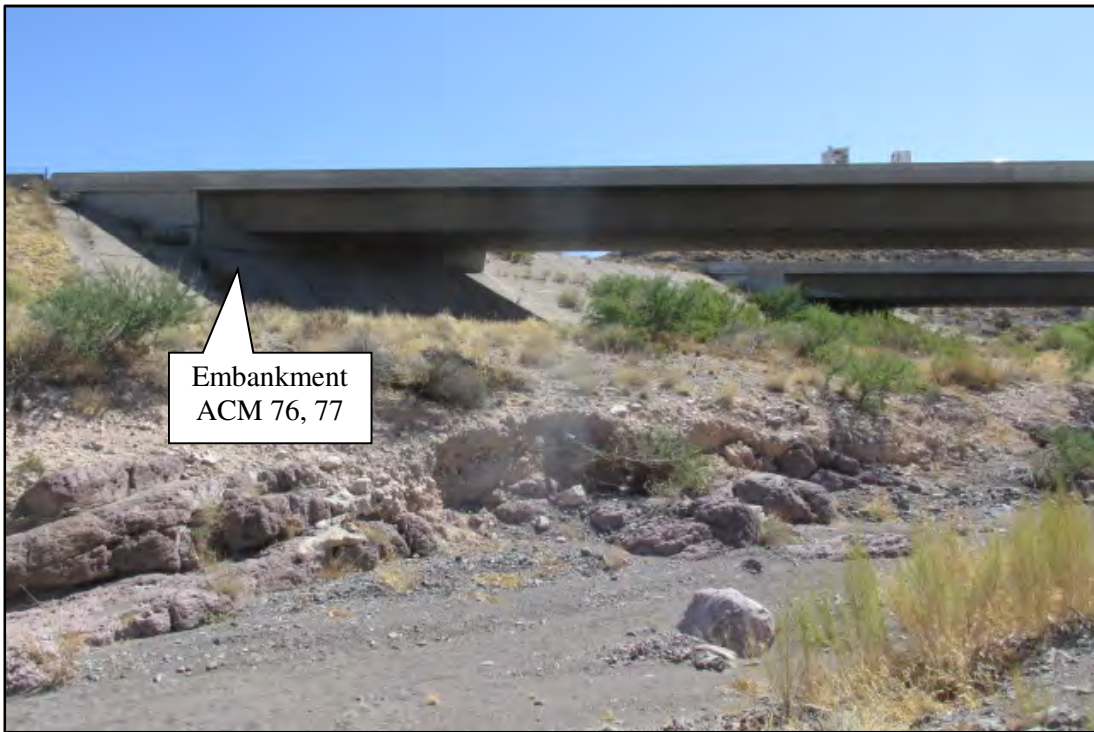
Photograph 16. View of the Clack Canyon Wash OP WB embankment slope.
Photograph date: October 1, 2019.

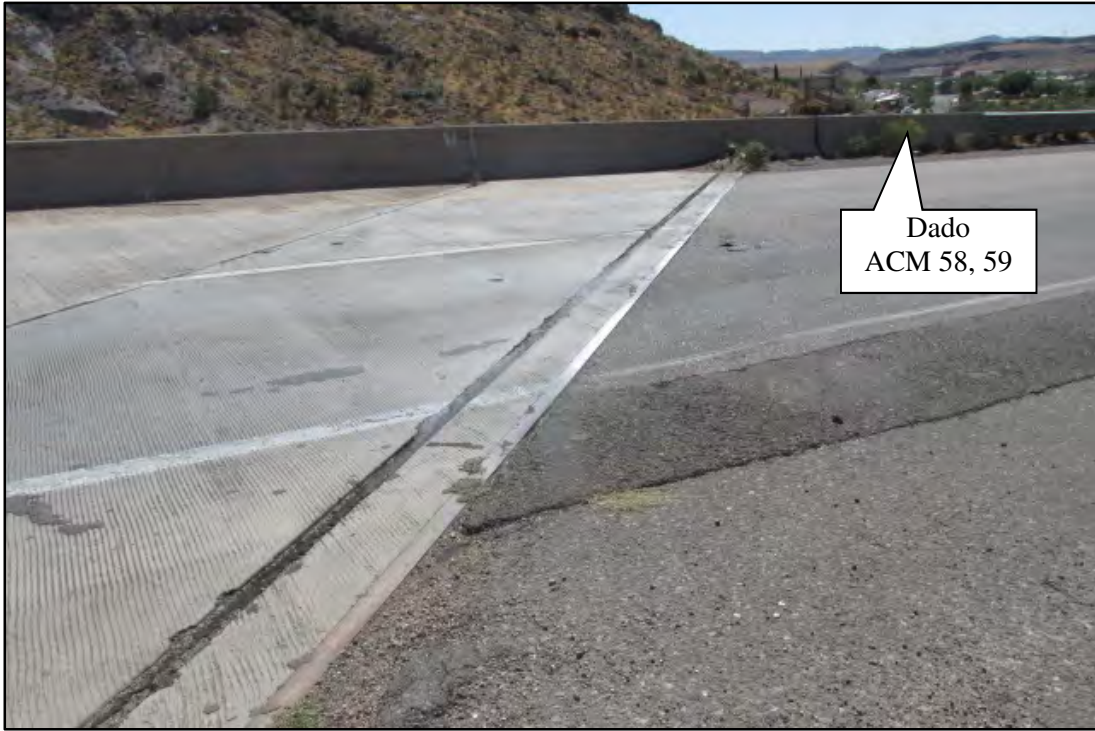
Photograph 17. View of the Clack Canyon Wash OP EB dado.
Photograph date: October 1, 2019.

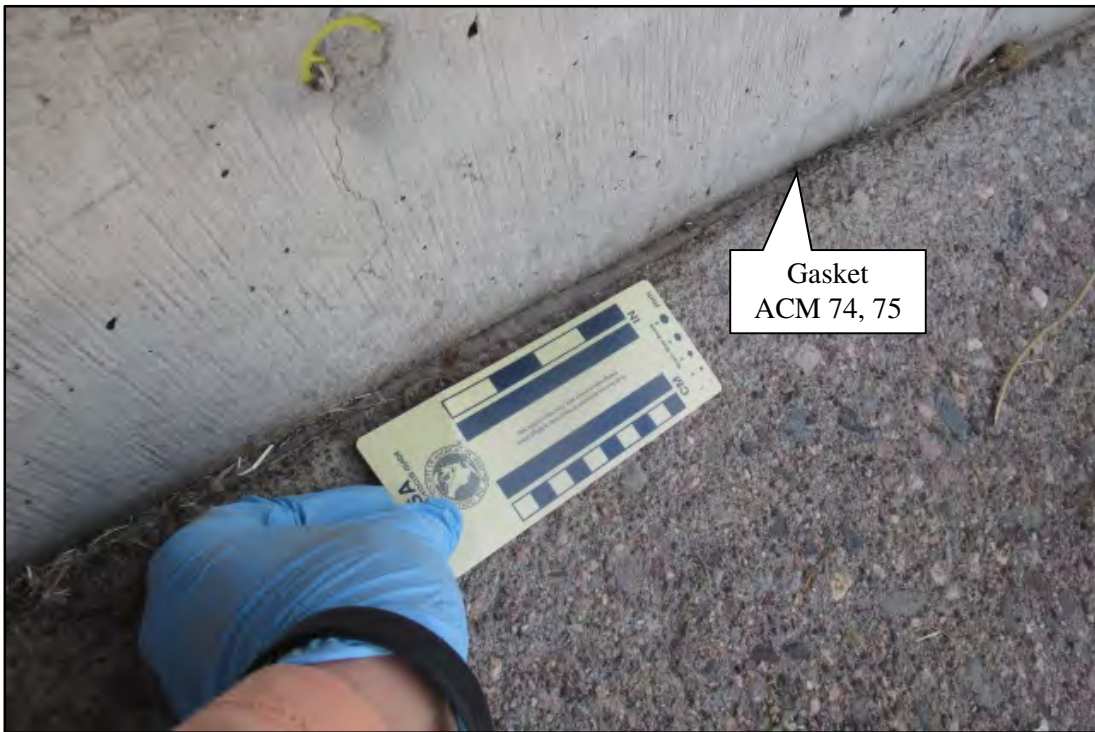
Photograph 18. View of the Clack Canyon Wash OP WB dado/embankment slope gasket.
Photograph date: October 1, 2019.

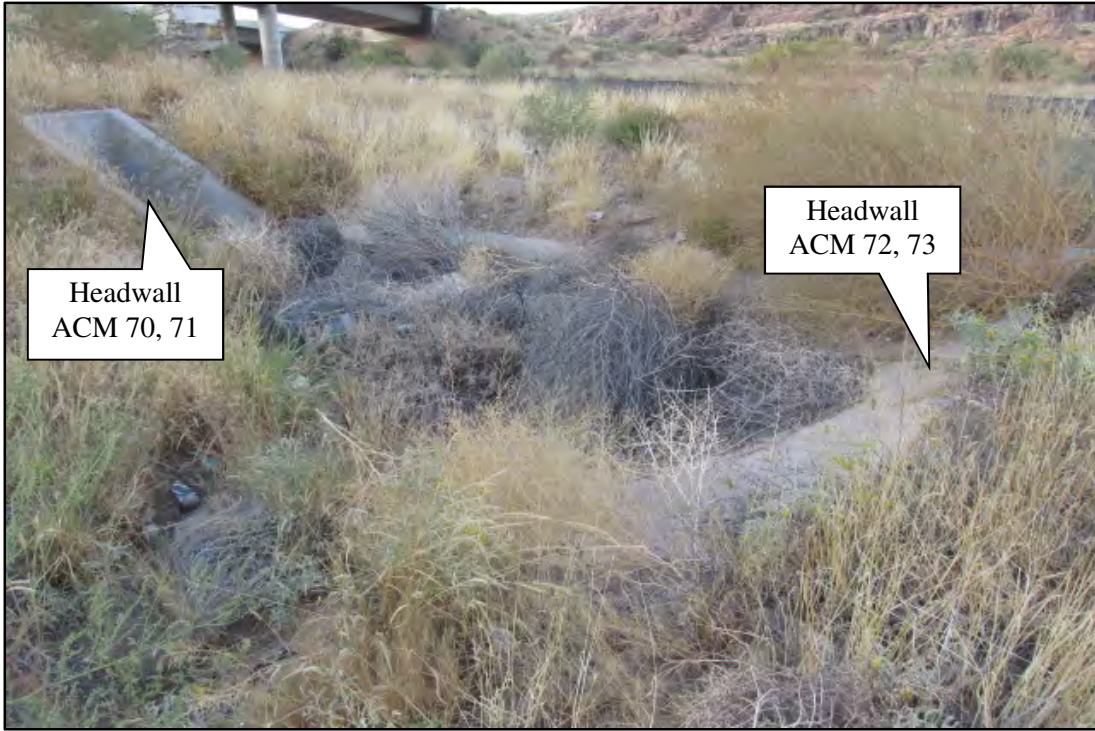
Photograph 19. View of the Clack Canyon Wash OP WB NEC RCMP and catch basin.
Photograph date: October 1, 2019.

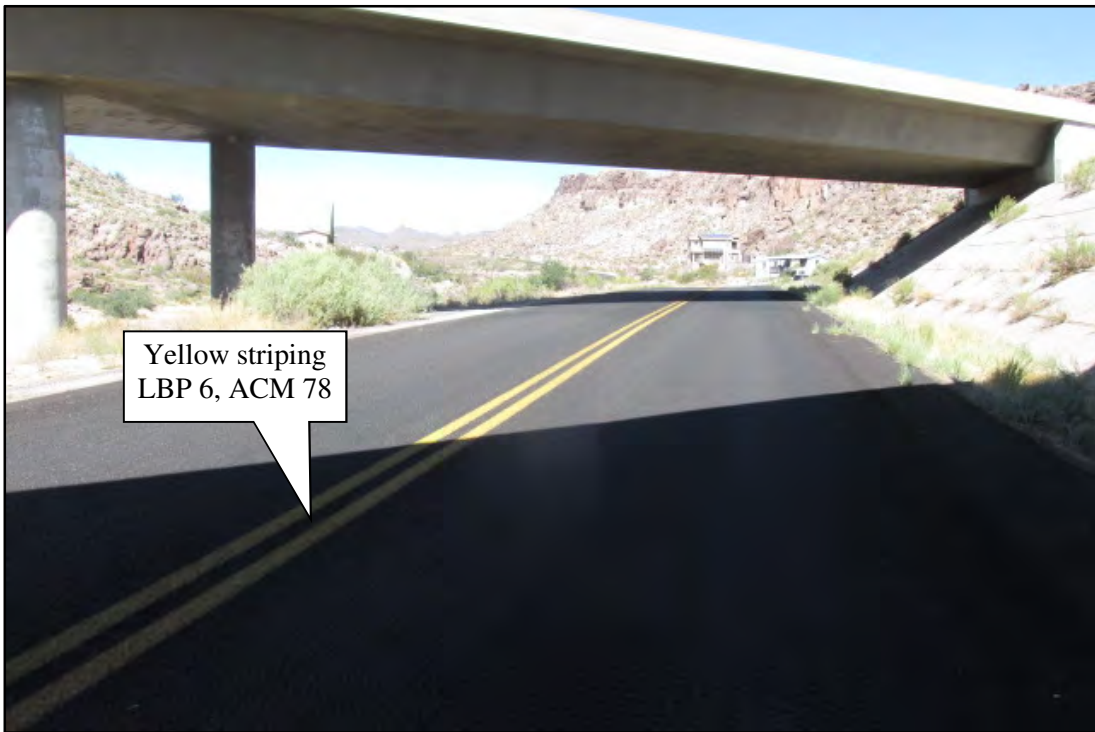
Photograph 20. View of the Clack Canyon Road new yellow striping paint.
Photograph date: October 1, 2019.

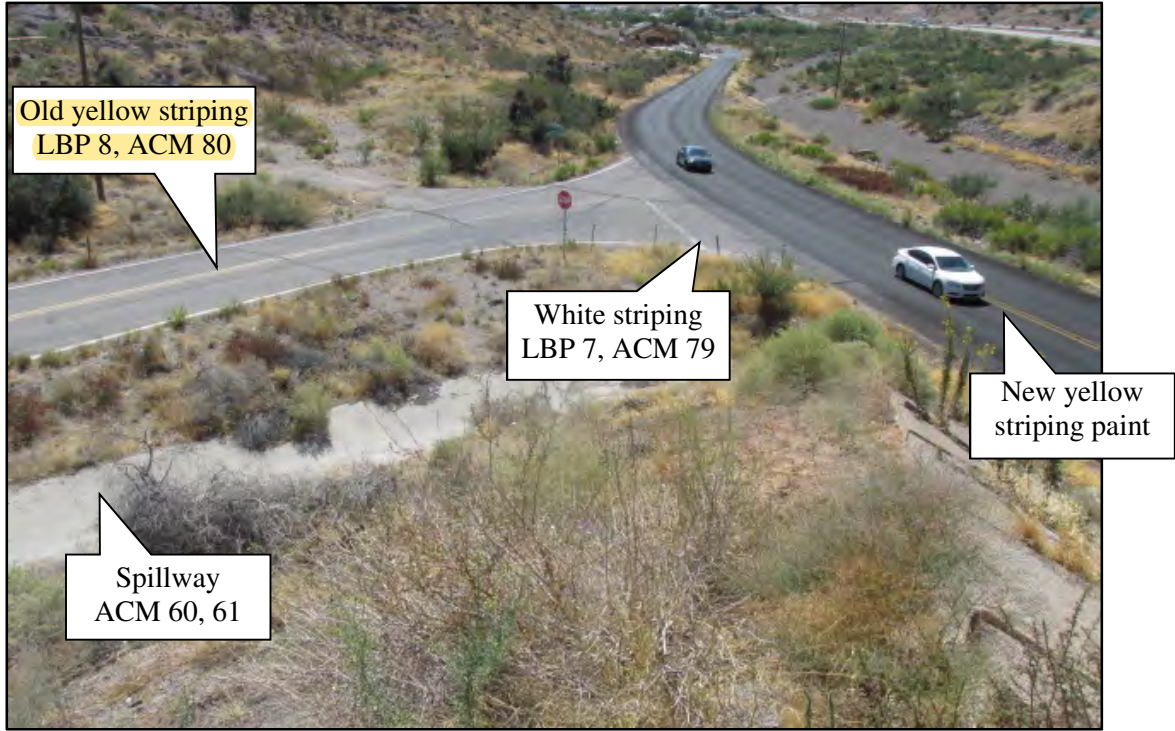
Photograph 21. View of the Clack Canyon Road striping paint and spillway.
 Photograph date: October 1, 2019.

- The contractor shall submit a Lead-Based Paint Removal and Abatement Plan for the removal of the Clack Canyon Road old yellow striping paint parallel to the Clack Canyon Wash bridges within the project limits to the Engineer and the Arizona Department of Transportation Environmental Planning hazardous materials coordinator (602.920.3882 or 602.712.7767) for review and approval at least 10 (ten) working days prior to paint striping obliteration activities.

- No Clack Canyon Road old yellow striping parallel to the Clack Canyon Wash bridges paint obliteration shall occur until the Lead-Based Paint Removal and Abatement Plan is approved by the Arizona Department of Transportation Environmental Planning hazardous materials coordinator and implemented.

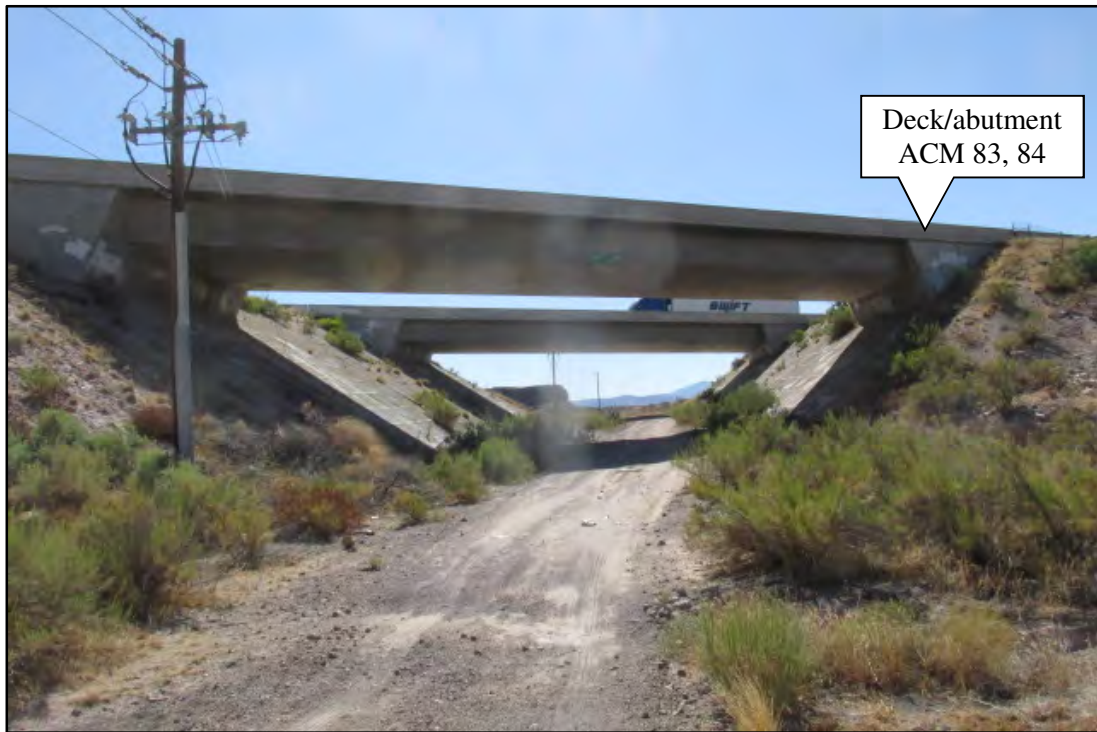
Photograph 22. View south of the White Cliff Road OP WB Structure #1840, MP 50.09 (foreground)
 and White Cliff Road OP EB Structure #1839, MP 50.09 (background).
 Photograph date: October 1, 2019.

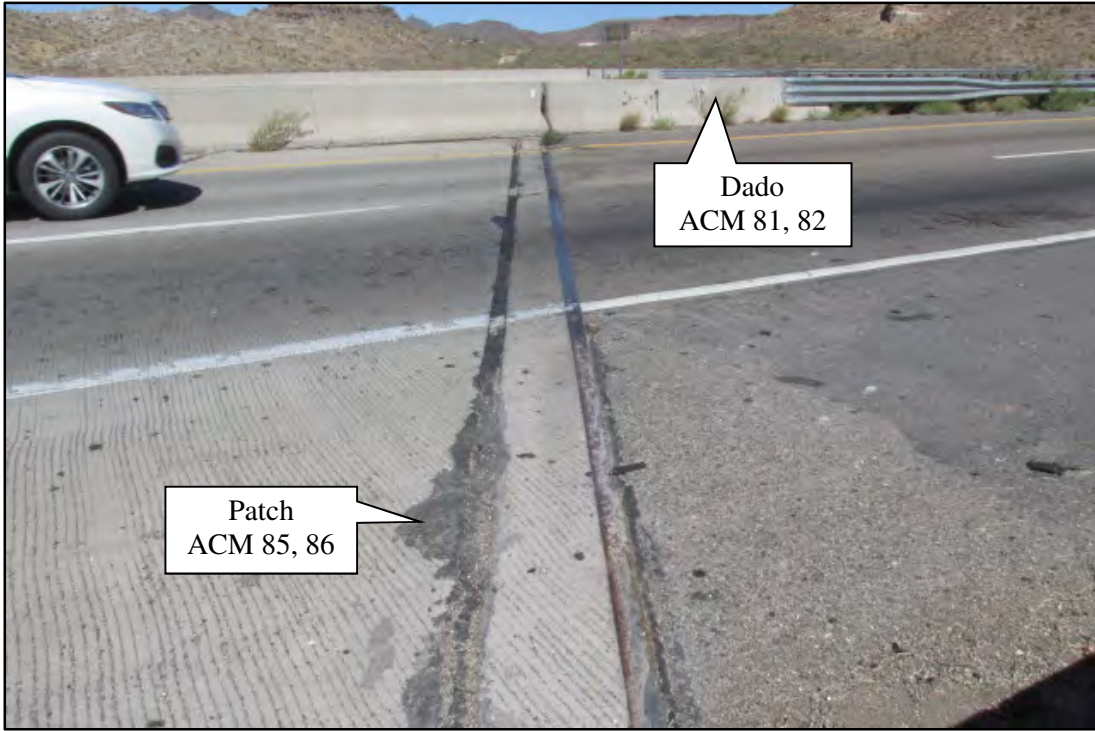
Photograph 23. View of the White Cliff Road OP WB dado and expansion joint patch.
Photograph date: October 1, 2019.

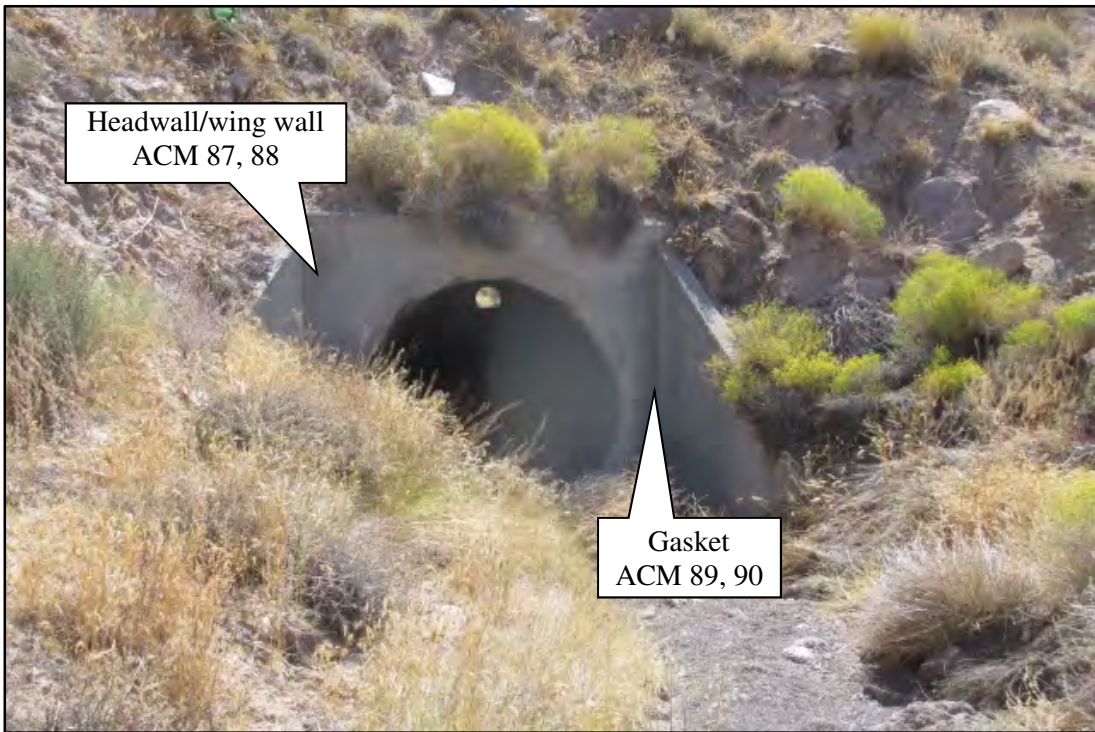
Photograph 24. View of the White Cliff Road OP WB RCMP.
Photograph date: October 1, 2019.

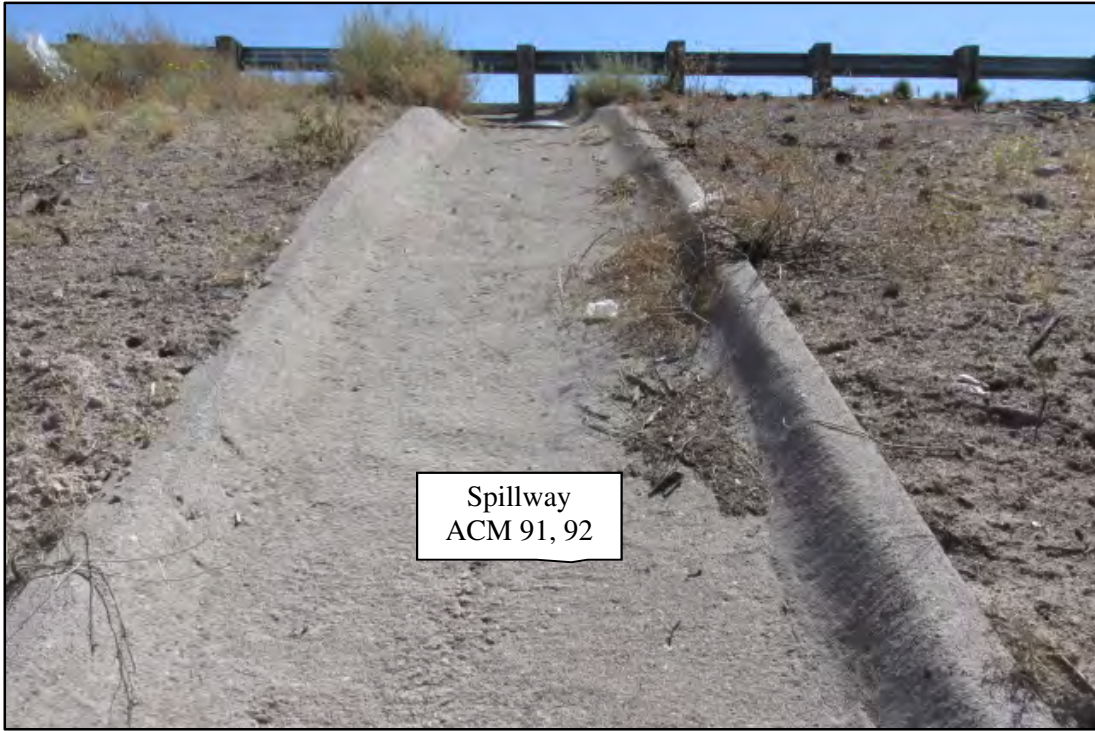
Photograph 25. View of the White Cliff Road OP WB spillway.
Photograph date: October 1, 2019.

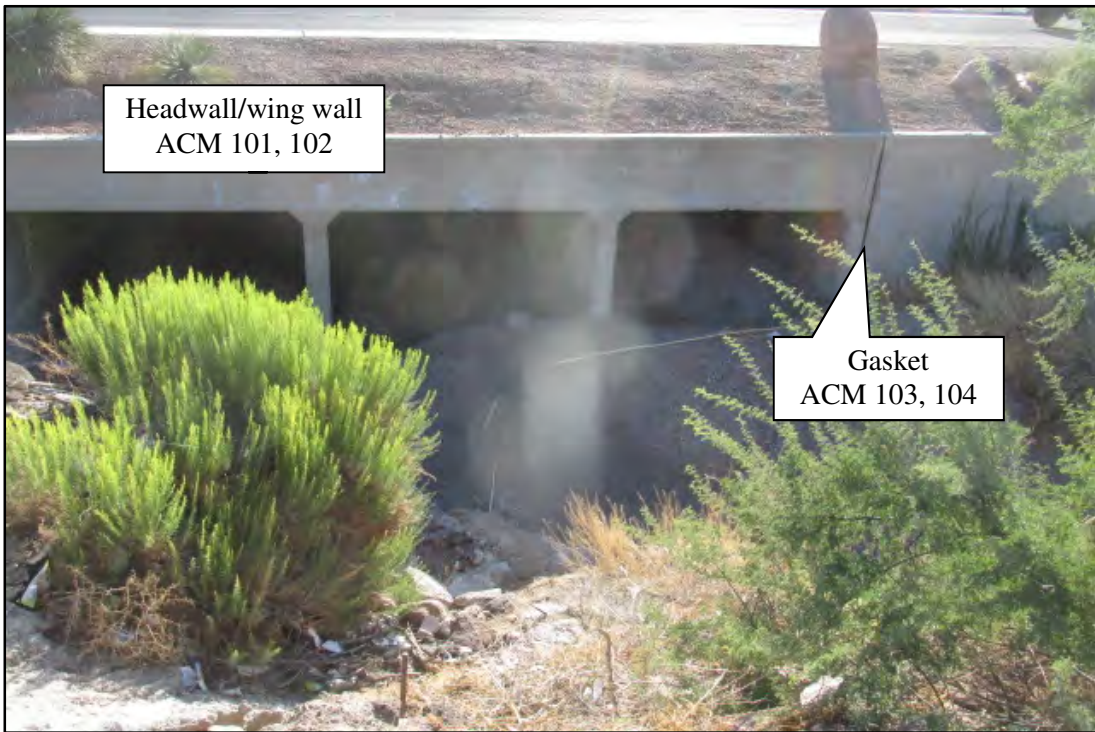
Photograph 26. View northeast of RCB under US Highway 93 (US 93), near MP 70.3.
Photograph date: October 1, 2019.

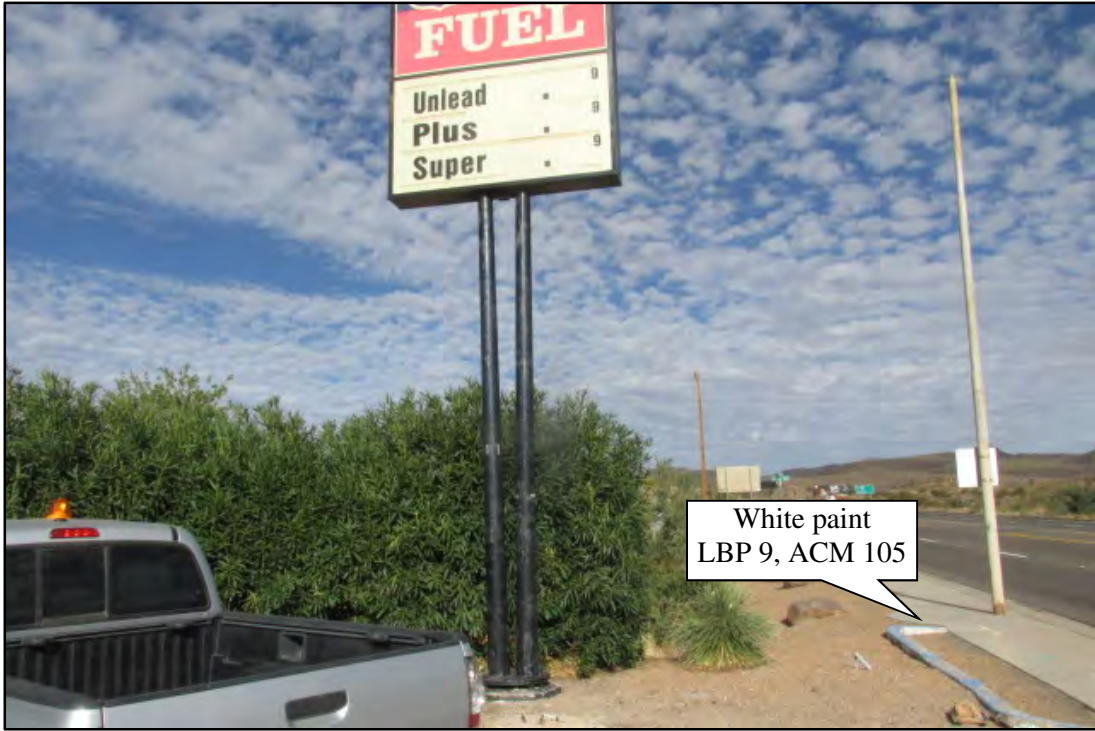
Photograph 27. View northeast of white curb paint along US 93 near MP 70.3.
Photograph date: October 16, 2019.
