December 20, 2019
 ACS Project No. 18-096

- NO ACM
- LBP on yellow striping paint
Clack Canyon Road
- LBP on drainage grate West
Kingman TI EB
- OSHA lead at multiple locations

Re: Asbestos and Lead-based Paint Sampling and Analysis
 NH-NHFP-040-A(212)S
 040 MO 048 H7993 01C
 I-40/US 93 West Kingman System Traffic Interchange

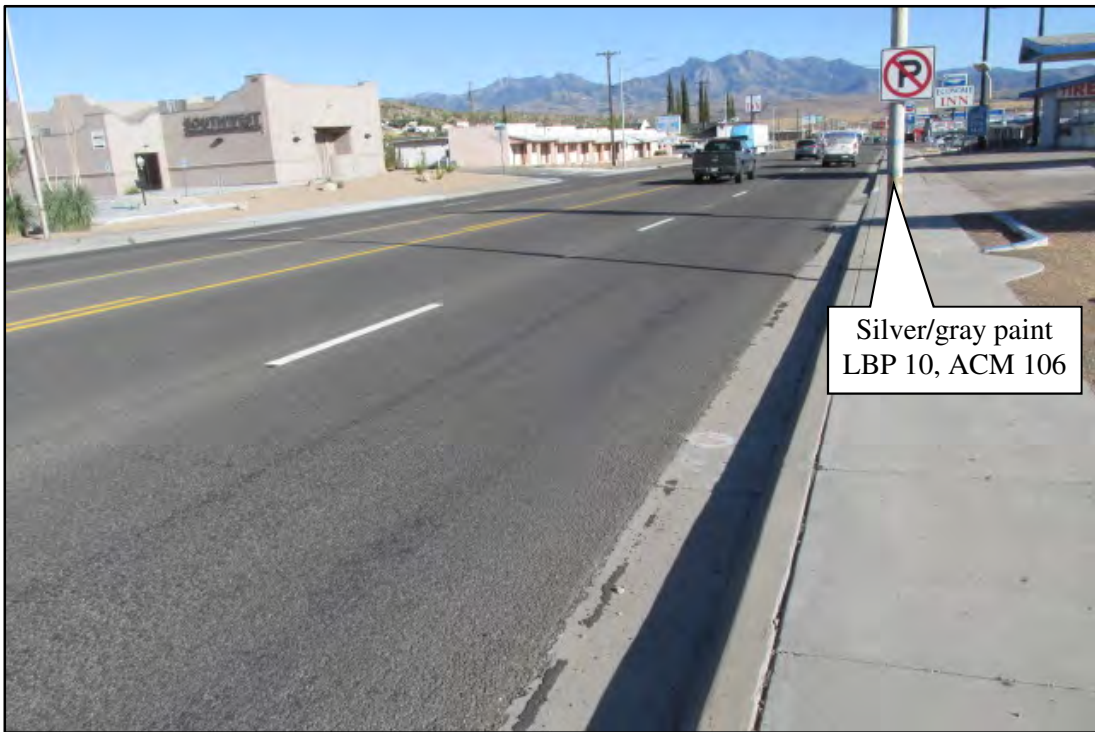
Photograph 28. View southwest of US 93, near MP 70.3.
Photograph date: October 1, 2019.

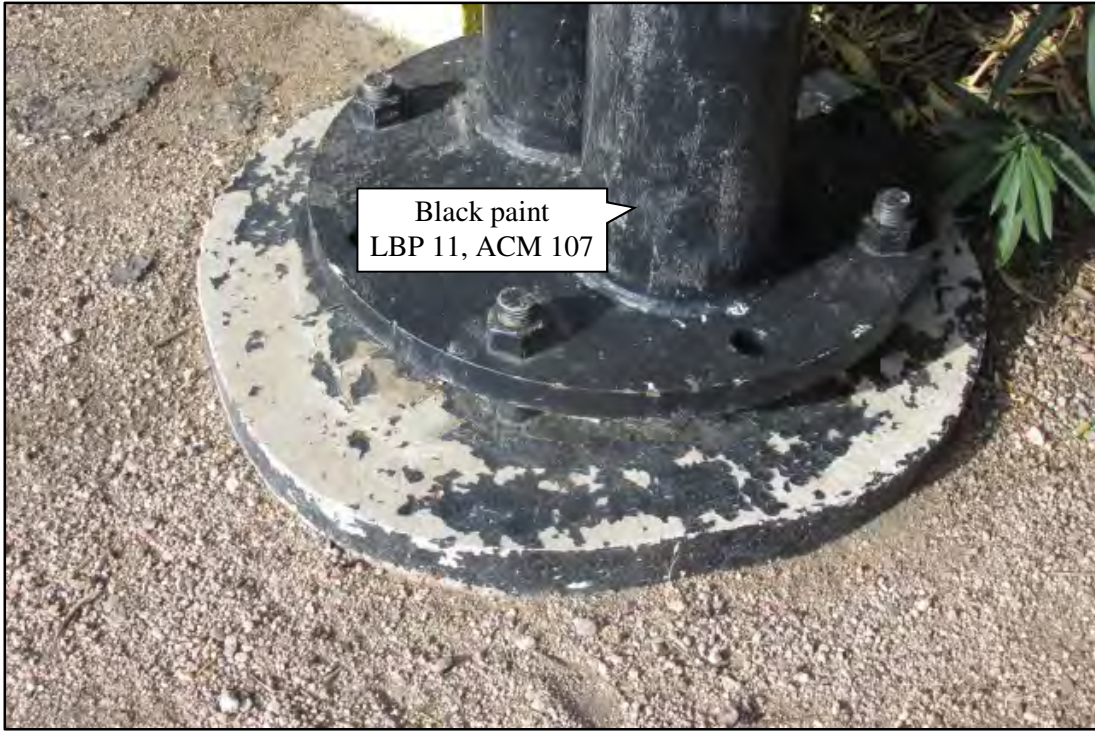
Photograph 29. Close-up view of black sign pole paint along US 93, near MP 70.3.
Photograph date: October 16, 2019.

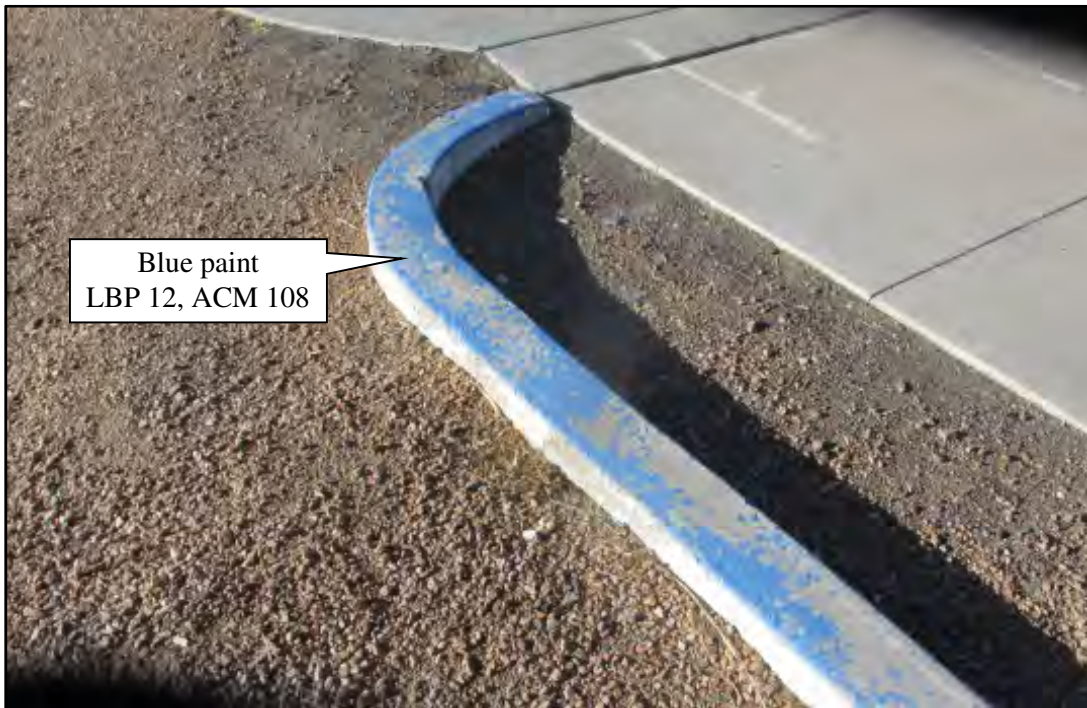
Photograph 30. View northeast of the blue curb paint along US 93, near MP 70.3.
Photograph date: October 1, 2019.

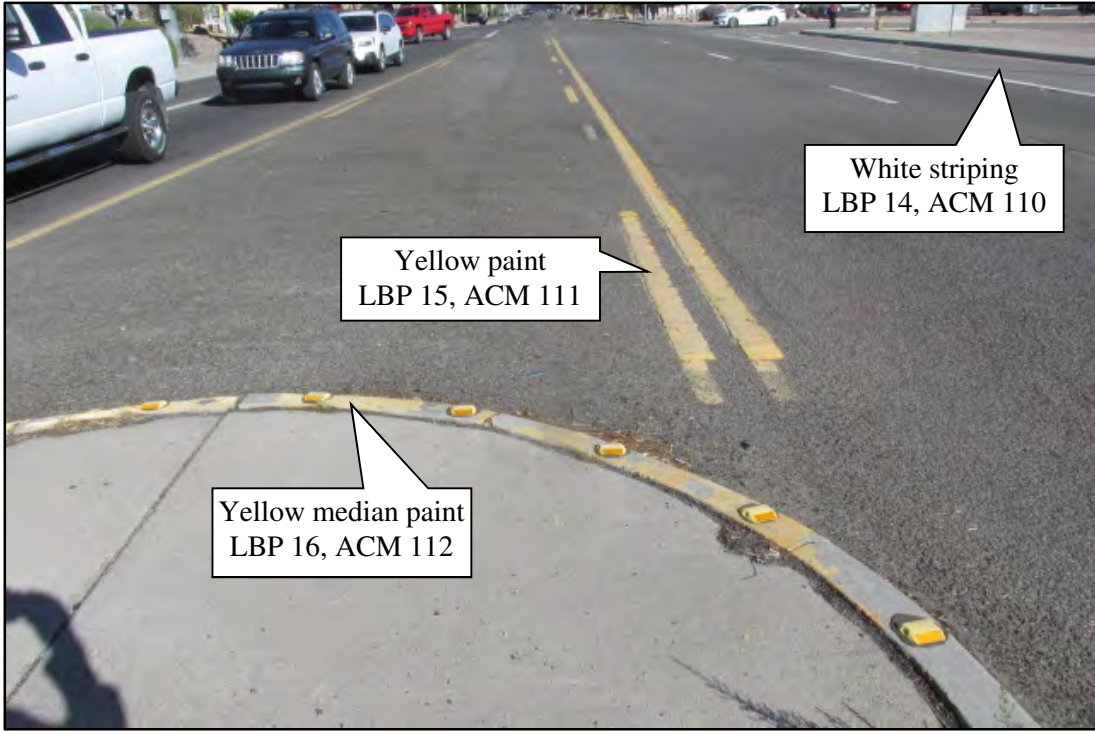
Photograph 31. View east of East Beale Street yellow median, and yellow and white striping paint.
Photograph date: October 1, 2019.

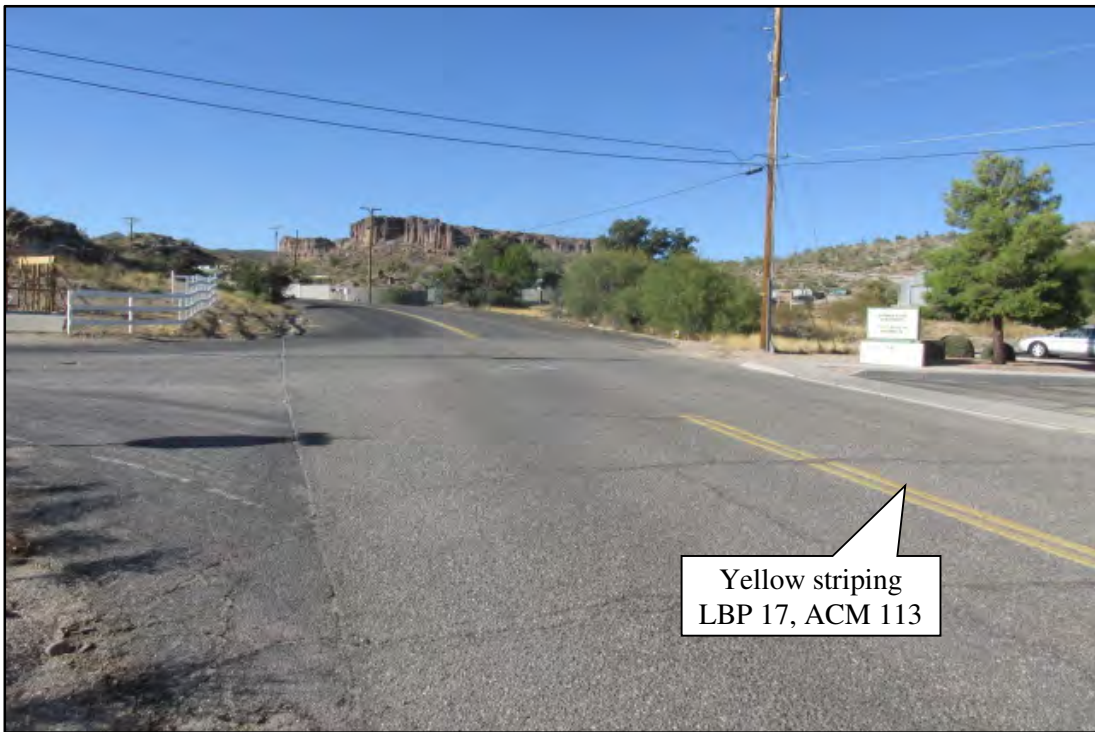
Photograph 32. View northwest of Fort Beale Drive yellow striping paint at Betty Lane.
Photograph date: October 1, 2019.
