Phase I

Environmental Site Assessment

I-40/US 93 West Kingman System Traffic Interchange

ADOT Project No. 040 MO 048 H7993 01C

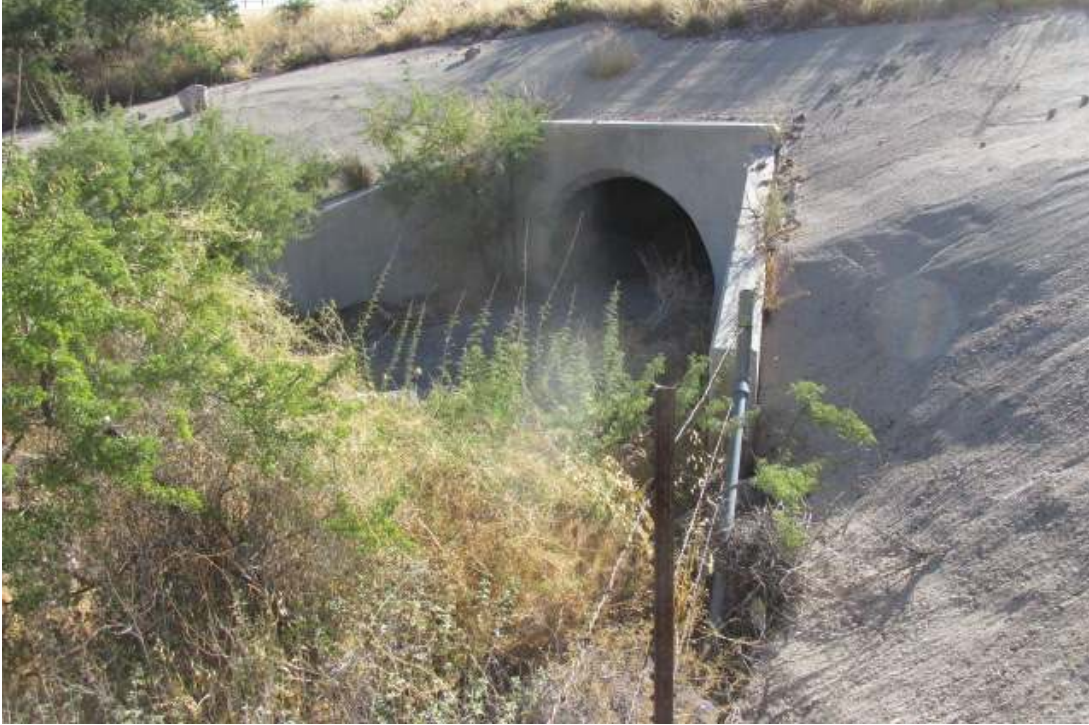
Photograph 9. View northeast of the I-40 reinforced corrugated metal pipe culvert (RCMP), near MP 48.3. Typical of the concrete drainage within the Study Area.

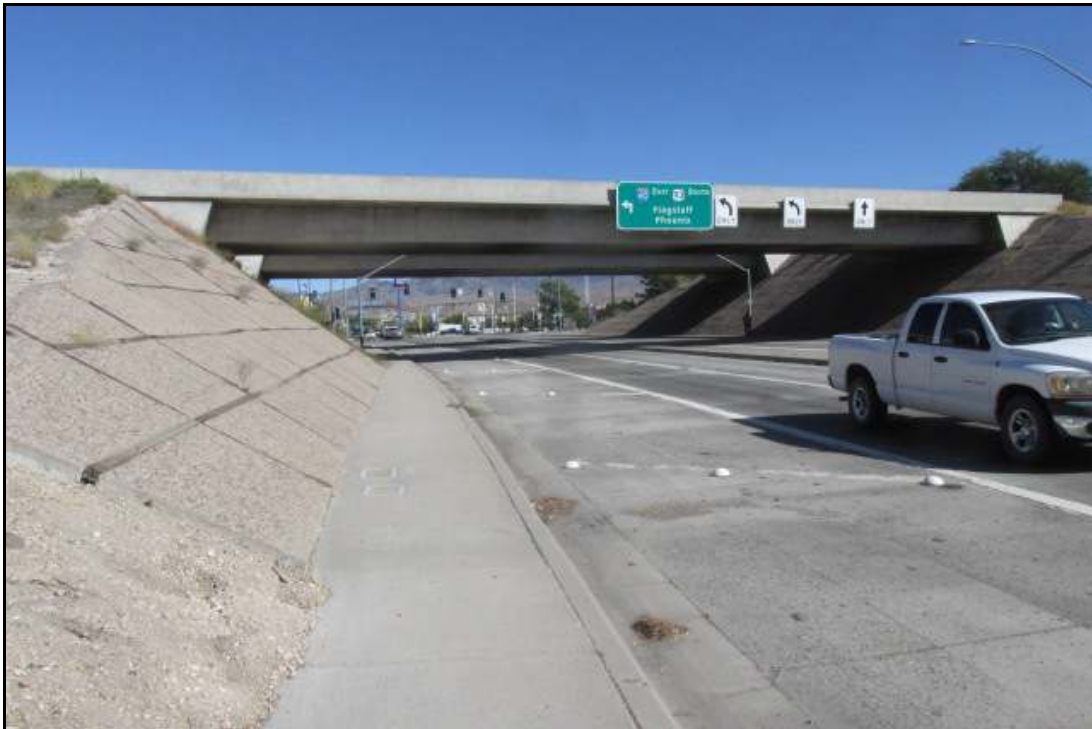
Photograph 10. View east of the West Kingman traffic interchange (TI) overpass (OP) eastbound (EB), I-40 at MP 48.4.

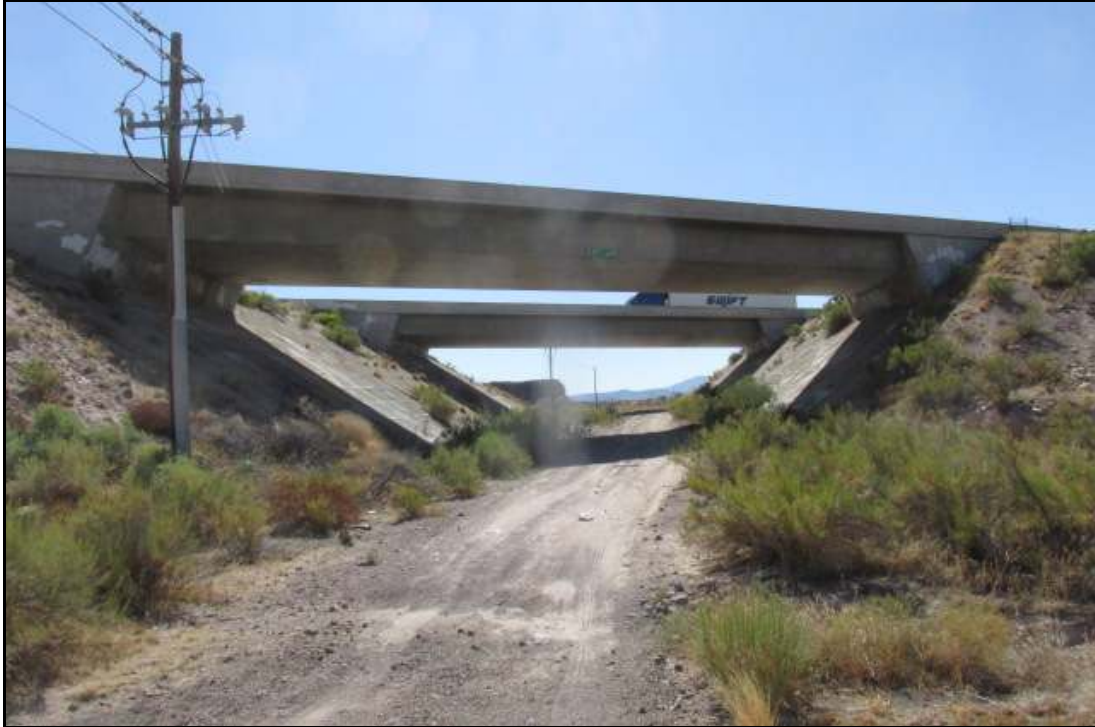
Photograph 11. View south of White Cliff Road OPs, I-40 at MP 50.09.
Photograph date: October 1, 2019.

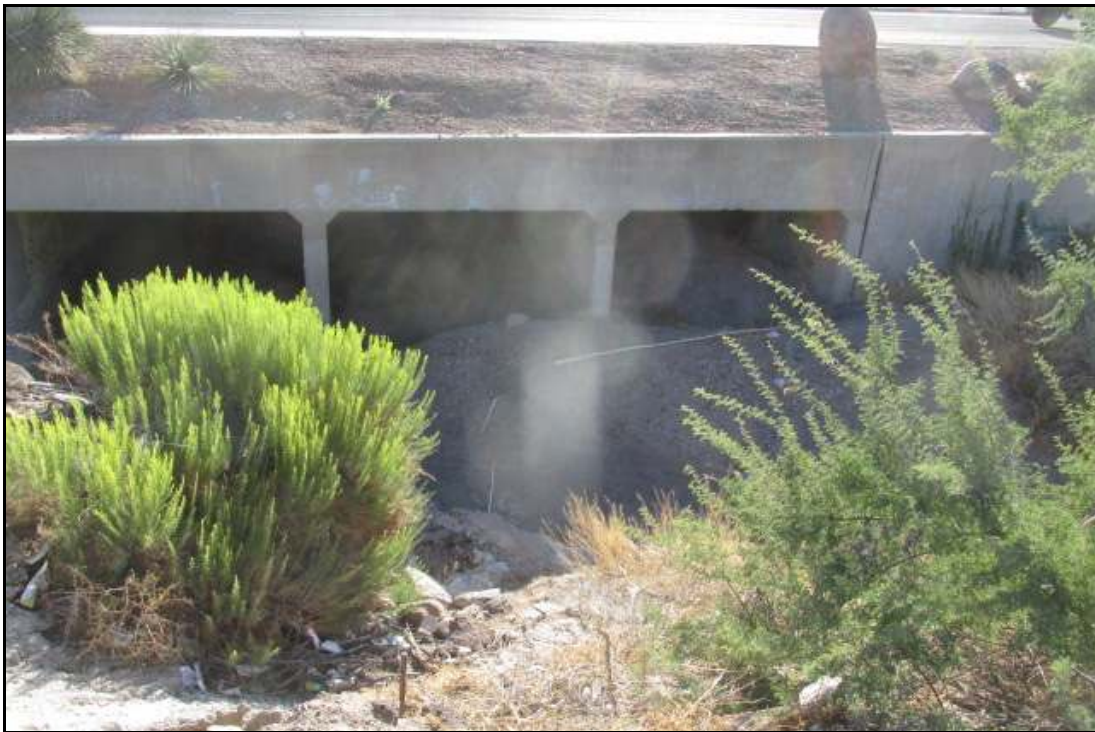
Photograph 12. View southwest of US 93 reinforced concrete box culvert (RCB) near MP 70.3.
Photograph date: October 1, 2019.

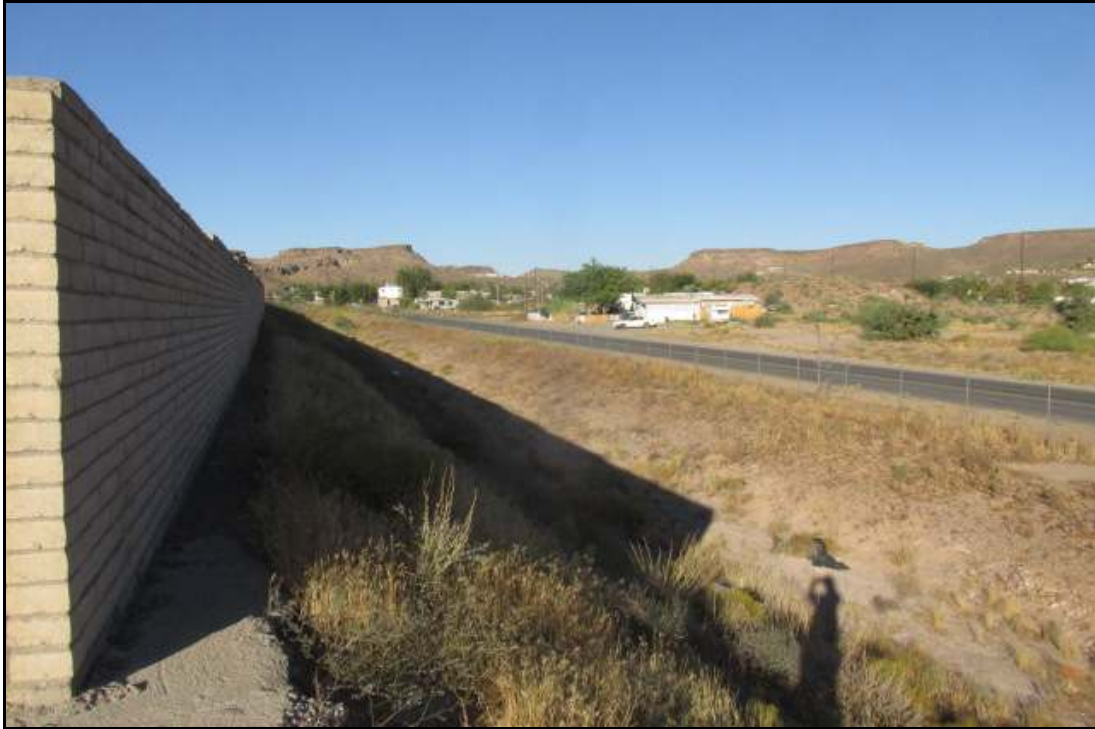
Photograph 13. View southwest of the I-40 north side drainage channel near MP 51.4.
Photograph date: October 2, 2019.

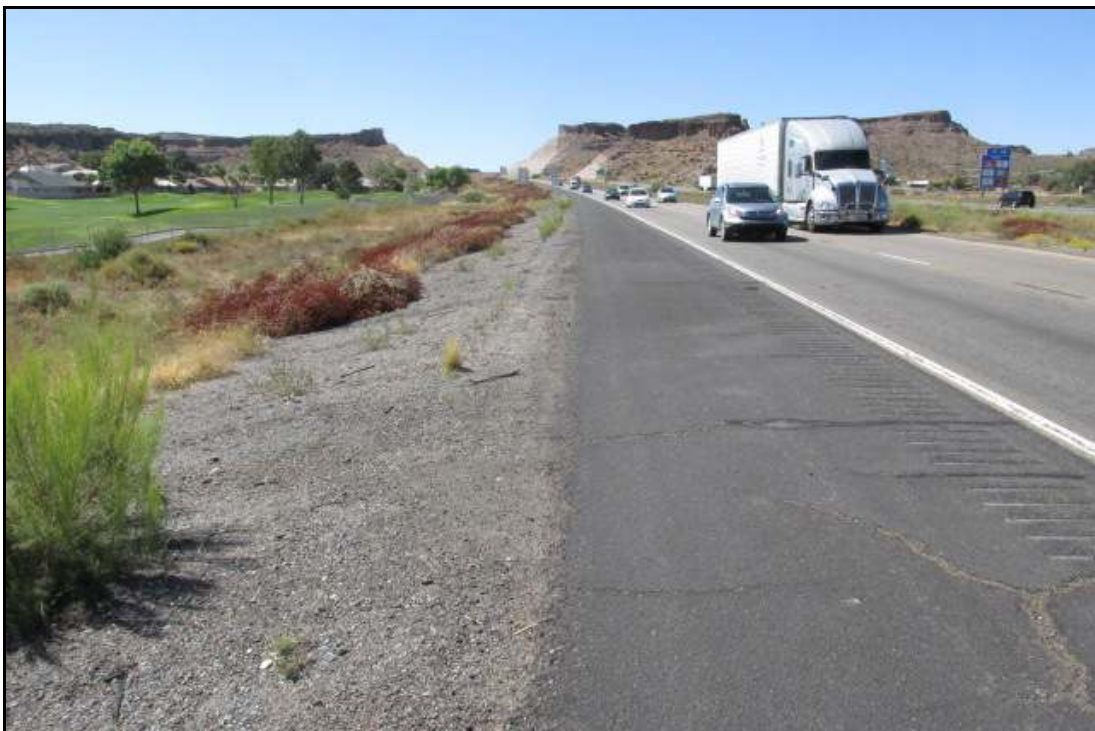
No surface structures or evidence of subsurface structures (e.g., sumps, vaults, oil/water separators, or other surface impoundments) were observed within the Study Area. Stormwater and drainage conveyance earthen channels are located along the north side of I-40 from the eastern project limits to approximately MP 51.0 (Photograph 14).

Photograph 14. View southwest of I-40 near MP 50.4, and the adjacent golf course.
Photograph date: October 2, 2019.
