Northwest Cochise County
Long- Range Transportation Plan

Railroad Crossing Assessment
Working Paper

March 2010

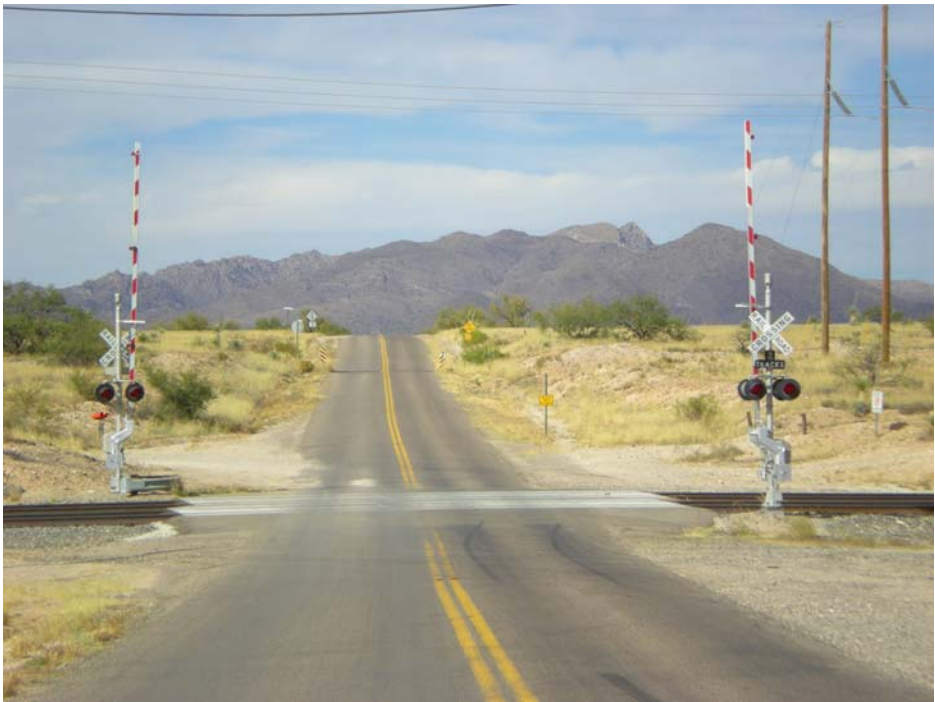
Photo No. 1

Mescal Road (748 709M) – located at railroad milepost 1023.65, the Mescal Road crossing includes one general travel lane in each direction that crosses two UPRR tracks. The crossing has been upgraded to include a concrete surface as well as safety gates with flashing lights.

View Direction of Photo:	
South	
Date: November 2009	
Description:	
Highway/Railroad at-grade crossing at Mescal Rd and UPRR. Crossing ID 748 709M

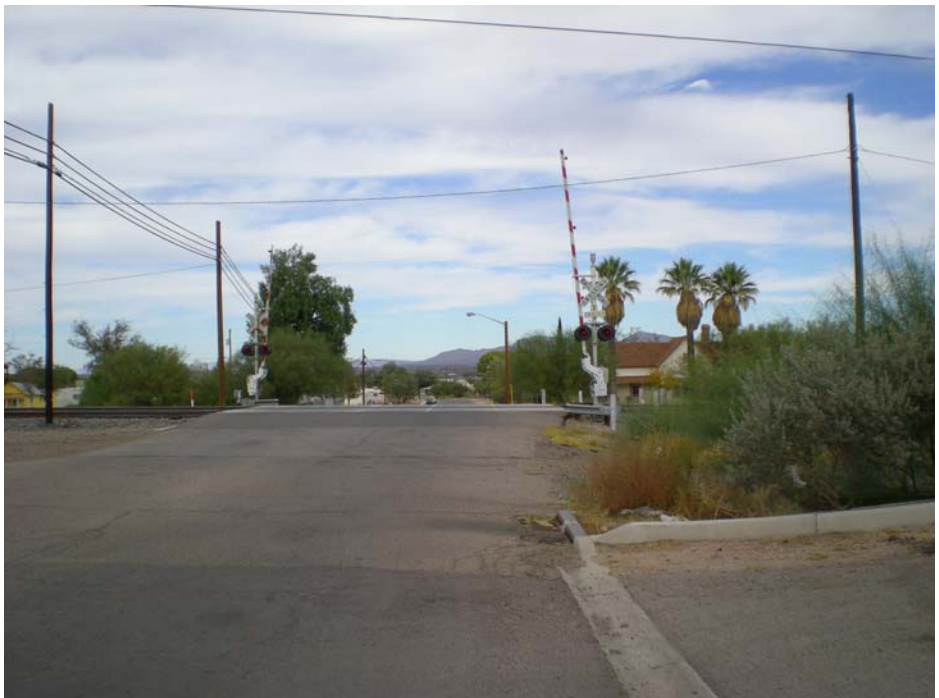
Photo No. 7

San Pedro Street (741 386V) – located at milepost 1032.68, the San Pedro Street crossing includes two general purpose lanes that cross two UPRR tracks. This crossing has been upgraded to include a concrete surface as well as safety gates and flashing lights. Similar to the Patagonia Street crossing, this crossing is one of two crossings identified by the FRA at this railroad milepost and is considered the crossing for the "Main" UPRR track. The maximum train speed for this crossing is 55 mph.

San Pedro Street (741 385N) – the second of two crossings identified at San Pedro Street is located at milepost 1032.69. Similar to Patagonia Street, this crossing is located at and includes the same crossing characteristics as crossing id 741 386V, previously described. This crossing is also identified by the FRA as crossing the "Spur House" track along the UPRR line. The maximum train speed for this crossing is 10 mph.

View Direction of Photo:	
North	
Date: November 2009	
Description:	
Highway/Railroad at-grade crossing at San Pedro Street and UPRR. Crossing ID 741 386V & 741 385N

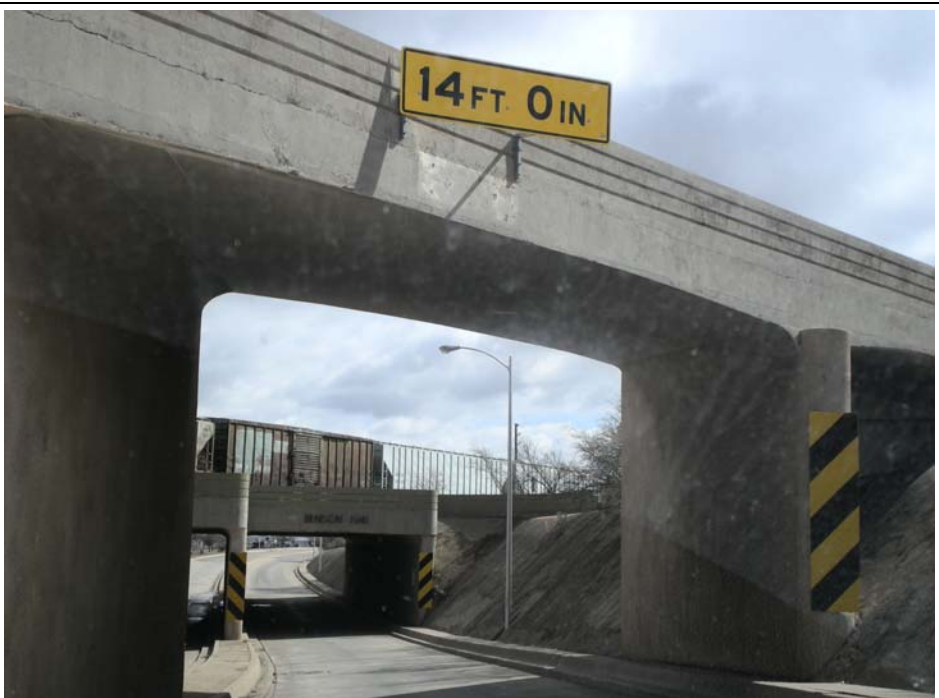
Photo No. 8

4th Avenue/I-10 Business (BUS) (741 387C) – located at milepost 1033.0, the 4th Ave/I-10 BUS crossing is the second grade-separated crossing located in the study area where the highway passes under two UPRR tracks. 4th Avenue includes four general purpose travel lanes separated by a center median.

Currently, there are two existing grade-separated crossings located within the study area, both of which include UPRR and I-10. One is located along I-10, west of Ocotillo Street where I-10 passes under the railroad. The other is located at the Business I-10 (B-10)/SR 80 interchange where B-10/I-10 passes under the railroad. The B-10/I-10 crossing was identified by project stakeholders as needing improvements for congestion relief.

View Direction of Photo:	
Date: February 2010	
Description:	
Grade separated crossing at 4th Avenue/I-10 BUS and UPRR. Crossing ID 741 387C

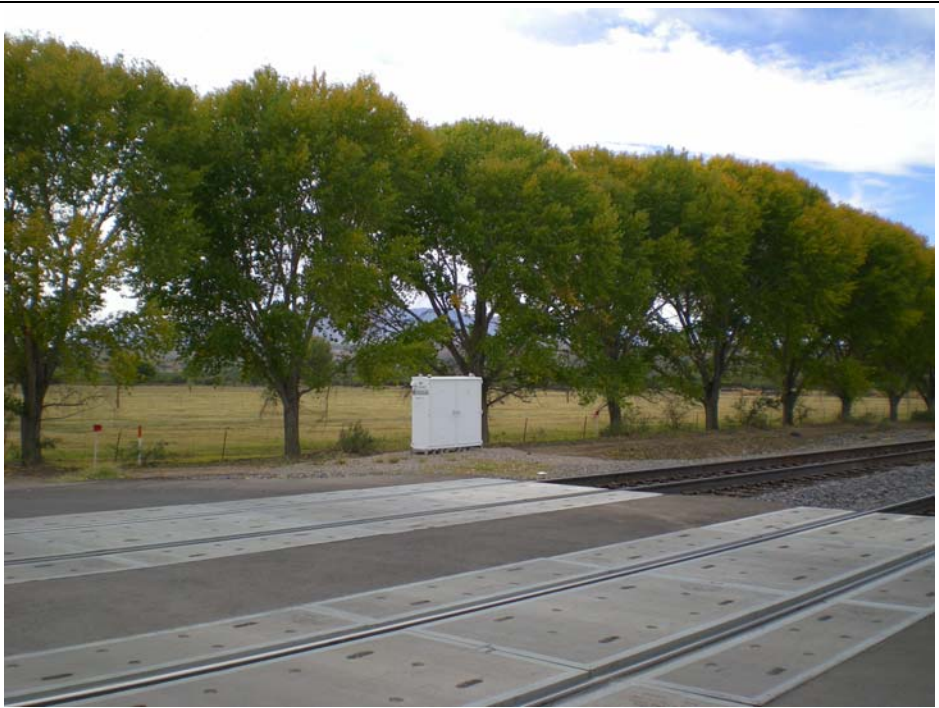
Photo No. 10

Benson Airport Road (741 388J) – located at milepost 1034.25, the crossing at Benson Airport Road includes one travel lane in each direction which crosses two UPRR tracks. The crossing has been upgraded to include a concrete surface as well as safety gates and flashing lights.

View Direction of Photo: Northeast	
Date: November 2009	
Description: Close up of improved crossing bed at Benson Airport Rd and UPRR. Crossing ID 741 388J

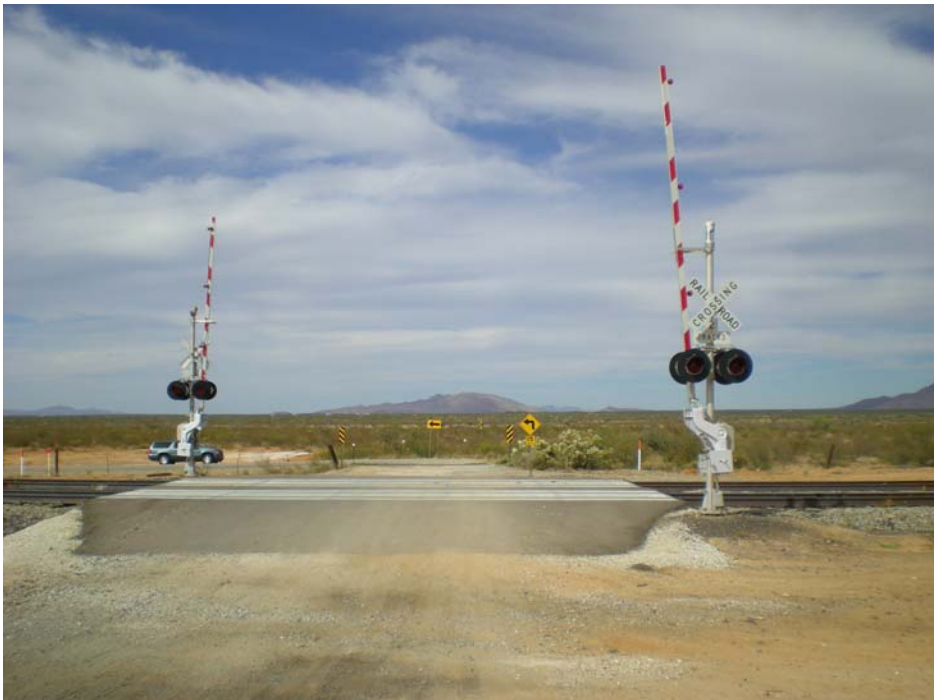
Photo No. 11

Sibyl Road (741 389R) – located at milepost 1041.93, the Sibyl Road crossing includes a dirt road with one travel lane in each direction which crosses two UPRR tracks east of Benson. This crossing has been upgraded to include a concrete surface with safety gates and flashing lights.

View Direction of Photo:	
North	
Date: November 2009	
Description:	
Highway/Railroad at-grade crossing at Sibyl Road and UPRR. Crossing ID 741 389R

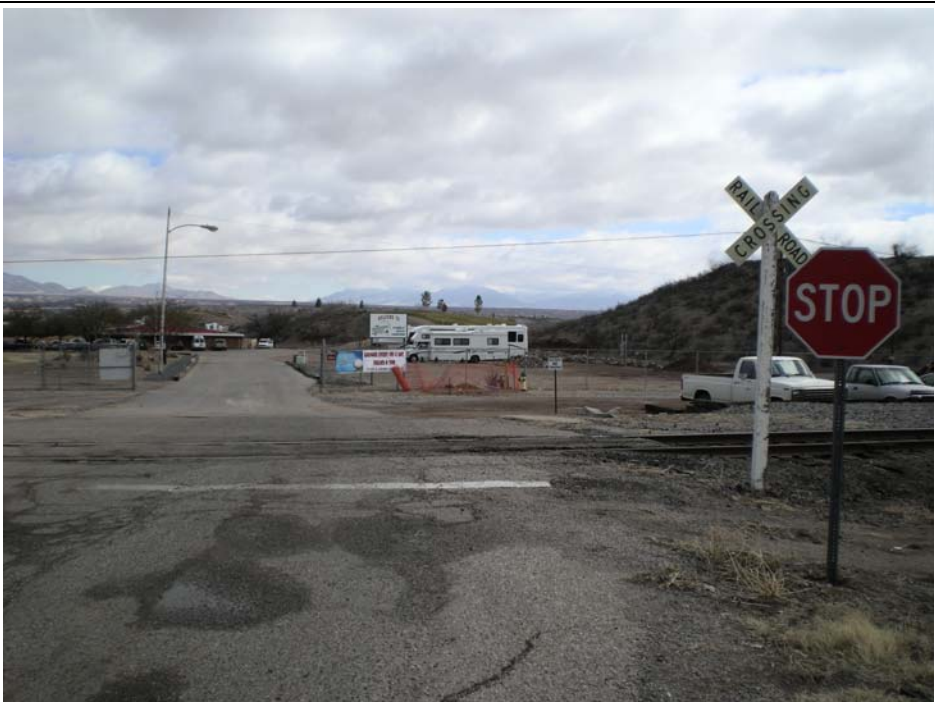
Photo No. 12

Country Club Road (741 720N) – located at milepost 1034.23, Country Club Road is a private road with two general purpose lanes that cross the single track SPSR line. This crossing has an asphalt surface and is protected by crossbuck signs and stop signs. This private road provides access to the golf course located southeast of the City of Benson.

View Direction of Photo:	
Date: February 2010	
Description:	
Private highway/railroad at-grade crossing at Country Club Road and SPSR. Crossing ID 741 720N

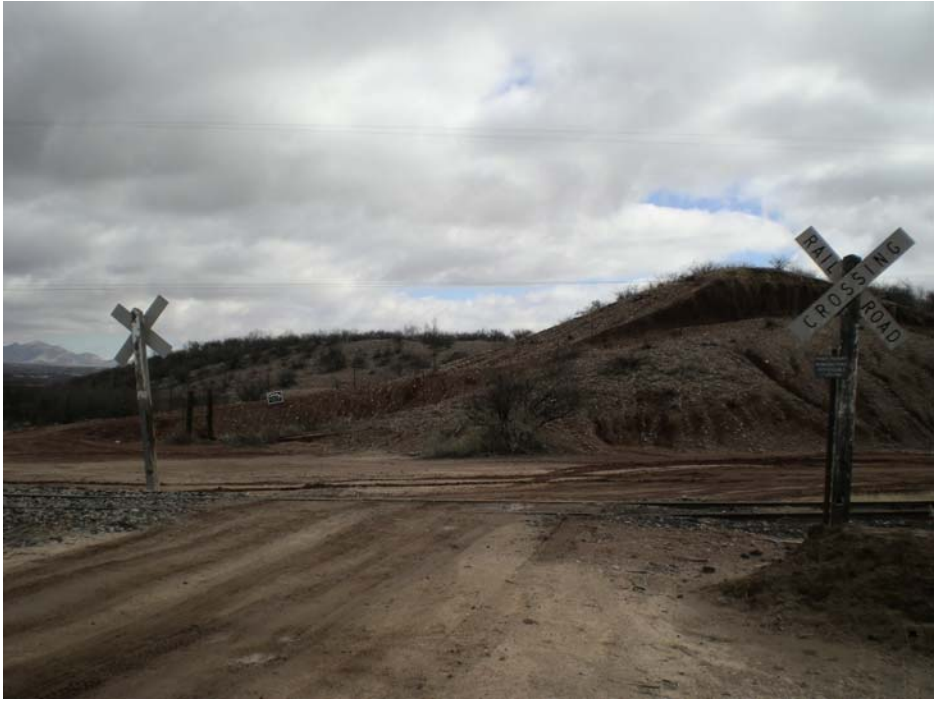
Photo No. 13

Heartleaf Lane (741 721V) – located at milepost 1034.43, Heartleaf Lane is a private dirt road that crosses the single track SPSR line southeast of the City of Benson. Additional crossing information is not available for this crossing

View Direction of Photo:	
Date: February 2010	
Description: Private highway/railroad at-grade crossing at Heartleaf Lane and SPSR. Crossing ID 741 721V

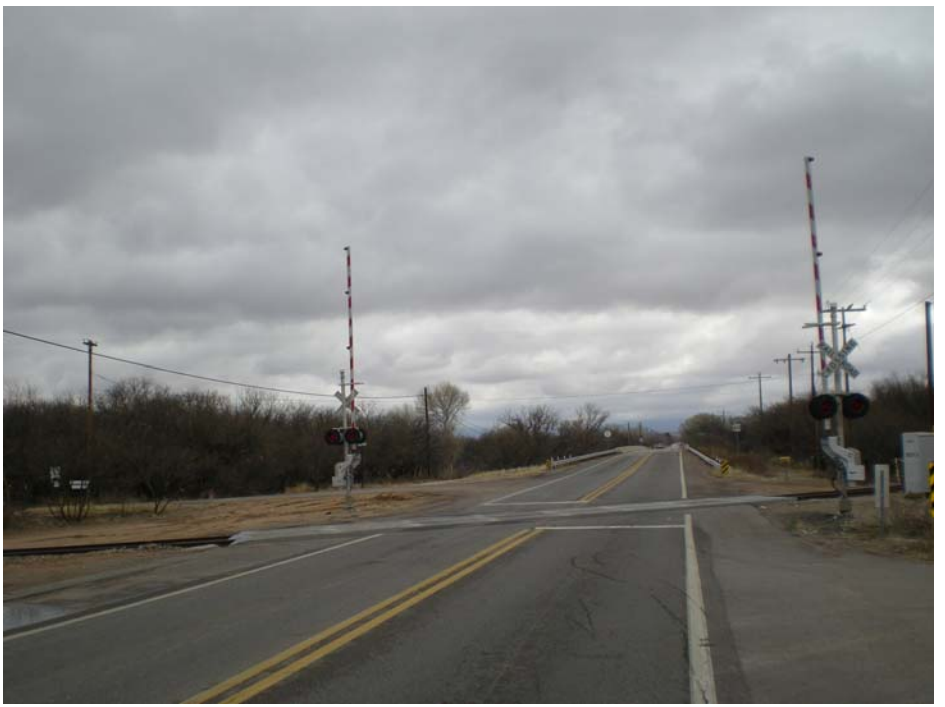
Photo No. 14

SR 80 (741 722C) – located at milepost 1037.90, SR 80 is a state route with one general purpose travel lane in each direction. SR 80 crosses the single track SPSR line in the southwestern portion of the study area. This crossing has been upgraded to include a concrete surface as well as safety gates and flashing lights.

As part of the double tracking project, for the UPRR Sunset Route through Northwest Cochise County, all public at-grade crossings along the UPRR line were updated to the most recent industry standards and include concrete crossings, advance warning signs, crossbucks, bells, gates, and flashing lights. Recently, the only public crossing along the SPSR line at SR 80 was updated by replacing the rubber crossing material with a concrete surface.

View Direction of Photo:	
Date: February 2010	
Description: Highway/railroad at-grade crossing at State Route 80 and SPSR. Crossing ID 741 722C
