Tech Brief

Maintenance of High Tension Cable Barrier

CATEGORY: Maintenance

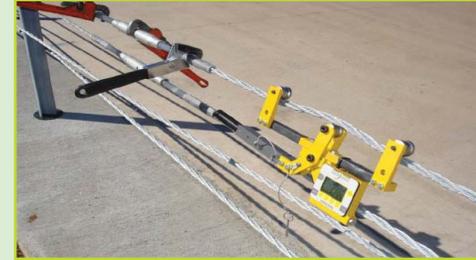
A

Cable Inspections: It is important that crews routinely check tension, even in the absence of an impact (photograph A), as per manufacturers' recommendations. This is particularly important during the first few years following cable installation. Cables can lose tension because of construction stretch, temperature changes, anchor creep, fitting slippage, and/or previous impacts elsewhere in the same run of HTCB. Maintenance personnel should also check the tension and inspect the individual cables for kinks or broken strands as part of routine maintenance (at least annually), and also following any repair, in accordance with manufacturer guidelines.

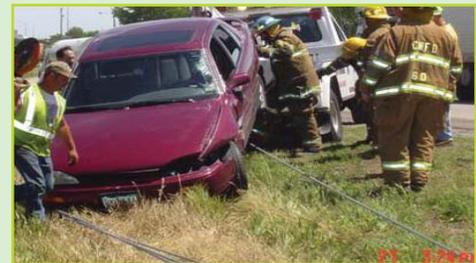
B

In situations where there is an impact and the vehicle becomes tangled in the cable (photograph B), it is important to keep the cable intact. In many situations, the vehicle can be removed by pulling it in the opposite direction from which it hit the system. Maintenance personnel (as well as emergency responders) should consider cutting the cables only under life-threatening situations and other alternatives for loosening the cables are not feasible. Alternatives to cutting the cable include:

- Loosen cables at the turnbuckles.
- Cut a turnbuckle rather than a cable. This alternative requires removing the adjacent posts on either side of the turnbuckle.

Note: Before cutting a turnbuckle, ensure all personnel are clear of the cable. Cut the center of the turnbuckle between two undamaged posts away from the impact area. Contact manufacturers for any specific considerations for their particular system.
