REPORT NUMBER: FHWA-AZ89-260

SIZING RIPRAP FOR THE PROTECTION OF APPROACH EMBANKMENTS & SPUR DIKES AND LIMITING THE DEPTH OF SCOUR AT BRIDGE PIERS & ABUTMENTS

Volume I: Literature Review & Arizona Case Histories

Prepared by:
Simons, Li & Associates, Inc.
4600 South Mill Avenue, Suite 280
Tempe, Arizona 85282

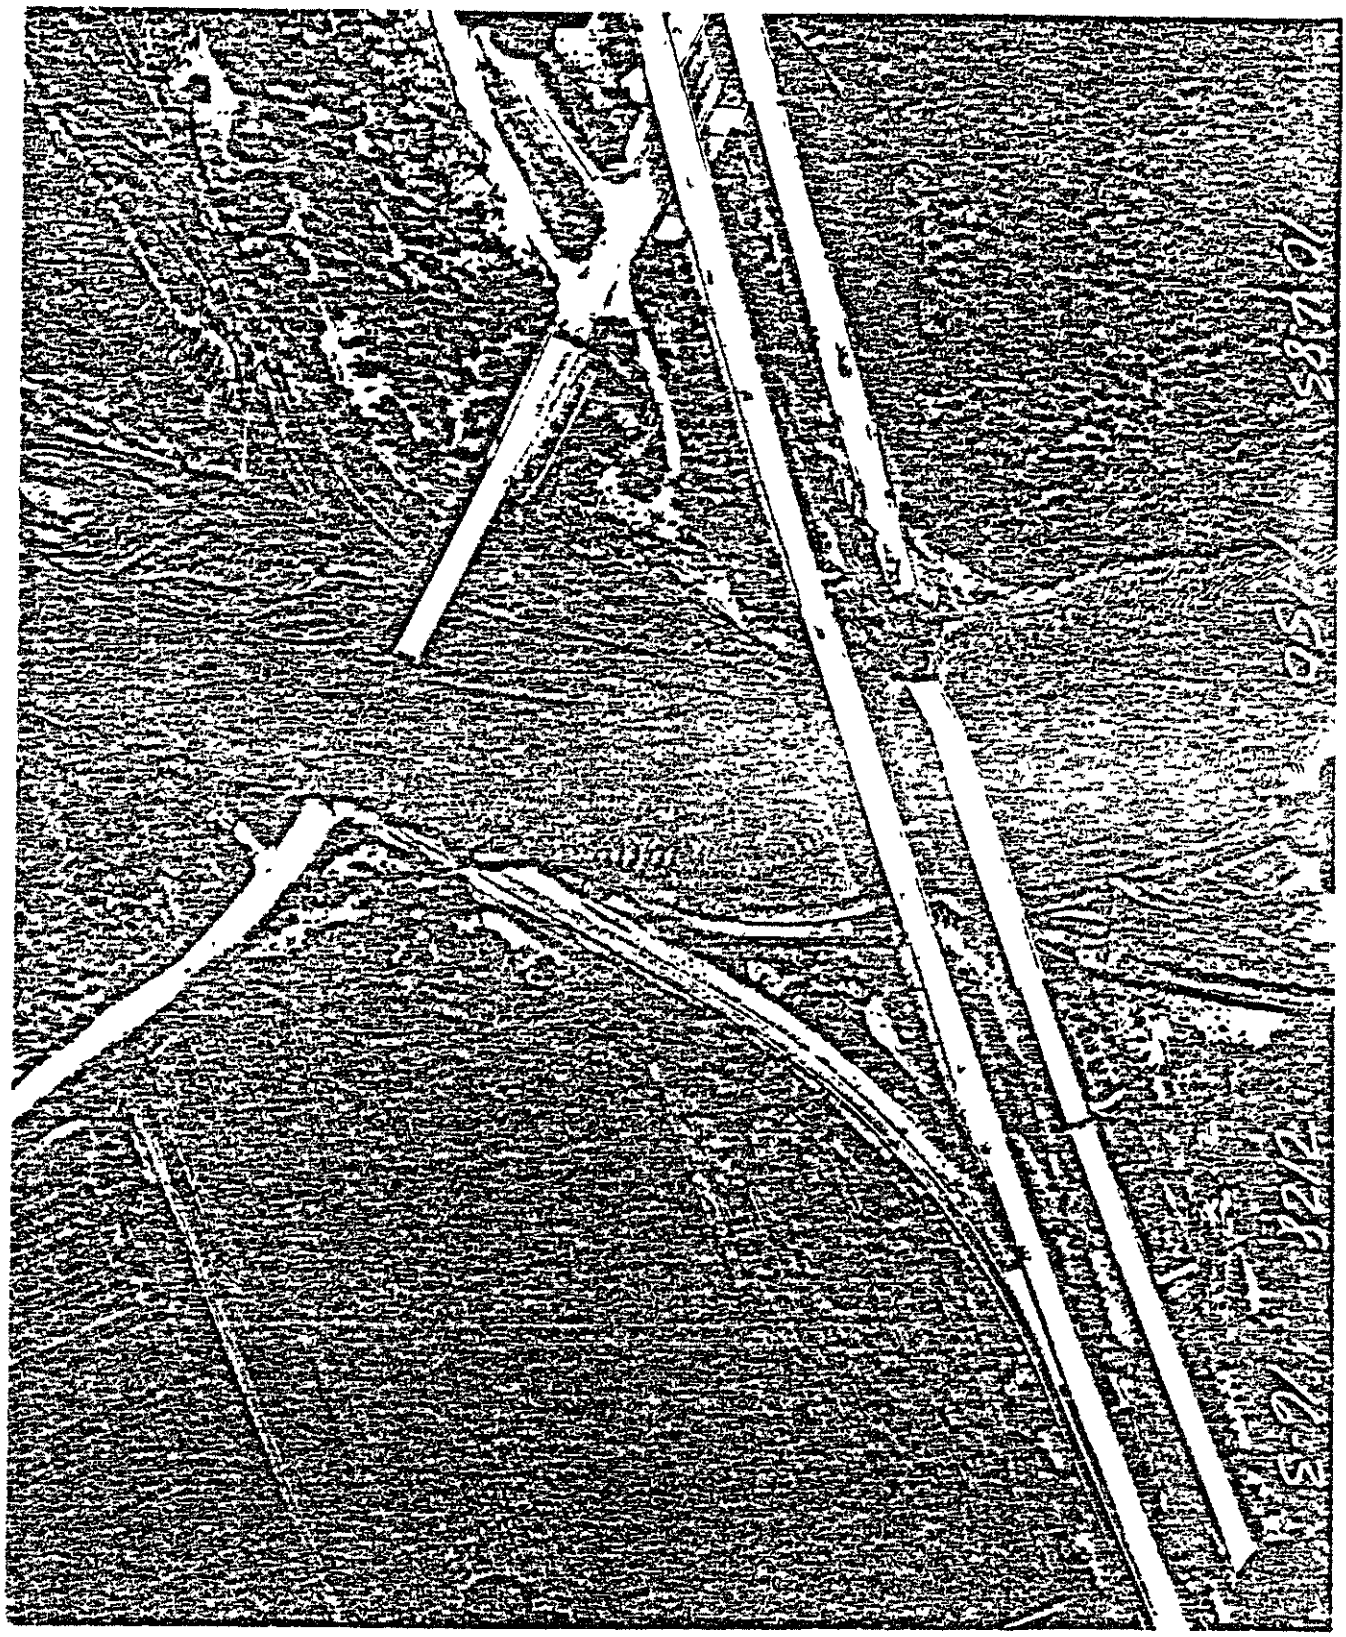
Figure 6. Santa Cruz River topography at I-19 bridge after October 1983 flood. Scale 1"=133' (ADOT Hydraulics Group)

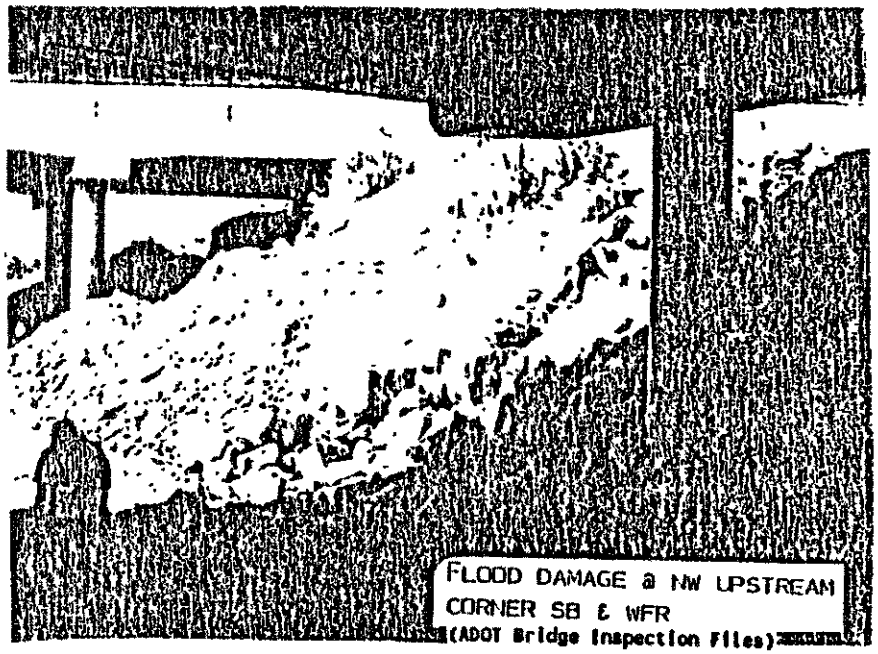
FLOOD DAMAGE @ NW UPSTREAM CORNER SB & WFR
(ADOT Bridge Inspection Files)
