ARIZONA DEPARTMENT OF TRANSPORTATION

REPORT NUMBER: FHWA-AZ-7904

PERFORMANCE OF CONCRETE JOINT SEALANTS IN HOT CLIMATES

Final Report

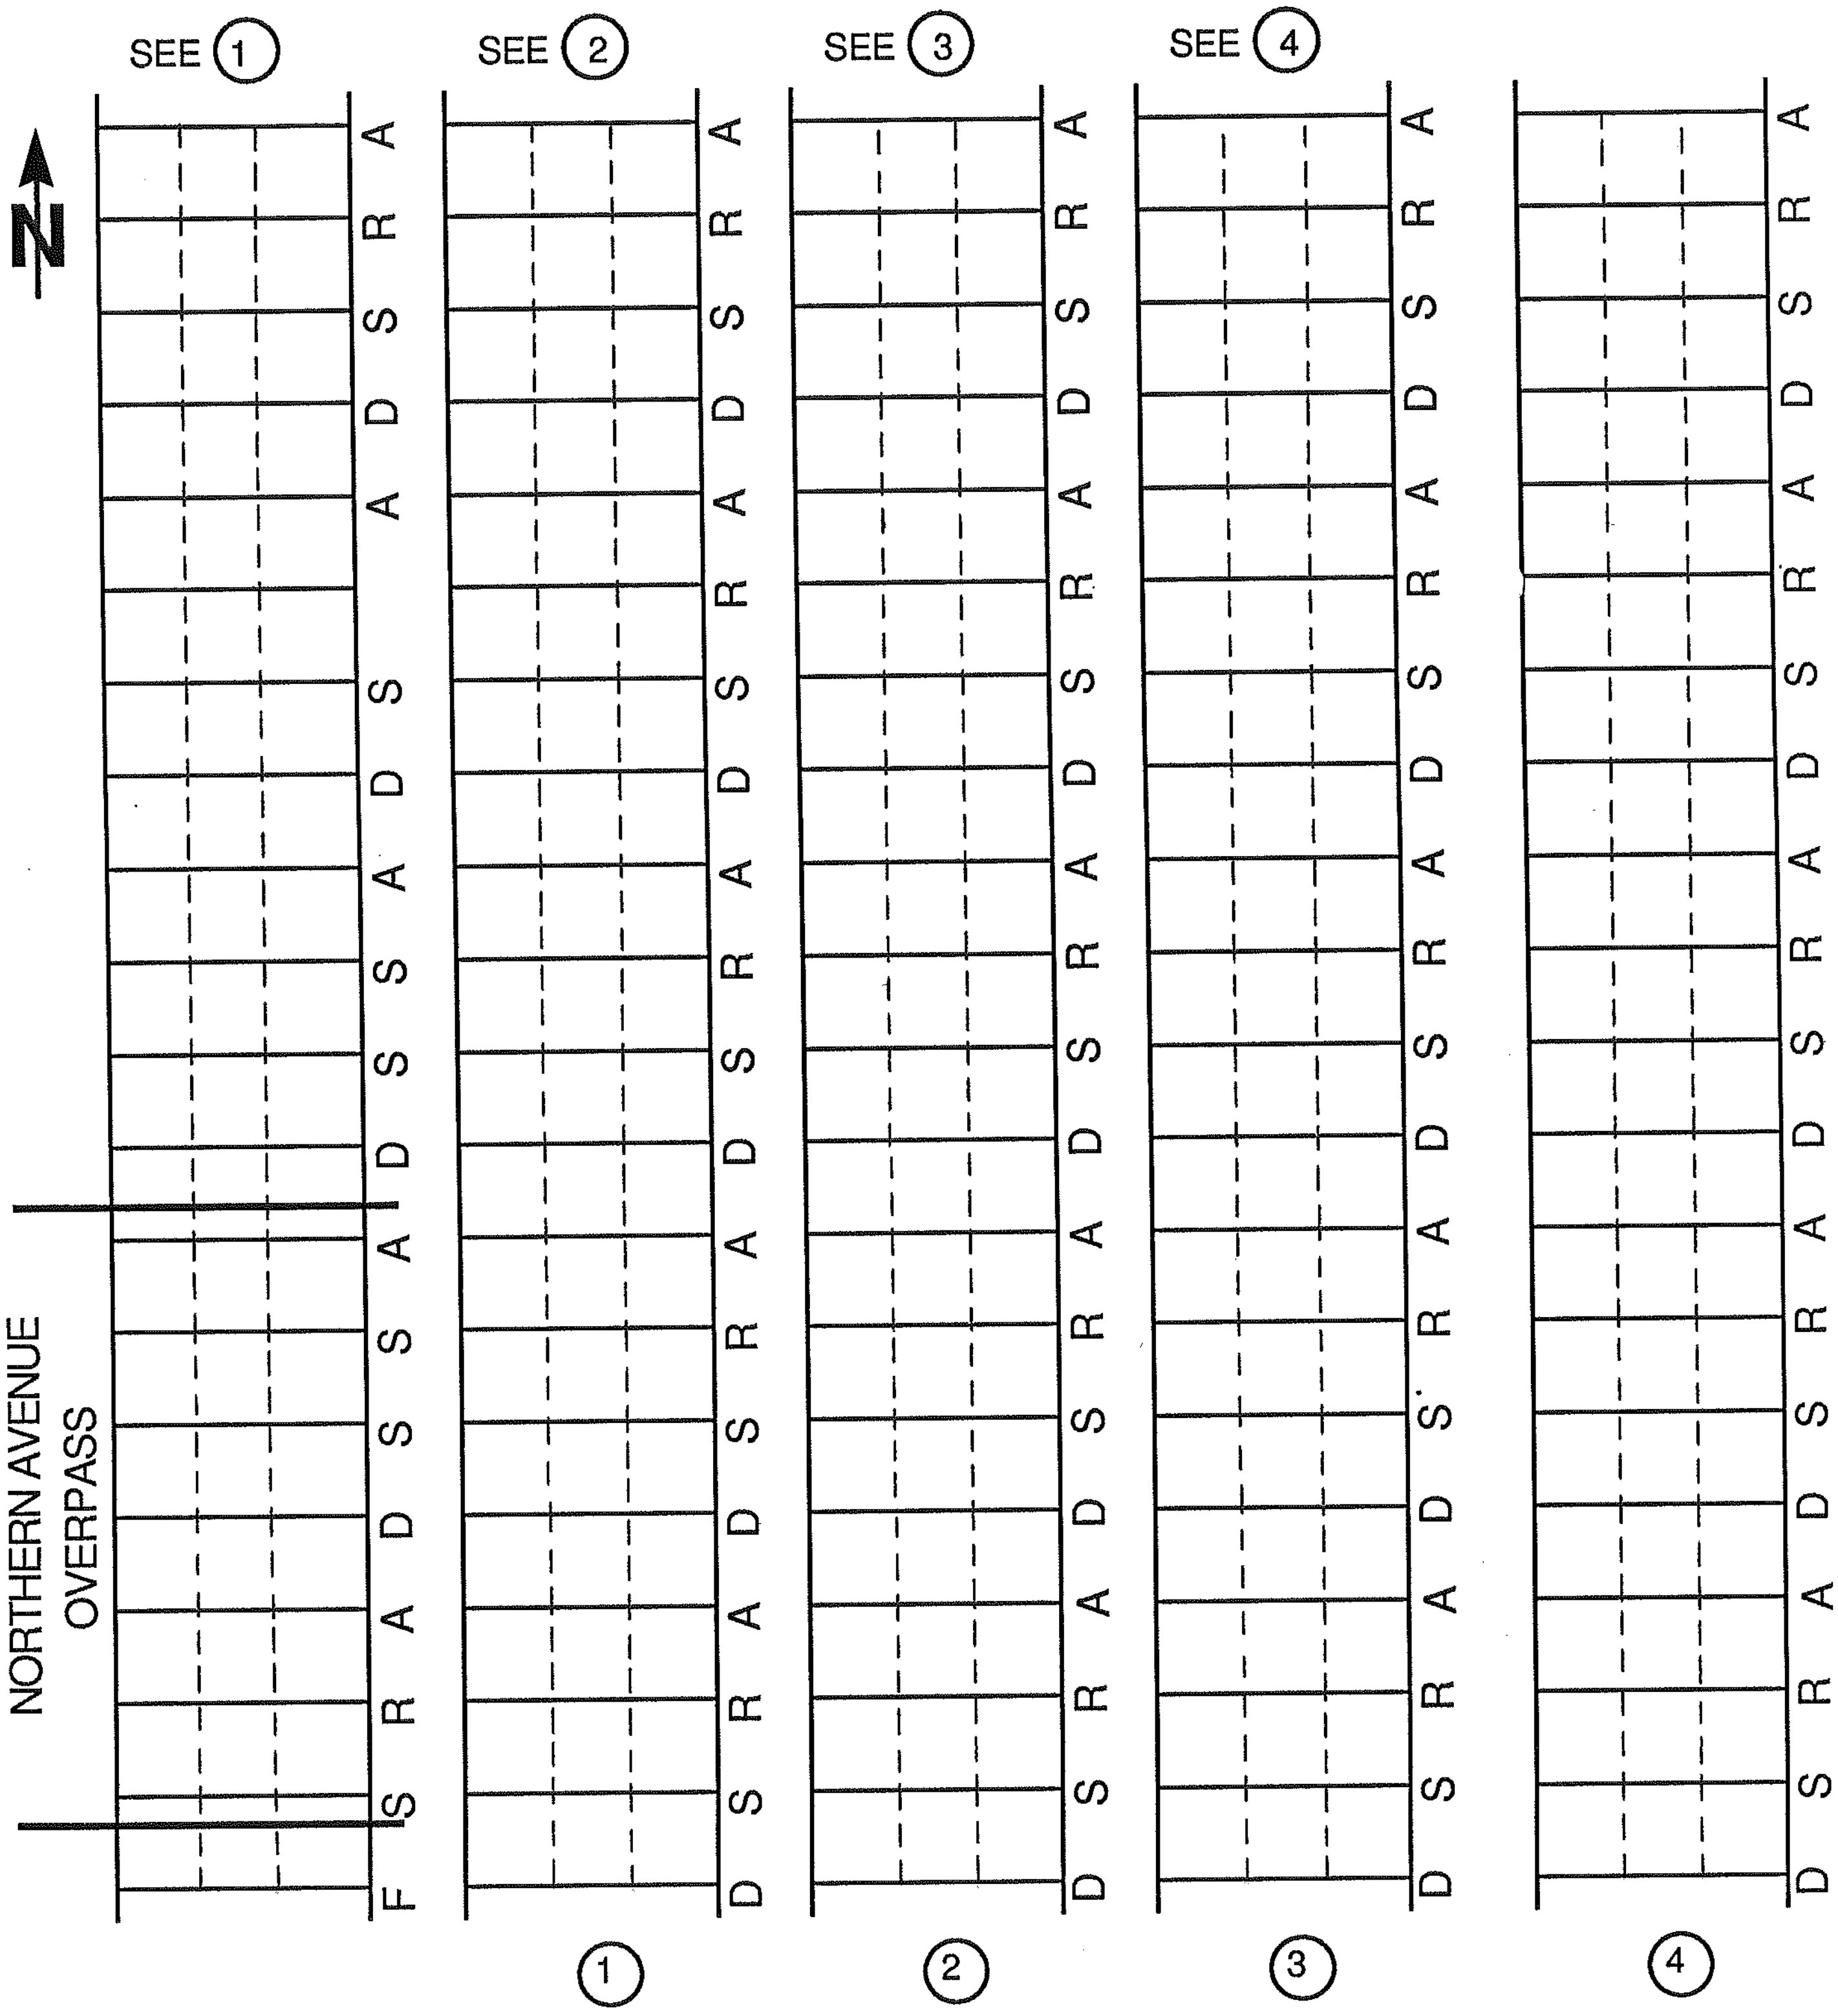
FIGURE 3. - LOCATION OF TEST SEALANTS

Joint geometries for the experimental project were constructed in accordance with the corresponding manufacturer's specifications (Table 2). The location of the different test sealants on the project are illustrated in Figure 3.

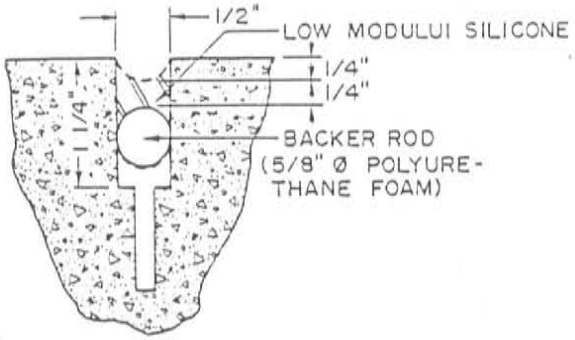
FIGURE 4 - DOW 888 JOINT

Dow 888, unlike the other sealants used on this project, is cold applied. Prior to the placement of the joint sealant, a 5/8" diameter polyurethane foam backer rod was placed in the joints to a depth of 7/8" below the pavement surface (Figure 4).

The performance of the 24 joints sealed with Dow 888 has been good. The sealant set up quickly to a tack free states, remained firm and resilient, and appeared to be unaffected by temperature variations. There has been no embedment of incompressibles to date. When surveyed in February 1982 (approximately two and one-half years after installation), all of the 24 joints were in excellent condition. In the survey conducted in June 1984, seven joints were noticed in which the sealant was too high and had pulled away from the joint wall. In each case the torn length occurred in the wheel path and was less than ten percent of the length of the joint. Heavy infiltration of sand and larger incompressibles was noted in these area. Additionally, a few other areas were noted in which the sealant was flush with the pavement surface. However, apart from these small areas, the sealant is well bonded to the sides of the joint walls. In order to test the ability of the sealant to bond to the concrete a small transverse cut was made and the sealant was pulled out of the joint. Except in the poorly sealed areas the sealant failed in cohesion rather than adhesion. In 1987 a final evaluation was performed and the joints were in the same condition as the 1984 evaluation. Roughly 20 percent of the joints had small bond failures of 1' or less caused by the sealant being too high.

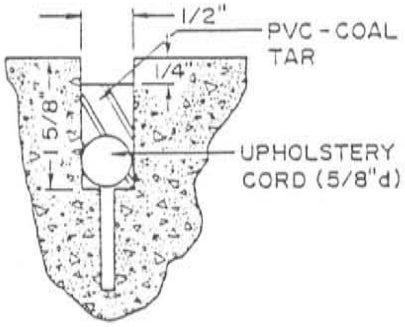
FIGURE 5 - SUPERSEAL JOINT

The Superseal 444 was placed by a subcontractor under the supervision of the manufacturer's representative. Prior to sealant placement, an upholstery-cord backer rod was placed in the joints (Figure 5). The sealant was heated in a double-boiler melter-kettle (Figure 10) to above 275°F. The hose, wand, and nozzle used to place the material was similar to that used in the Dow 888 placement. The sealant flowed quickly into the joints with no apparent problems. The temperature of the sealer was 290°F and the air temperature at the time of placement was 90°F.

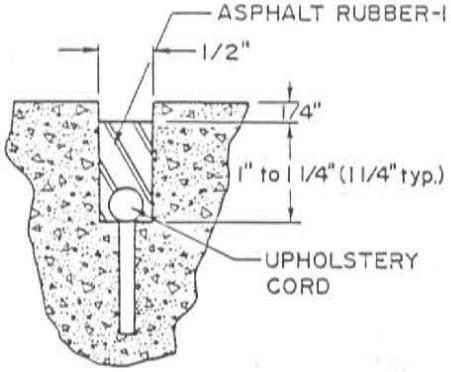
FIGURE 6 - OVERFLEX JOINT

The equipment used to install the Overflex-MS2 was the same as that used to install Superseal 444. A rubberized asphalt blend of AR-2000 asphalt and TPO-44 was blended and allowed to react in a double-boiler melter-kettle on site. The sealer was placed by the subcontractor at a temperature of 375°F. The air temperature at the time of placement was 85°F. A typical cross section of the joint is shown in Figure 6.

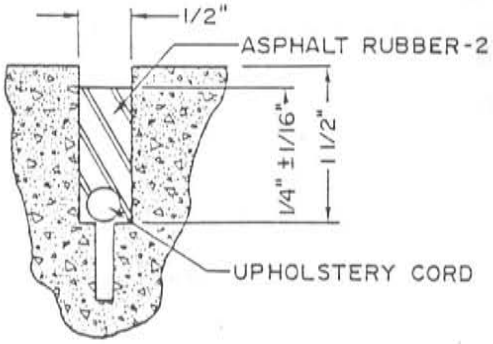
FIGURE 7 - ARCO JOINT

The manufacturer placed their own plant blended rubberized asphalt. The first ten joints were placed using a 1" placer nozzle which produced an occasional overfilled or underfilled joint. After the tenth joint, a smaller nozzle was used which produced better results. The equipment used was similar to that used to install the Superseal 444 joint sealer. The material was placed at temperatures varying from 350°F to 395°F. The air temperature at the time of installation was 90°F. An upholstery cord was used to prevent the sealant from seeping into the lower recess of the joint (Figure 7).

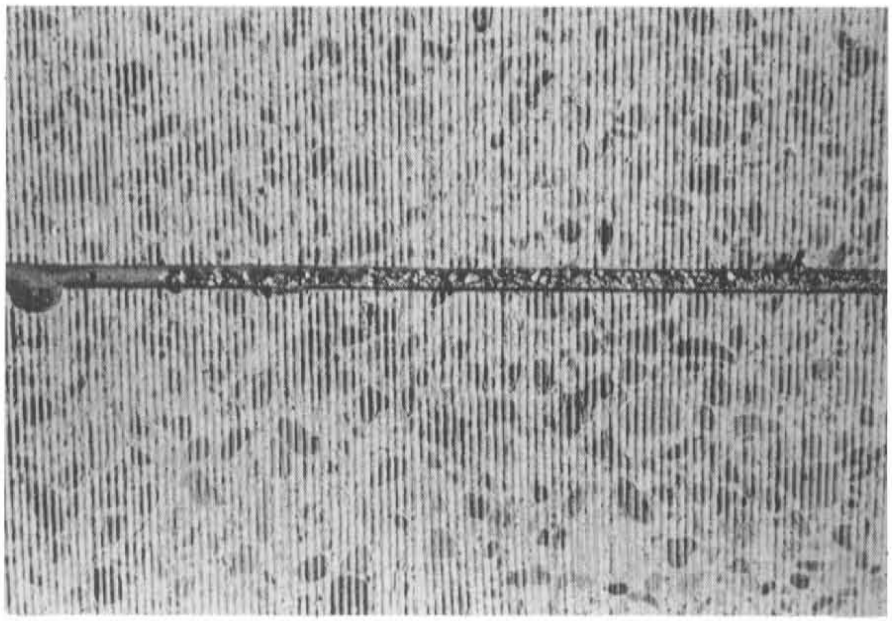
The appearance immediately after construction of the joints sealed with Superseal 444 was very good. However, after about one and one-half years of service, the sealant hardened, particularly at the top, and cracks were noticed in the top 1/8" of the joint seal. At the same time the bond between the sealant and the sides of the joint began to deteriorate in the top 1/8" of the seal. Debris had also collected in most of the joints and the survey performed in February 1982, showed slight embedment of incompressibles in seven of the seals. Below the top 1/8" of the seal, the bond between the joint walls and the sealant is in good condition. At one joint, however, a four foot long pull-out occurred in October 1981. The ductility of the sealant is apparently influenced by temperature. The ambient temperature at the time of the survey was approximately 110°F, and during this survey it was noticed that the cracks formed in the sealant during the winter had closed due to the contraction of the joint and softening of the sealant. In March of 1987 it was noted that the top 1/4"-1/2" of the sealant was heavily weathered. There was a slight problem with incompressibles and the joint was not sealed on the surface.

FIGURE 11. - SUPERSEAL 444 JOINT WITH DEBRIS ON TOP

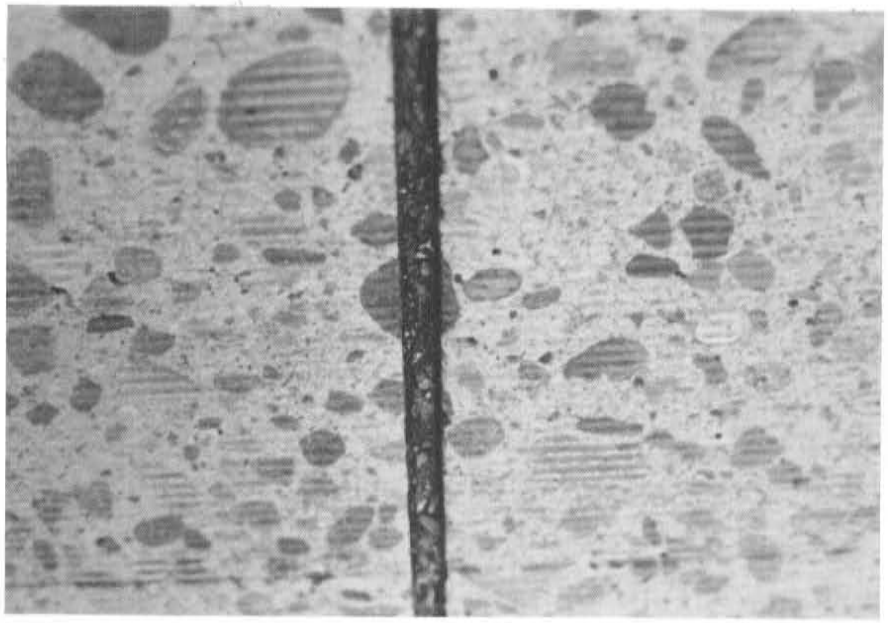
The Overflex-MS2 set up quickly. The day after installation the surface was found to be firm, resilient, well bonded to the side walls and capable of rejecting incompressible material pressed into it. However, debris collected easily in these joints and as early as May 1980, embedment of incompressibles was noticed in almost all of the joints. In the survey conducted in March 1981 the embedment of incompressibles in the sealant had reached severe proportions (from 70% to 100% of the length of the joint). The sealant had also hardened, particularly where incompressibles were embedded. In the survey conducted in February 1982, it was noted that all of the joins

were brittle, however, no cracks were noticed and a good bond between the sealant and the joint walls was maintained. During the subsequent summer surveys, the sealant had softened considerably and continued to collect incompressibles (Figure 12). In March of 1987 the material was brittle and full of incompressibles.

FIGURE 12. - INCOMPRESSIBLES EMBEDDED IN OVERFLEX-MS2

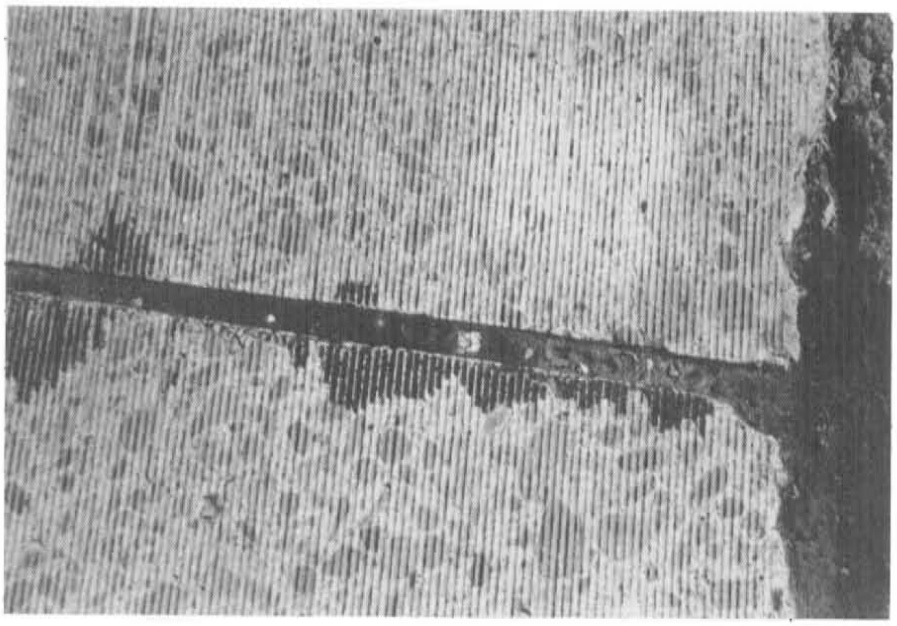
During the first survey, performed three days after the installation of the sealant, it was noted that the sealant had not set up and that it was possible to penetrate a finger through the sealant. Four and one-half months later, the material still had not set and many incompressibles were embedded in it (Figure 13). The sealant was hard and brittle in places where incompressibles were embedded and soft and sticky in other places. The sealant was well bonded to the sides of the joint and prevented water from entering the joint. Apart form a cyclic loss of ductility during the winter and softening during the summer, the performance of the sealant remained unchanged. The final evaluation in 1987 revealed that the material was embedded with incompressibles.

FIGURE 13. - ADOT'S JOINT SEALANT

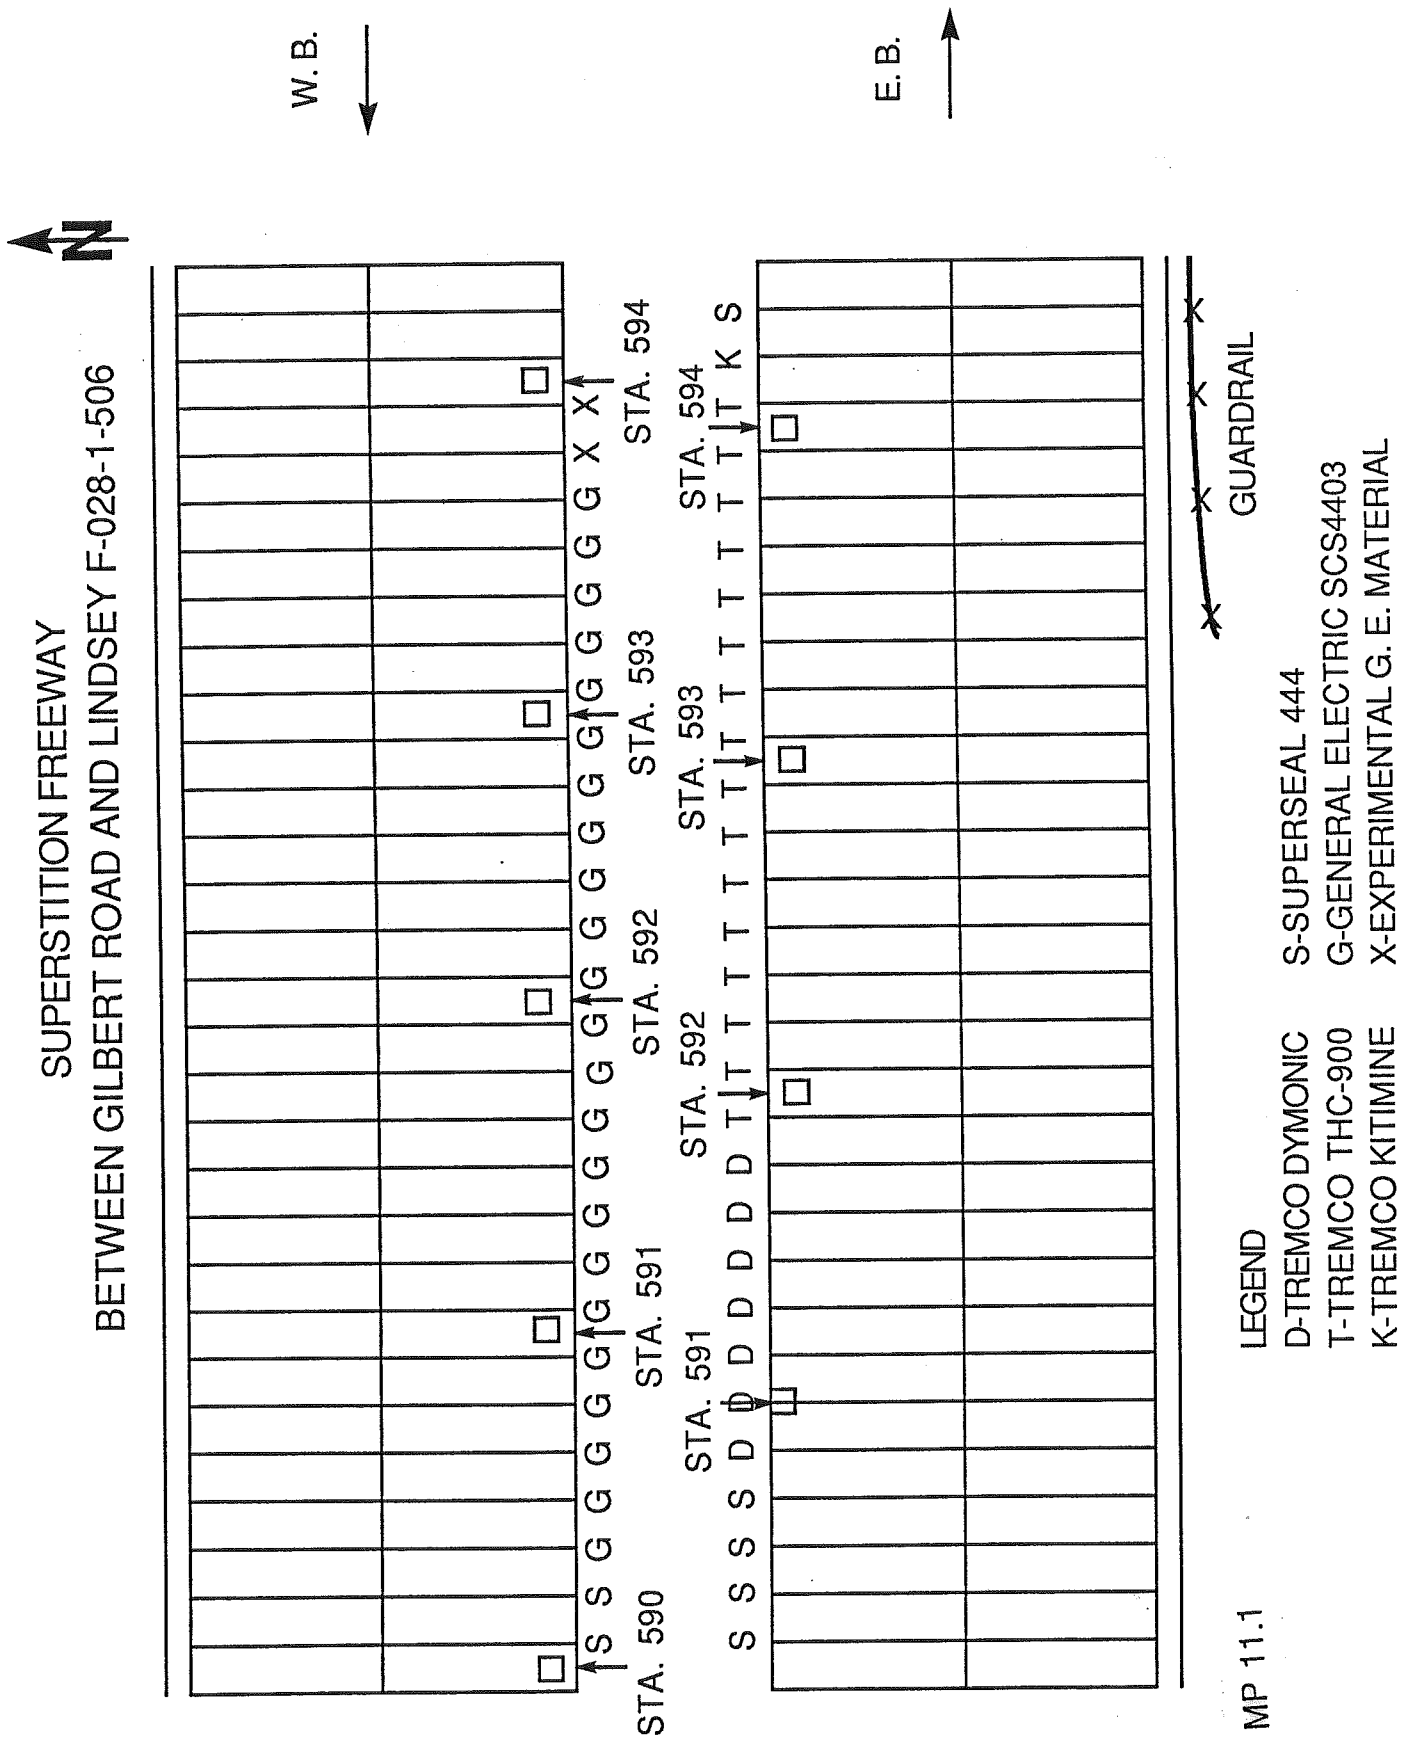
FIGURE 15 - LOCATION OF SEALANTS

The mainline pavement is a 38' wide, 9" thick, plain, portland cement concrete pavement. In order to improve drainage, the pavement was constructed with a 2% grade. Both longitudinal and transverse joints are sawed. The transverse joints are skewed and spaced at uneven intervals of 13', 15', and 17'. The joint geometry for both the silicone and polyurethane joints were 1/2" wide by 3/8" thick and are shown in Figure 14. The geometry for the Superseal 444 joints was the same as that used in the I-17 project. The location of the different sealants is shown in Figure 15.
