BITUMINOUS PAVEMENT REJUVENATOR

PRODUCT EVALUATION

84-01

JULY 3, 1986

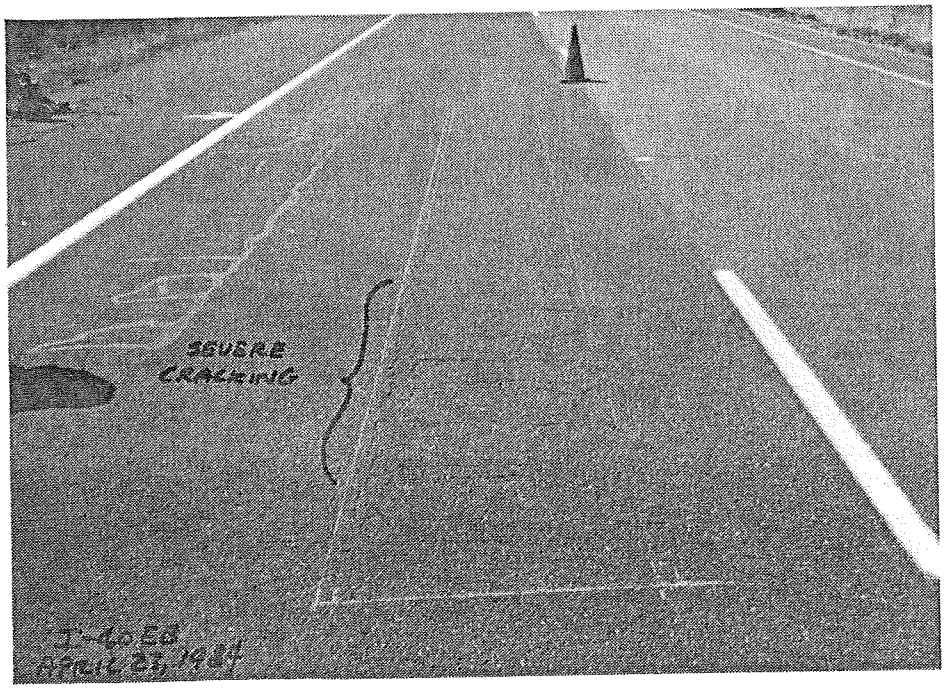
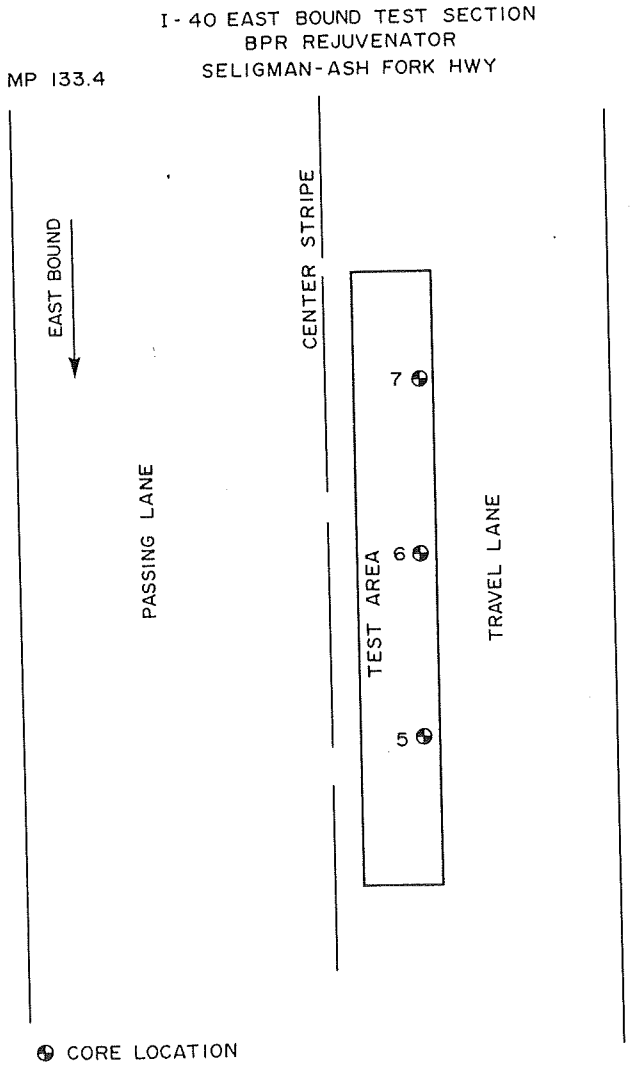
FIGURE 1 - LOCATION OF TEST SECTION, I-40 E.B

Subsequently, discussions between Research and District III indicated that a test section on I-40 near Crookton was appropriate and on April 23, 1984, small test sections (10 sq. yd.) were placed on the eastbound and westbound roadways (See Figures 1 and 2). After two months of performance, an evaluation of the test sections indicated that the treatment had been effective in healing the cracking and rejuvenating the asphalt. An apparent sealing of the surface was noted.

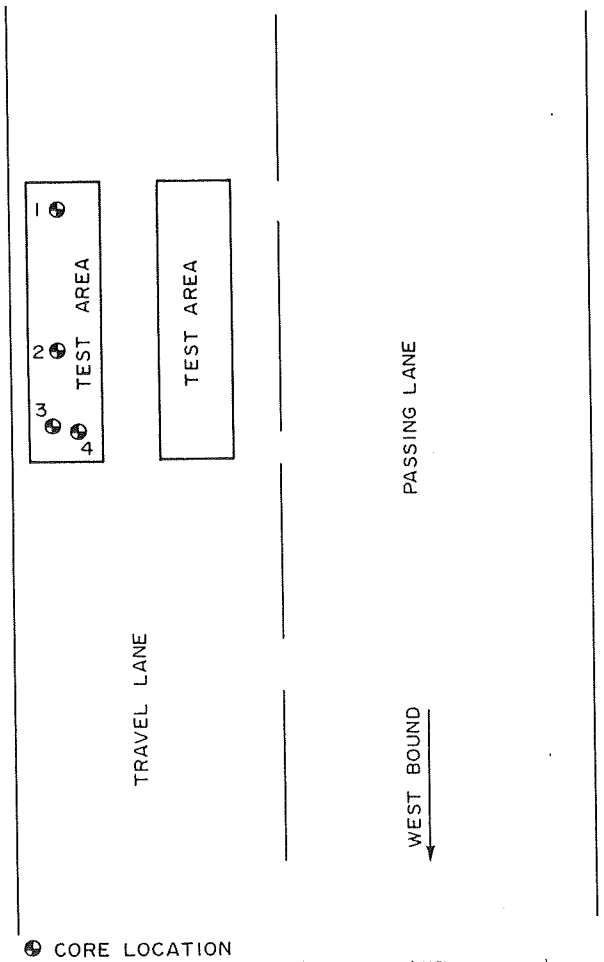
FIGURE 2 - LOCATION OF TEST SECTION, I-40 WB

I-40 WEST BOUND TEST SECTION
BPR REJUVENATOR
SELIGMAN-ASH FORK HWY

MP 130.05

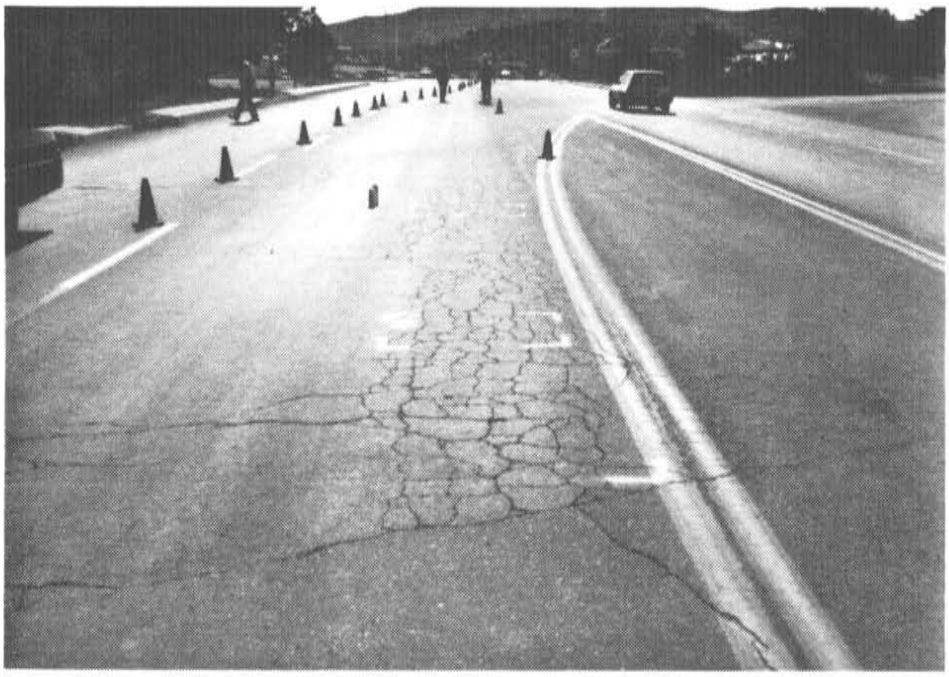
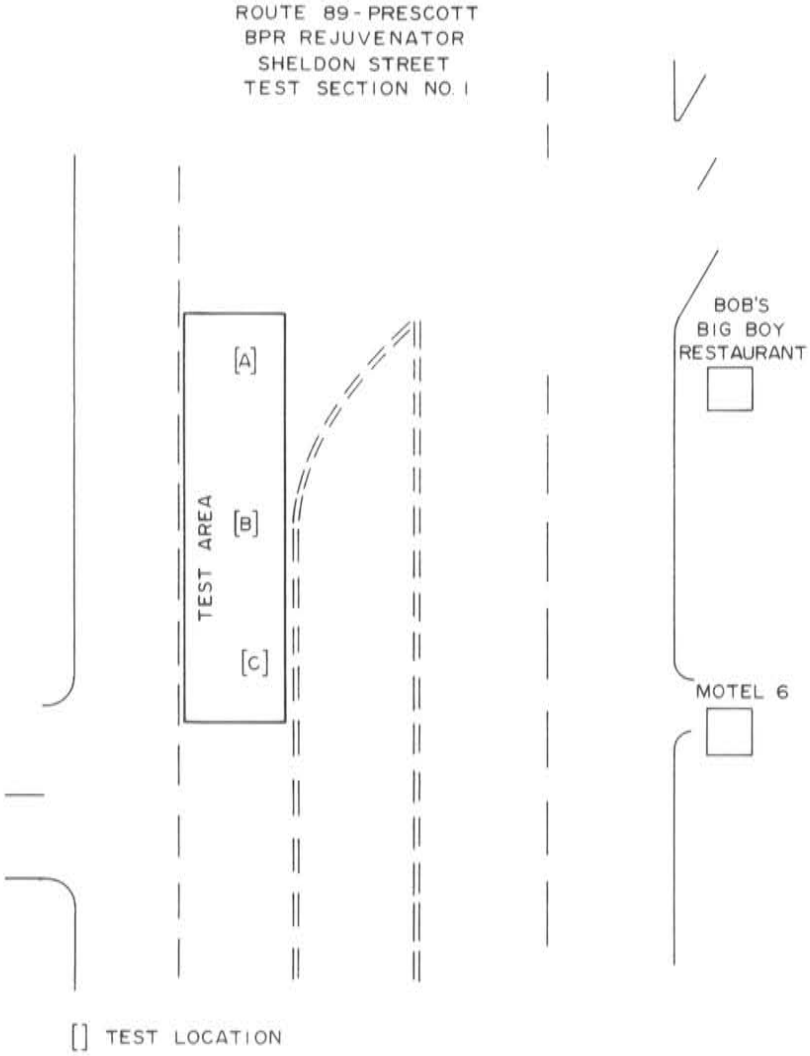
FIGURE 3 - LOCATION OF TEST SECTION, SHELDON STREET #1

Based upon the I-40 test results, a more ambitious test section on a severely distressed pavement was attempted. Sheldon Street in Prescott was selected for two additional sites; one site in front of the District office and a second site two blocks away (Figures 3 and 4). Both sites were approximately 125-150 square yards in size. Sheldon Street in this area was badly distressed and scheduled for reconstruction in the near future. Crack widths of over 1 inch were evident with soil infilling present. After two months of performance, a visual reconnaissance was performed and pavement cores retrieved. Results indicated definite surface sealing and the possibility of some crack healing. The severe crack widths and filling with soil fines inhibited penetration into the cracks and rejuvenation of the asphalt. Rejuvenation of some cracks appeared to have occurred but this was difficult to substantiate.

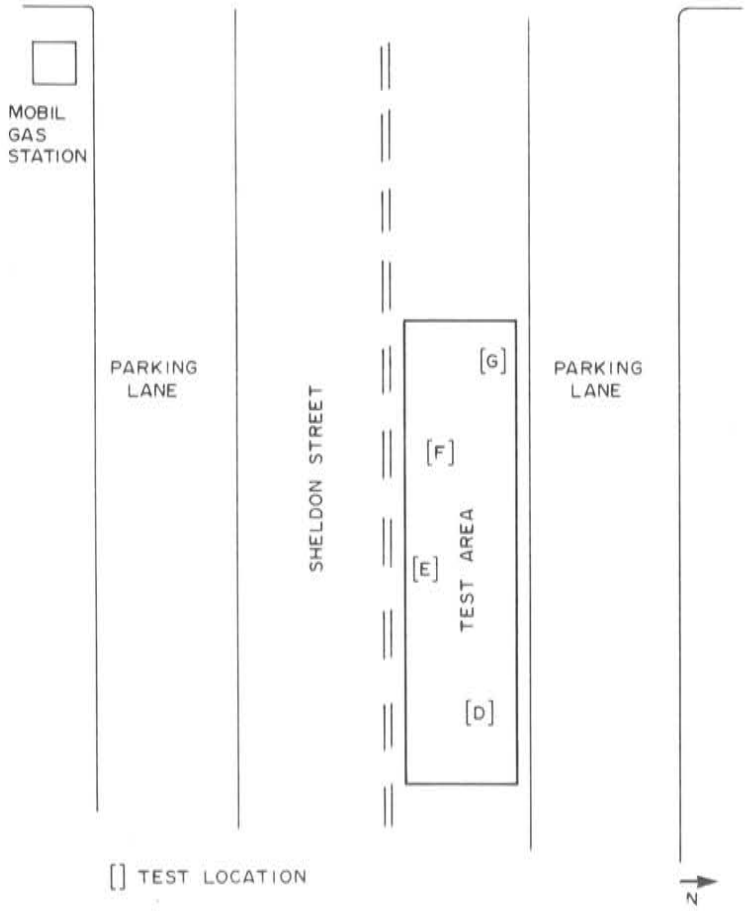
FIGURE 4 - LOCATION OF TEST SECTION, SHELDON STREET #2

ROUTE 89 - PRESCOTT
BPR REJUVENATOR
SHELDON STREET
TEST SECTION NO 2

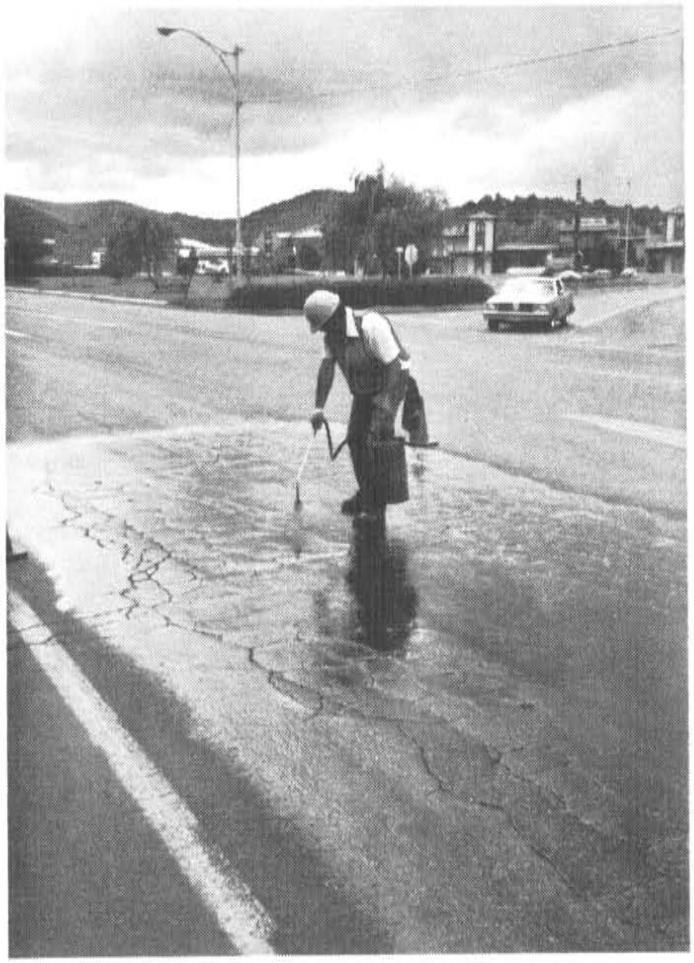
FIGURE 5 - APPLICATION OF BPR

At all the test site locations, the BPR was mixed, heated, and applied by manual methods. Three gallon hand-pump sprayers were utilized for application (Figure 5). After the BPR
