ARIZONA DEPARTMENT OF TRANSPORTATION

REPORT NUMBER: FHWA-AZ-9403

PERFORMANCE EVALUATION OF PORTLAND CEMENT CONCRETE PAVEMENT JOINT SEALANTS

Final Report

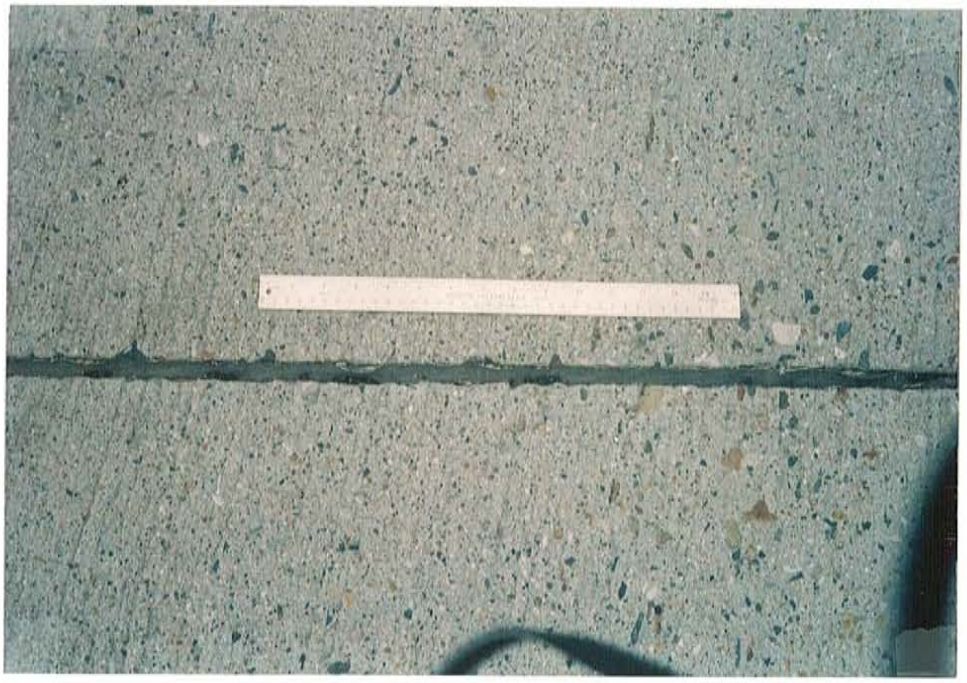
Figure 5: Typical appearance of silicone sealant joints after eight years

Figures 5 and 6 show a typical surface appearance of the silicone and asphalt-based sealants in April 1994. The results of data analysis for the 1994 field survey are summarized in Table 3 and depicted in Figures 7 through 10. The analysis indicated that eight years after the installation of the test section:

1. All sealants had good flexibility.
2. The average slab faulting was about 0.2 in. There was no significant difference in average faulting measurements among joint sets for the different sealants.
3. Dow Corning 888, Superseal 888, Crafco Roadsaver and Meadow Sof-seal sealants had experienced an average adhesive failure (partial and full

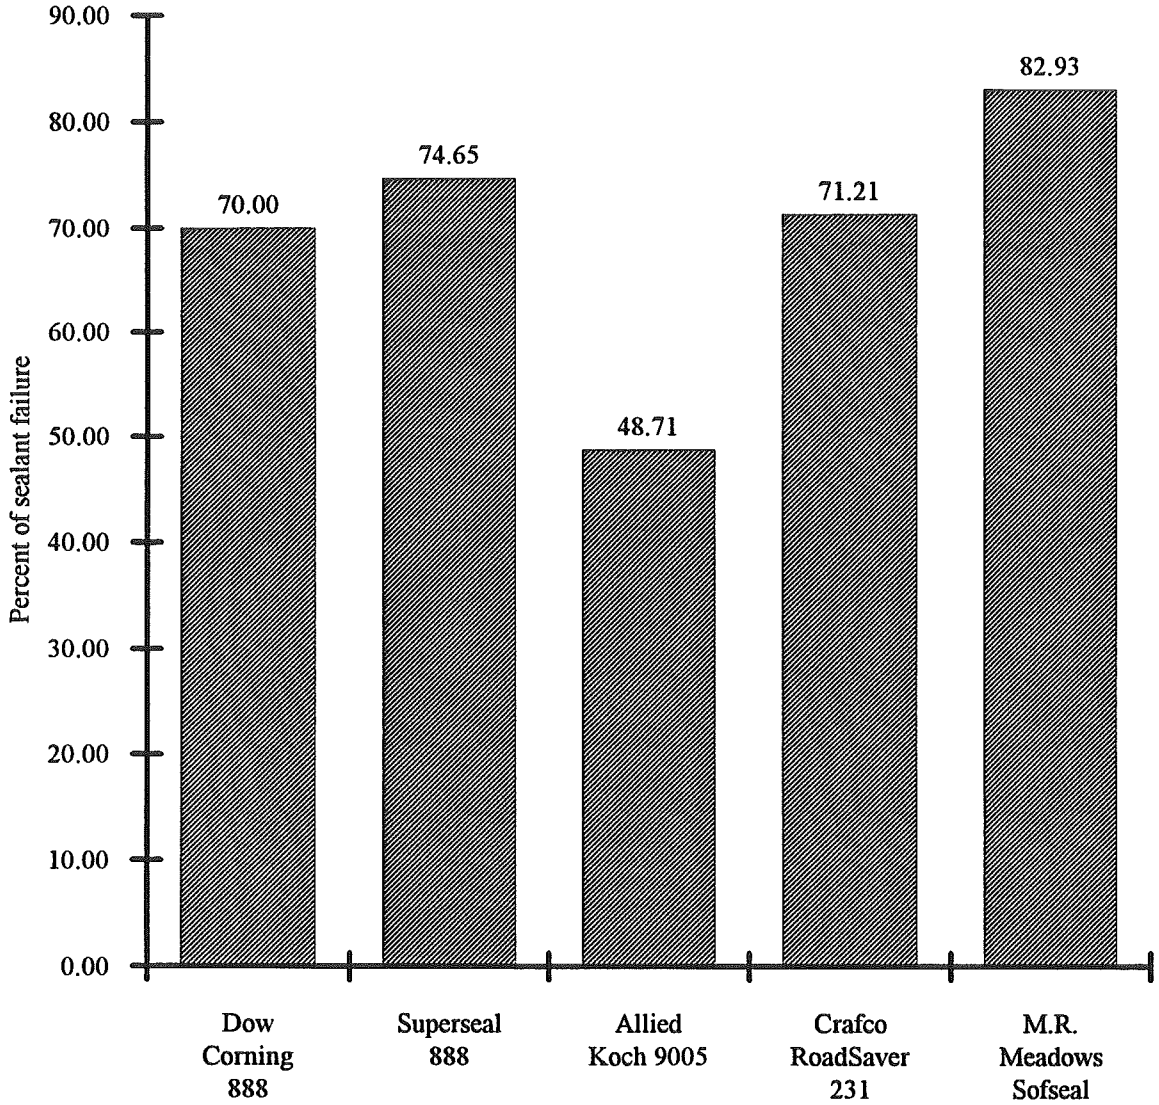
Figure 8: Percent of total sealant failure along joints

depth)rate of 65 to 80 percent along the joints. Allied Koch had an average adhesive failure rate of 40 percent.

4. Dow Corning 888, Superseal 888, Crafco Roadsaver and Meadow Soft-seal each experienced an average cohesive failure (partial and full depth) rate of less than five percent along the joints. Allied Koch had an average cohesive failure rate of 8.5 percent.
5. The average joint spalling was about 0.015 - 0.025 square feet for joints sealed with Dow Corning 888, Superseal 888, M. R. Meadows Sof-Seal; and approximately none for joints sealed with Allied Koch 9005 and Crafco Roadsaver 231.
6. Each of the silicones recessed an average of about 0.2 in. There was no significant recess for the asphalt based hot pour sealants.
7. Approximately 40 -- 60 percent of the Superseal 444 was missing from the joints in the surveyed half-mile roadway section.
8. Joint faulting at the outside edge of the travel lane was consistently higher than faulting near the centerline.
