Report Number 11
HPR-1-13(224)

PREVENTION OF REFLECTIVE CRACKING IN ARIZONA MINNETONKA - EAST (A Case Study)

Prepared by:
George Way, Research Engineer
Arizona Department of Transportation
Materials Service – Research Branch
1745 W. Madison
Phoenix, Arizona 85007

May 1976
Final Report

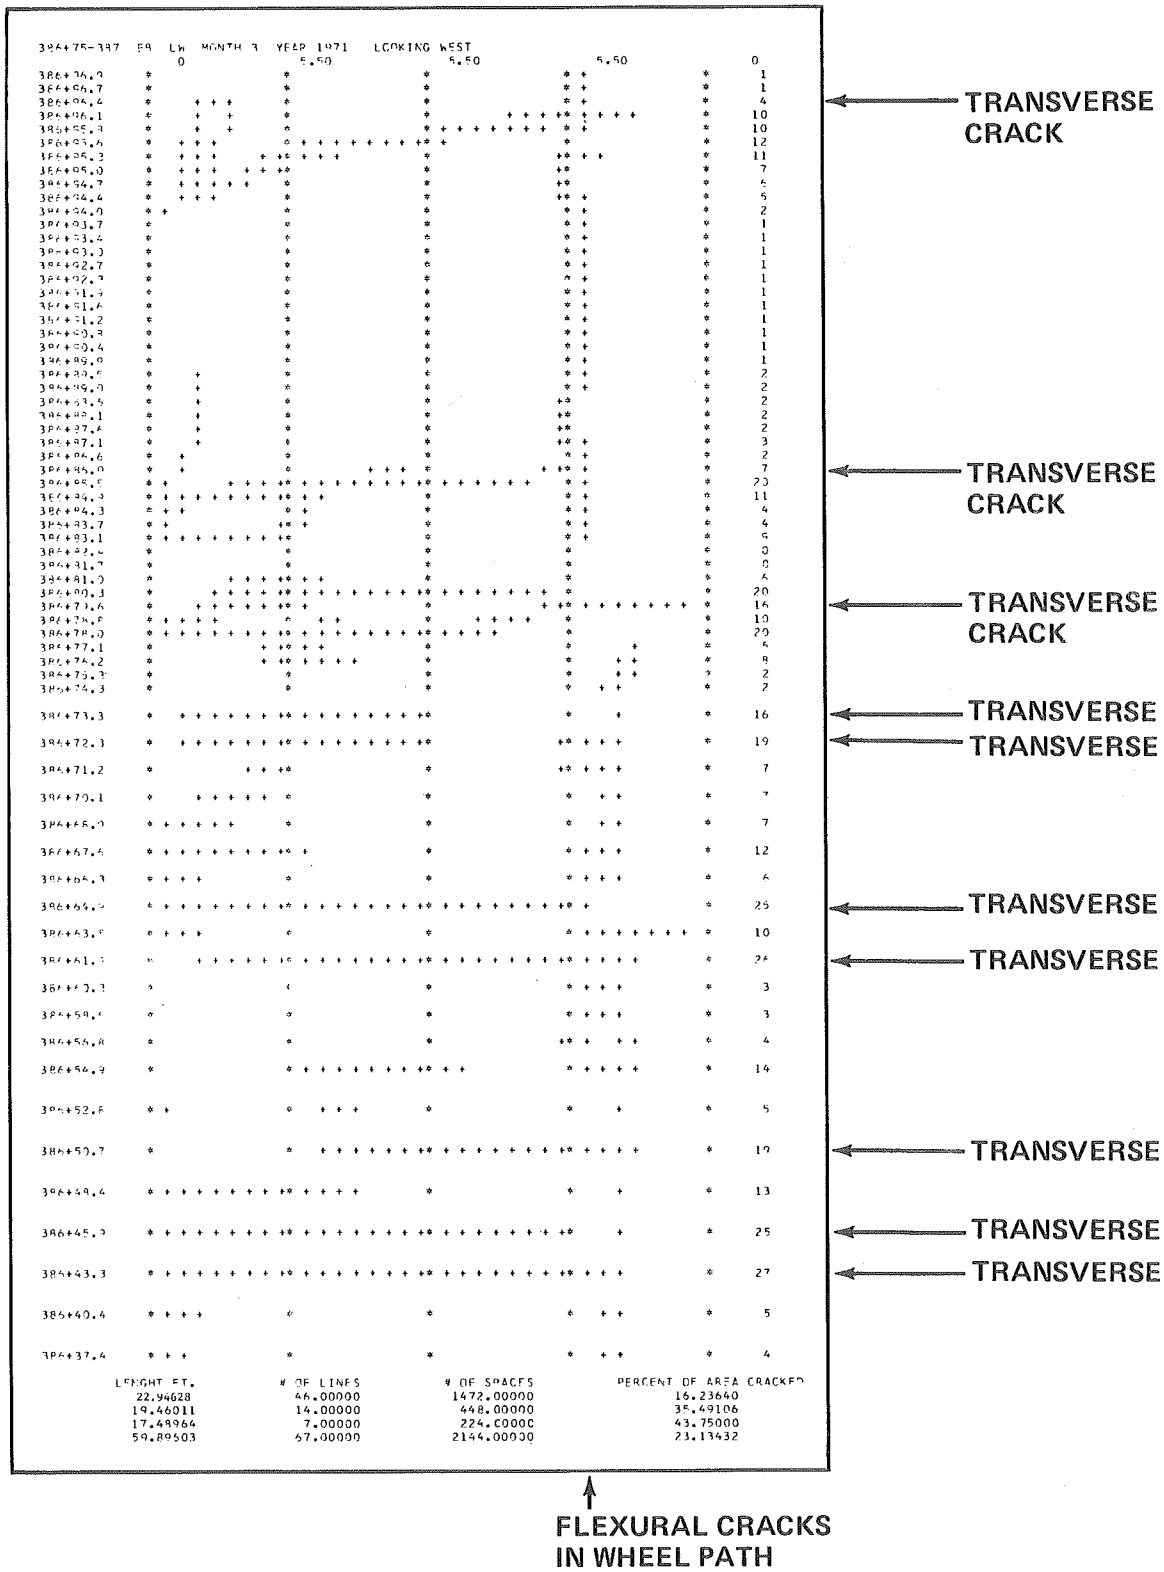
Figure 9. Typical Computer Readout, Crack Survey

LA 40/50
STATION 386 + 75 — 387 (SEE FIGURE 11, PHOTO 1)

LENGHT FT.	# OF LINES	# OF SPACES	PERCENT OF AREA CRACKED
22.94628	46.00000	1472.00000	16.23640
19.46011	14.00000	448.00000	35.49106
17.49964	7.00000	224.00000	43.75000
59.89503	67.00000	2144.00000	23.13432

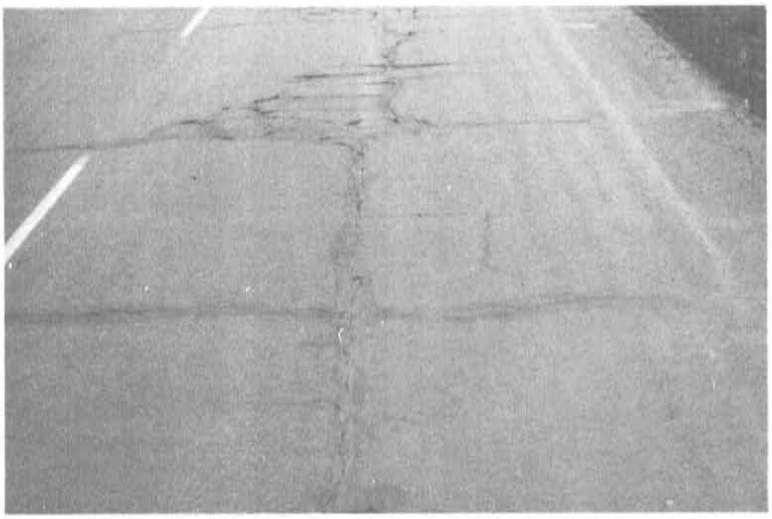
March 25, 1971
23.1% Cracking Before Overlay

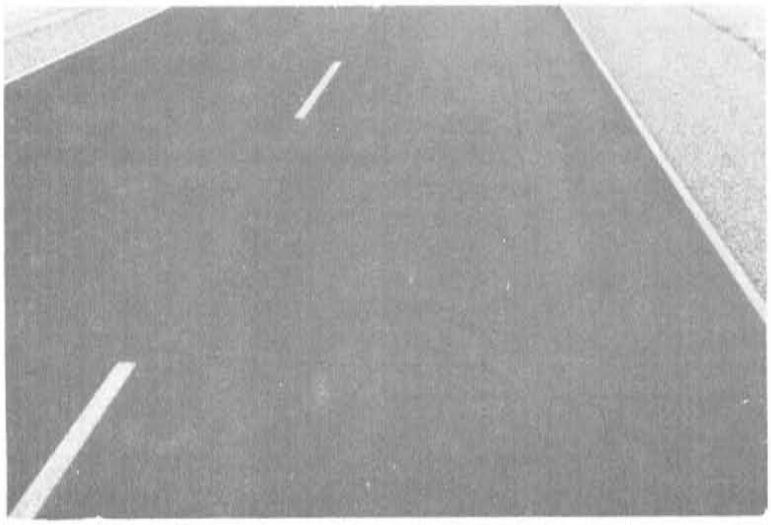
March 24, 1972
23.7% Cracking Before Overlay

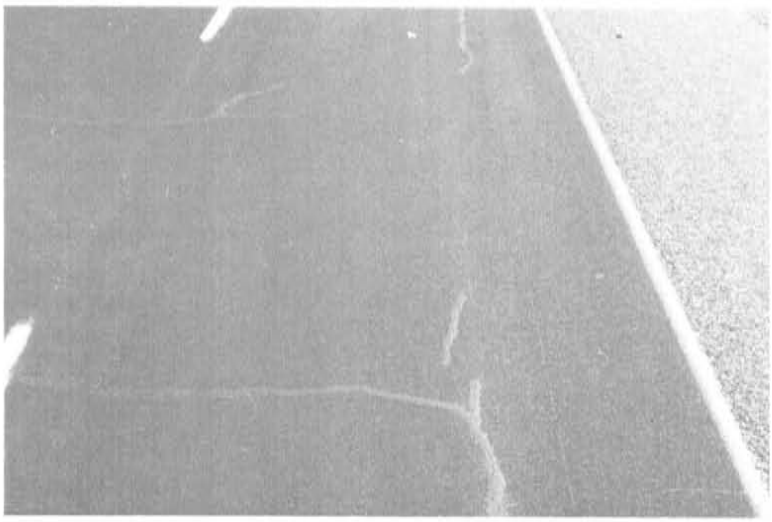
Figure 10. Typical History of Cracking, Control Section:
Sta 449+50- 75 Eastbound

Feb. 6, 1973
2.9% Cracking or 12.2% Reflected
Cracking After Overlay

Feb. 26, 1974
3.6% Cracking or 15.2% Reflected Cracking After Overlay

March 13, 1975
8.7% Cracking or 36.7% Reflected Cracking After Overlay

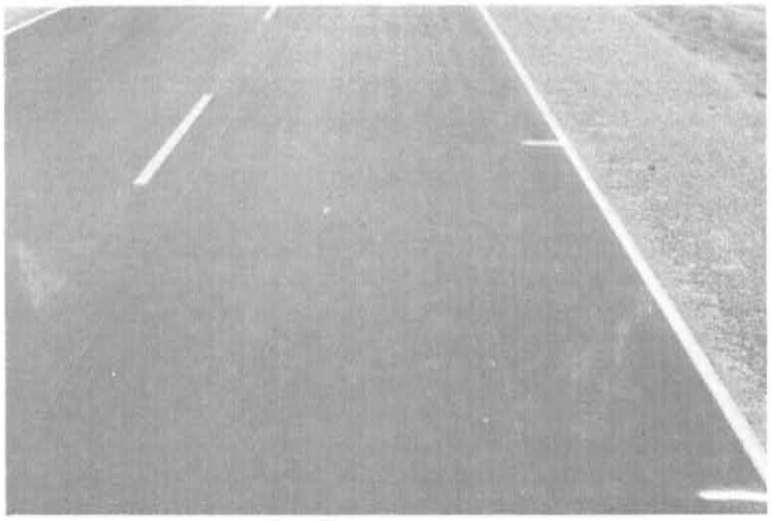
Figure 11. Typical Photo History of Cracking, LA 40/50, Sta 386+75–387

March 25, 1971, 23.1% Cracking Before Overlay

March 24, 1972
31.1% Cracking Before Overlay

Feb. 6, 1973
.5% Cracking or 1.6% Reflected
Cracking After Overlay

Feb. 26, 1974
2.6% Cracking or 8.4% Reflected
Cracking After Overlay

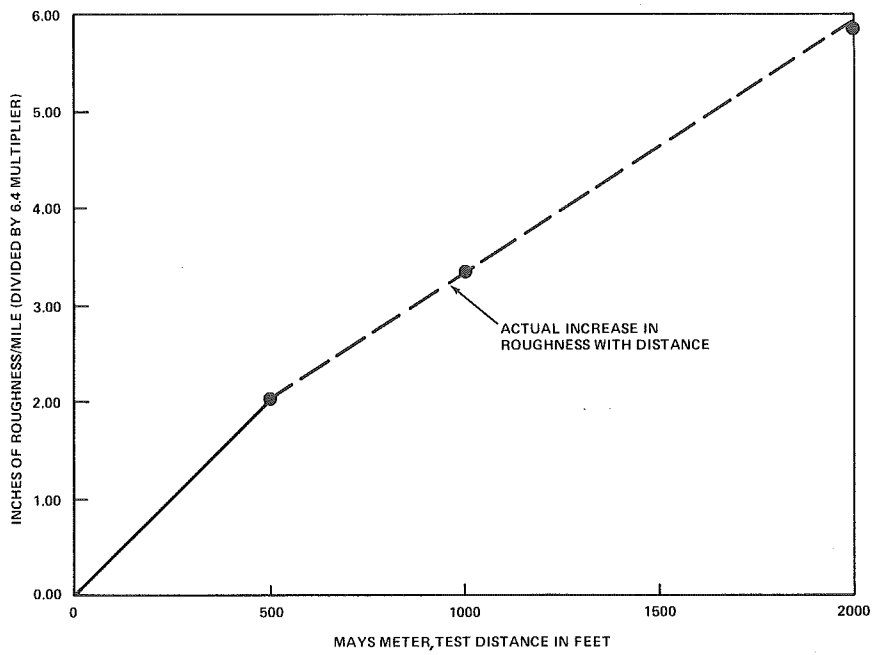
Figure 14, Mays Meter Roughness Before Overlay, (As a Function of Distance)

As can be seen, some test sections were not tested prior to overlaying. To overcome this inconsistancy, average roughness values for all reported sections were determined and plotted as shown in Figure 14. The three plotted points, surprisingly, fell close to a straight line; however, this line did not pass through the origin. This indicates that as the length of Mays-Meter test doubled or quadrupled roughness did not double or quadruple. This error is probably the result of interpolating the tape output from a mile length down to 500 foot sections. Table 6A, Appendix A, shows the percent of original roughness computed for all reported tests as well as by test section. In addition, Table 10 shows how each section would be ranked with respect to the various treatments.

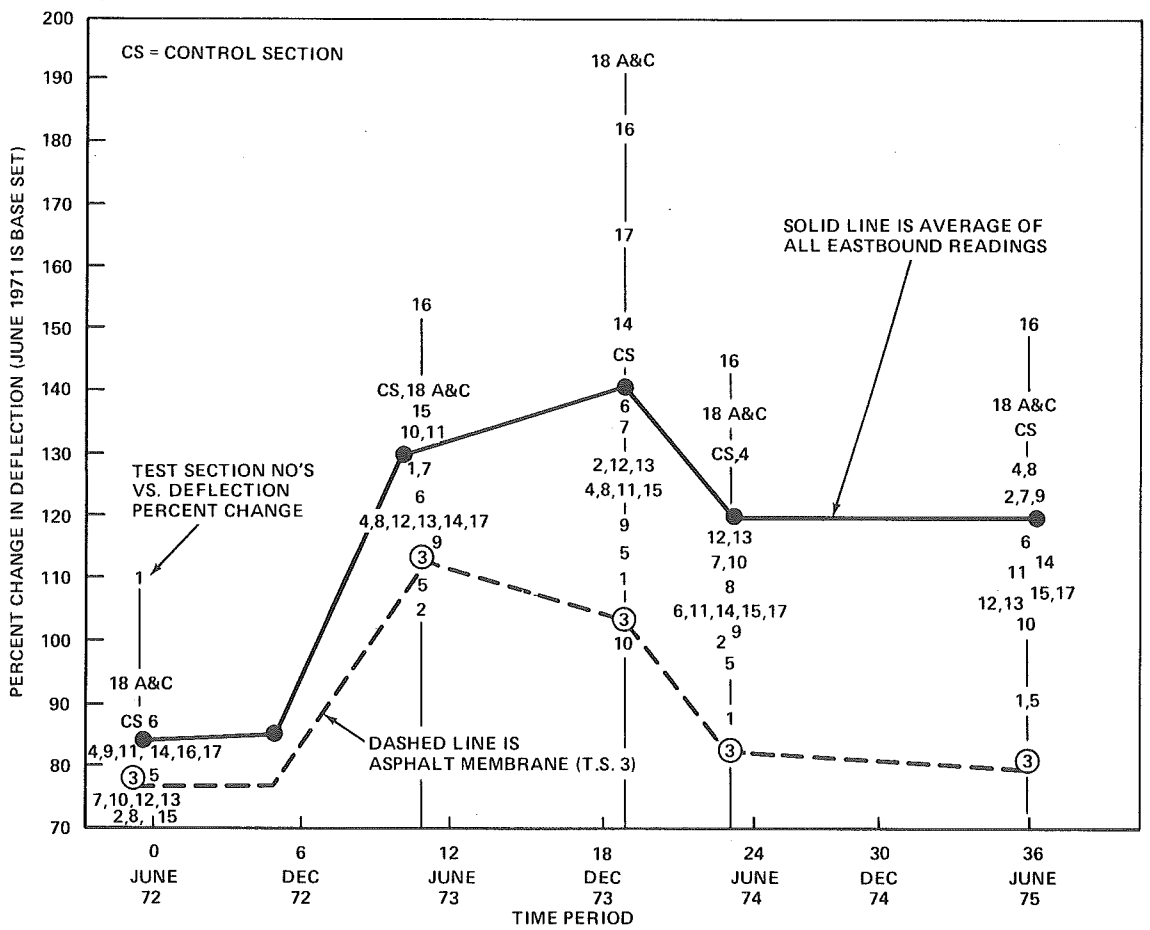
Figure 16. Deflection Performance – Percent Change, Comparison to Average Percent Change Curve

Figure 16 shows the percent change in deflection was less. This decrease could be the result of reduction in moisture entering the section and as such could be an added long term benefit.

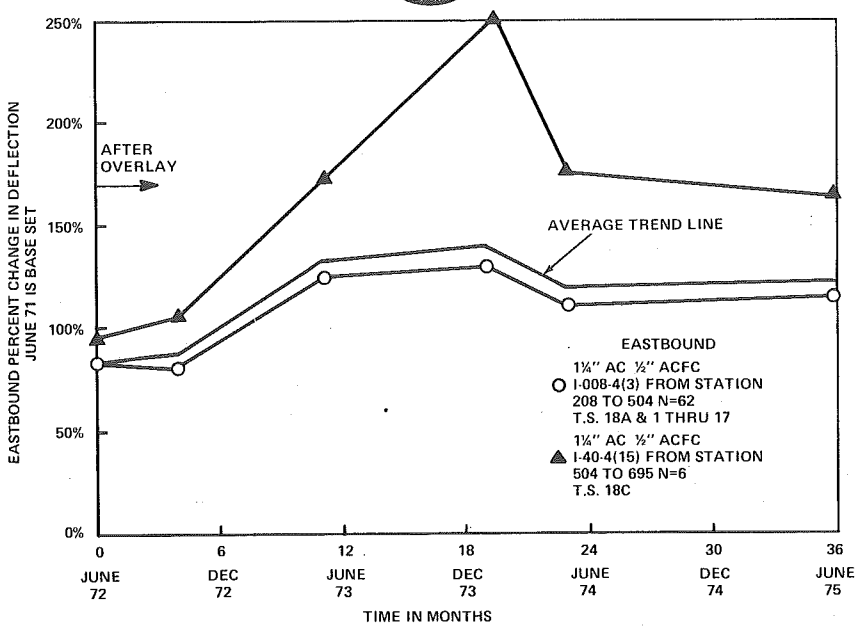
Figure 17. Deflection Comparison After Overlay (Eastbound)

For all test sections, structural design thickness was evaluated by deflection analysis. Figure 17 shows the percent change in eastbound deflections for the two overlaid projects (I 008-4 (3) and I 40-4 (15)). Both projects were overlaid with 1-1/4 inches AC and 1/2 inch ACFC. Deflections on Project I 40-4 (15) have increased at a remarkable rate and developed into a severe maintenance problem. In January of 1973, potholes began to appear on the eastbound portion of the I 40-4 (15) overlay project. District maintenance forces were concerned due to extensive patching required to cope with the problem. Later, in August of 1973, the Materials Division cored the highway and found that the old AC cake has stripped (asphalt washed off aggregate). Originally, the I 40-4 (15) highway had been constructed of a mineral aggregate which would now be considered a stripping aggregate. This particular aggregate is no longer considered a mineral aggregate under current stripping design criteria [11]. The higher deflection recorded during this study is significant in that it indicates loss of structural support due to stripping.

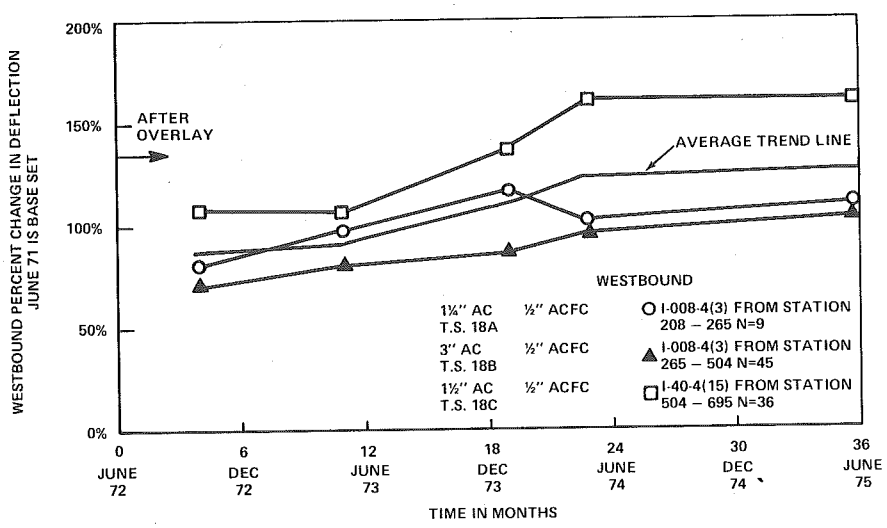
Figure 18. Deflection Comparison After Overlay (Westbound)

For the westbound highway, change in deflections are plotted in Figure 18. This figure is significant in that it shows improved deflection performance for the 3-inch overlay section. This section would normally be considered as the strongest structural section and should indicate minimum deflection change, as indeed it does. The performance of westbound I 40-4 (15) has been noticeably better than the eastbound highway. That is, no potholes have occurred on this section. As can be seen from Figure 18, the percentage change in deflection is high, but not as high as the eastbound highway. It is possible that improved compaction and mix design of the westbound overlay is responsible, at least in part, for the improved performance.

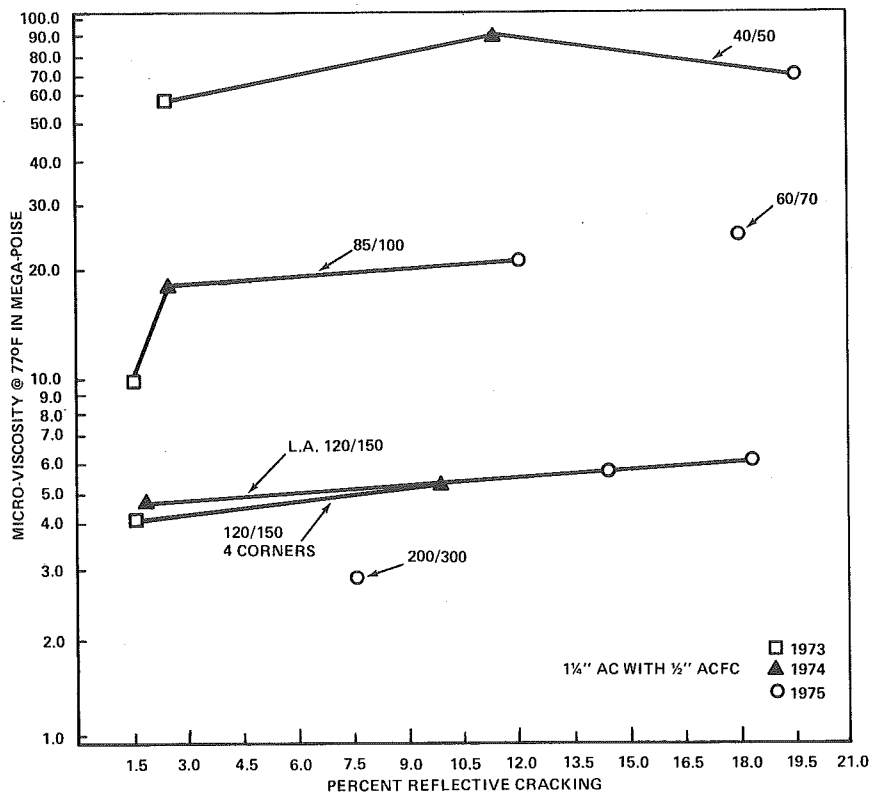
Figure 21. Percent Reflective Cracks versus Micro-Viscosity (T.S. 7, 8, 9, 10 and Control Sections)

case, it is possible to select an arbitrary temperature for performance comparison. By selecting microviscosity at 77°F it was possible to plot percent reflective cracking versus microviscosity, Figure 21. Data points from Table 9A, Appendix A, were plotted for various test and control sections. Figure 21 roughly shows that for the Minnetonka test temperature conditions, asphalts need to maintain microviscosities below 4.0 mega poise (equivalent penetration about 45, or absolute unaged viscosity of 3000 poises at 140°F) as long as possible. The length of time an asphalt can maintain such a value is a function of its initial viscosity, film thickness, voids and particular aging characteristics. Figure 22 shows viscosity versus time for the different asphalt grades used in the configuration of 1-1/4 inches AC and 1/2 inch ACFC. Assuming the 4.0 mega poise region to be critical for crack initiation, Table 17A, Appendix A, was derived to determine length of time required to age asphalt to the 4.0 mega poise value. As Table 17A shows, Appendix A, very little time was needed to age most of the asphalts to a state where cracking could be initiated. The actual crack formation or intensity of cracking, as Table 17A demonstrates, apparently needs some additional catalyst to trigger crack formation. This catalyst is probably temperature, since reflective cracks tend to appear in the winter months. This being the case, the 4.0 mega poise value takes on the role of an indicator test which could point to future reflective cracking problems depending on temperature.

In general it can be concluded that asphalt properties do have an influence on preventing reflective cracks. In summary, the combination of a low viscosity asphalt and a slow aging asphalt tailored to the ambient climatic condition can reduce reflective cracks.
