REPORT NUMBER: FHWA/AZ AZ88/227

POROUS PAVEMENT FOR CONTROL OF HIGHWAY RUNOFF

First Annual Monitoring Report

July 1988

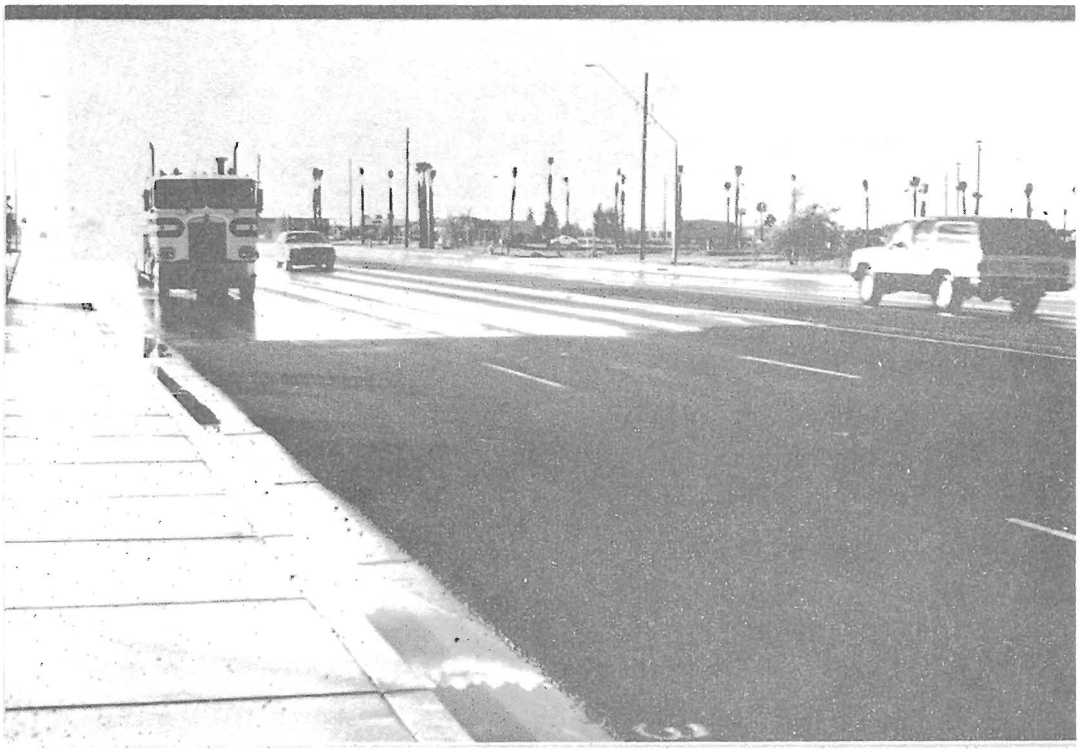
FIGURE 13. CONVENTIONAL AND POROUS PAVEMENT SHORTLY AFTER RAINSTORM

The surface of both pavements has been observed during rainstorms on October 9, 10, and 11, 1986. It was visually observed that the surface of the porous pavement, although wet, did not have any standing or excess water on its surface. The surface of the conventional pavement section was also wet, but sheets of water could be seen on the surface along with water flowing in the

curbs. Slides and video tapes of those conditions were made during a rainstorm on February 24, 1987, by Western Technologies Inc. showing that the porous pavement section was functioning properly. A typical condition of the two pavement surfaces after a rainstorm is presented in Figure 13.

Visual observations of the porous pavement during several rainstorms revealed the elimination of water spray from car and truck tires. Reducing the amount of water on a pavement surface, will decrease hydroplaning and should reduce skid related accidents. Also, lane striping could be observed on the porous pavement road section. Although the porous pavement was not observed during a rainstorm at night, increase lane recognition should increase driving safety. These conditions were documented by slides and videotapes. The condition of the two pavement surfaces after a rainstorm is presented in Figure 13.
