ARIZONA DEPARTMENT OF TRANSPORTATION

REPORT NUMBER: AZ89-227

POROUS PAVEMENT FOR CONTROL OF HIGHWAY RUNOFF

Interim Report

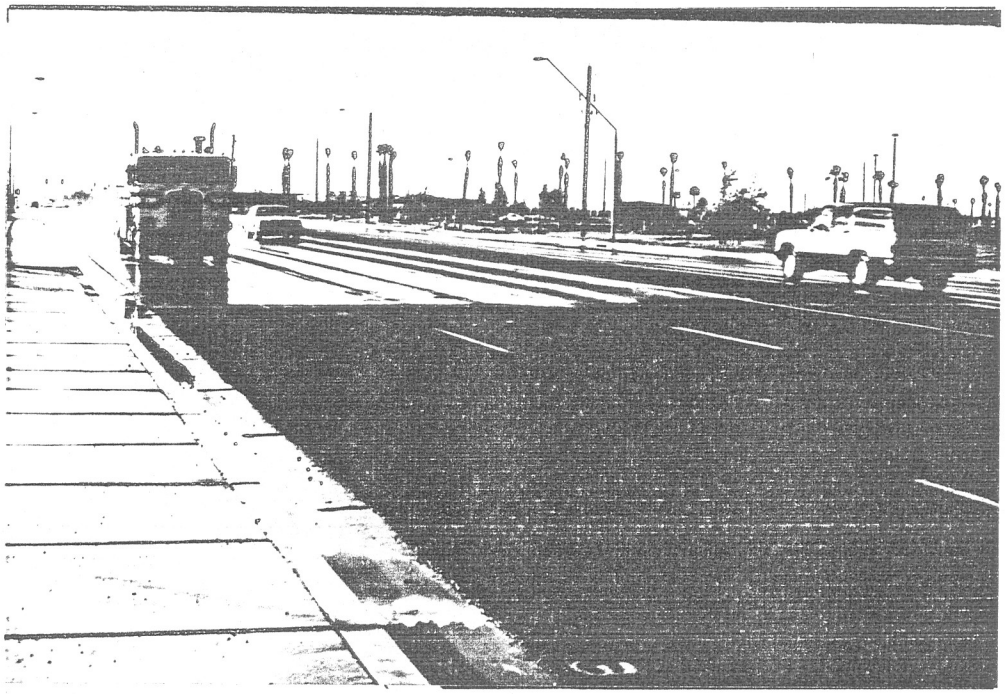
FIGURE 13. CONVENTIONAL AND POROUS PAVEMENT
SHORTLY AFTER RAINSTORM

The surface of both pavements has been observed during rainstorms on October 9, 10, and 11, 1986. It was visually observed that the surface of the porous pavement, although wet, did not have any standing or excess water on its surface. The surface of the conventional pavement section was also wet, but sheets of water could be seen on the surface along with water flowing in the curbs. Slides and video tapes of those conditions were made during a rainstorm on February 24, 1987, by Western Technologies Inc. showing that the porous pavement section was functioning properly. A typical condition of the two pavement surfaces after a rainstorm is presented in Figure 13.

Visual observations of the porous pavement during several rainstorms revealed the elimination of water spray from car and truck tires. Reducing the amount of water on a pavement surface, will decrease hydroplaning and should reduce skid related accidents. Also, lane striping could be observed on the porous pavement road section. Although the porous pavement was not observed during a rainstorm at night, increase lane recognition should increase driving safety. These conditions were documented by slides and videotapes. The condition of the two pavement surfaces after a rainstorm is presented in Figure 13.
