## TABLE OF CONTENTS

## 1 SCOPE

## 2 BRIDGE INSPECTION RESPONSIBILITIES

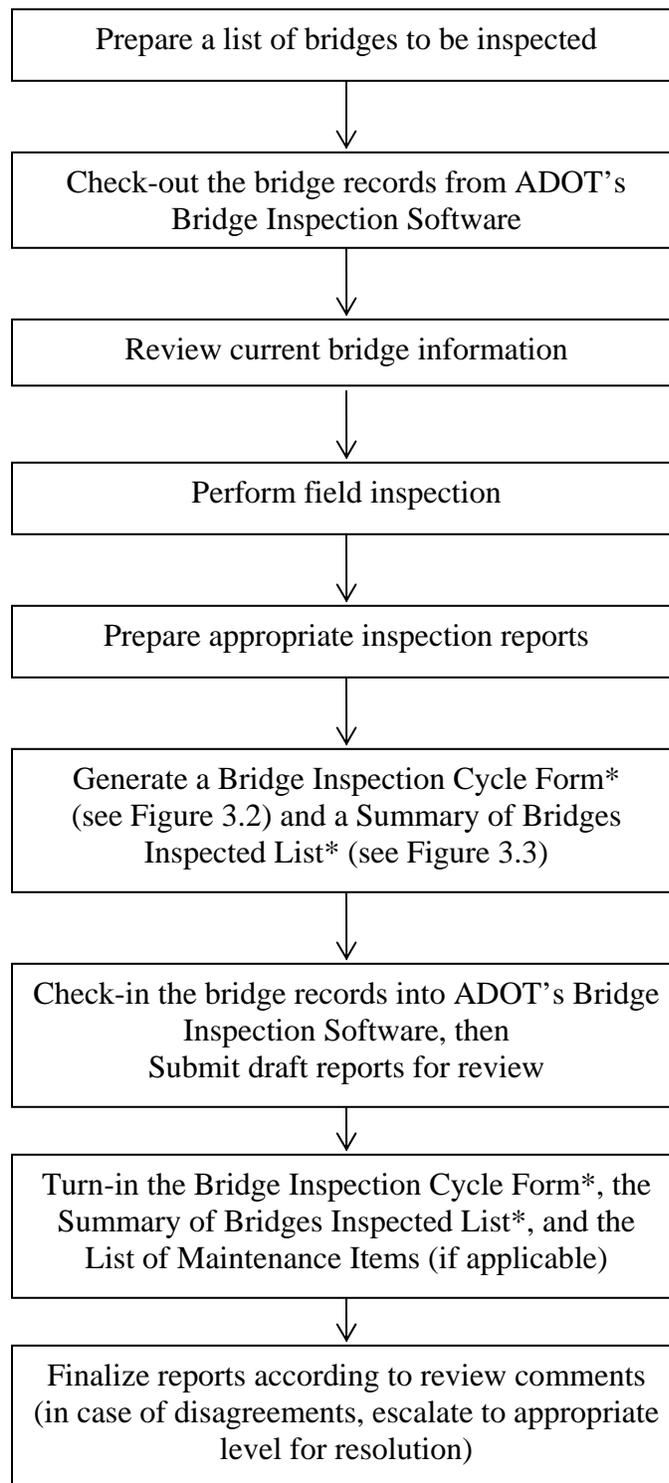
Figure 3.1 – ADOT Bridge Inspection Flowchart

All bridge inspections shall be performed in accordance with these guidelines and shall comply with the NBIS. Figure 3.1 displays a flowchart that details the bridge inspection process. The submittal package should include the following items in the order shown below:

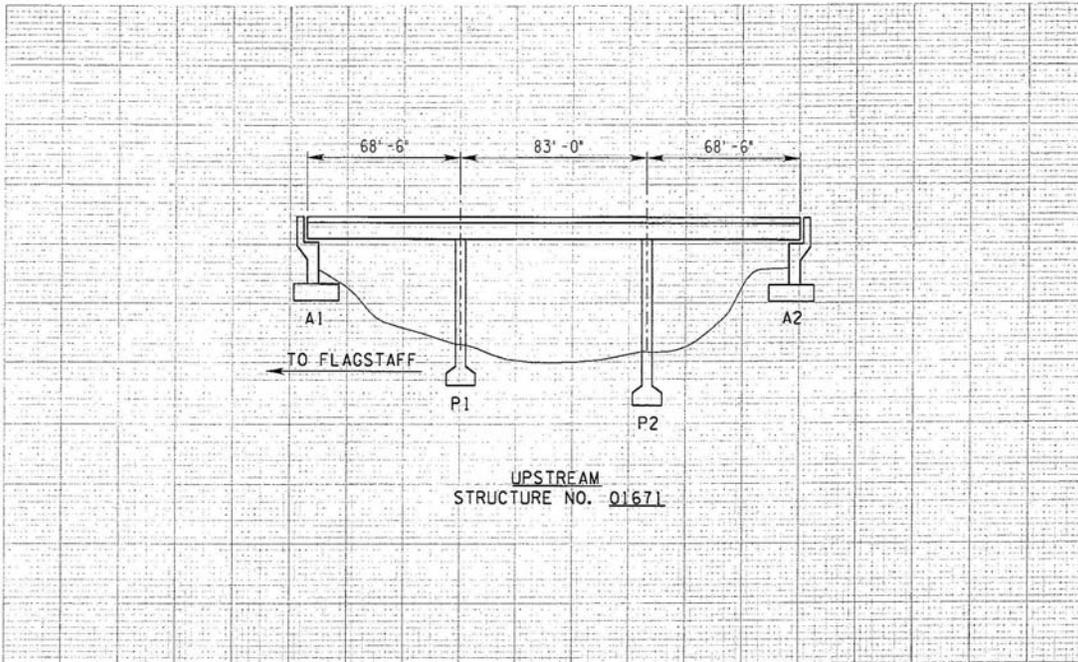
**Channel Profile Diagram**

Insp. No.	Insp. date	Inspector's Initial	Channel Profile Location (U/S or D/S)	Depth at Abut. 'A1' face or at Support, 'P' (RHS)	Depth at quarter span	Depth at mid span	Depth at 3/4 span	Depth at the left side of Support 'P'	Depth at the right side of Support 'P'	Depth at quarter span	Depth at mid span	Depth at 3/4 span	Depth at the left side of Support 'P'	Depth at the Right side of Support 'P'	Depth at quarter span	Depth at mid span	Depth at 3/4 span	Depth at Abut. 'A2' face or at Support, 'P' (LHS)
19	9/12/04	SPS	US	4'0"	11'10"	19'6"	38'9"	44'2"	46'0"	51'0"	52'8"	50'10"	49'0"	48'0"	46'0"	37'1"	27'0"	10'1"

† 64-4505 R04/03 Note: Channel depths will be measured from the bottom of the girder or the slab; For short span (<40'), depths at quarter & three-quarter lengths may not be necessary; Local scour, if observed at locations other than above, will be noted on this sheet with inspection date; RHS-->Right Hand Side; LHS--> Left Hand Side.

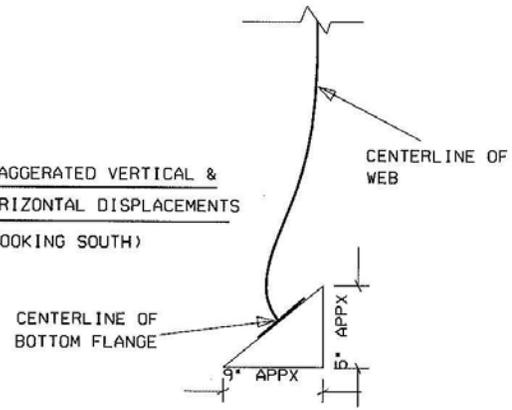
ABOUT 9 FEET LENGTH OF LONGITUDINAL DISTORTION WAS OBSERVED IN THE IMMEDIATE VICINITY OF SOUTHMOST LANE

EXAGGERATED VERTICAL & HORIZONTAL DISPLACEMENTS (LOOKING SOUTH)

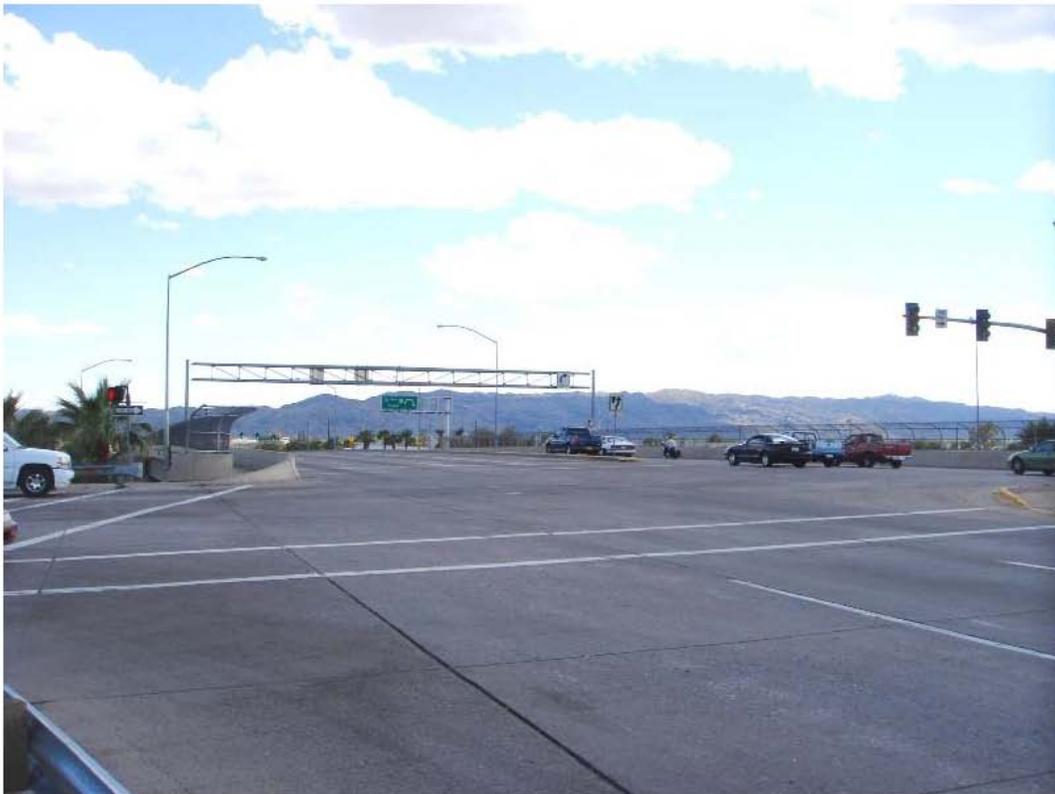
**Photo No.:** 1  
**File Name:** 0219009A.jpg  
**Descriptions:** Roadway ID looking south

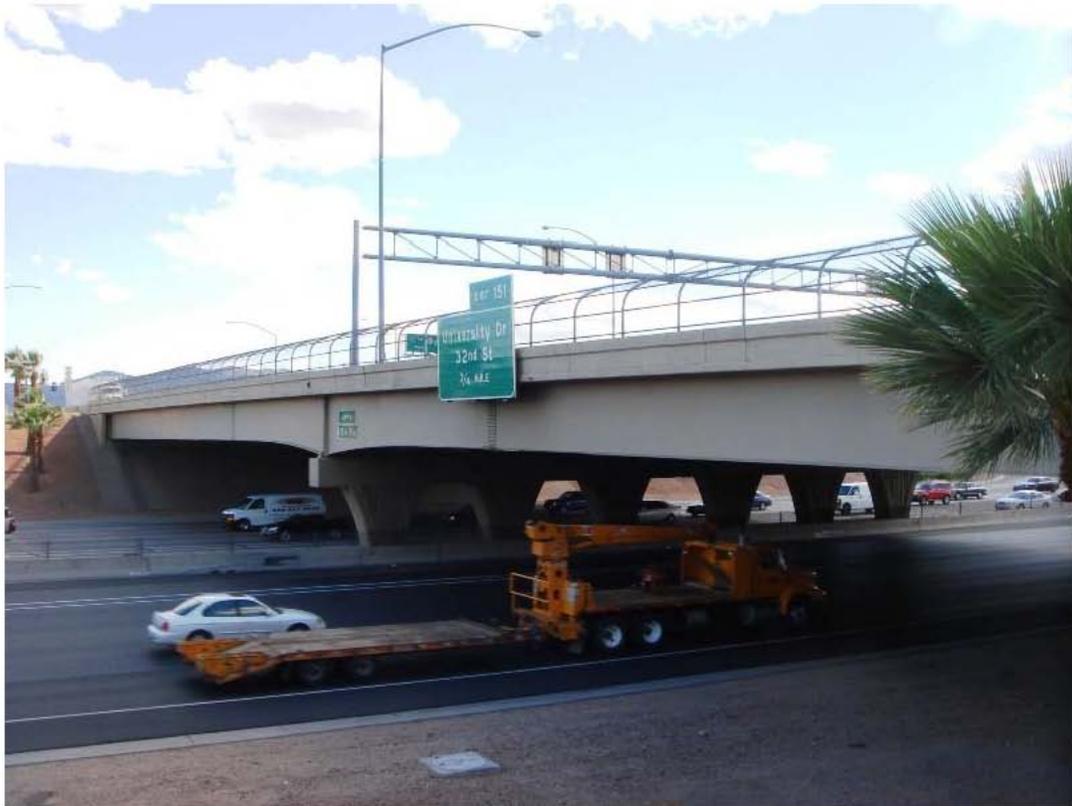
**Photo No.:** 2  
**File Name:** 0219009C.jpg  
**Descriptions:** Elevation ID looking west

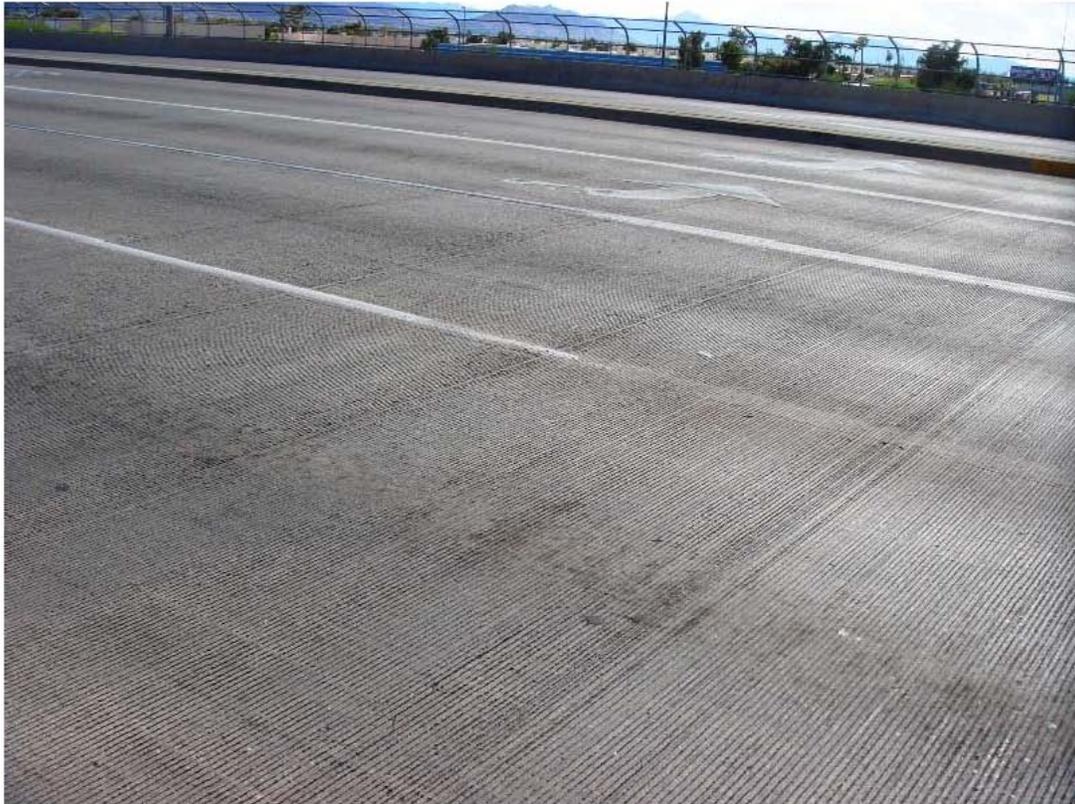
**Photo No.:** 3  
**File Name:** 0219009E.jpg  
**Descriptions:** Typical deck wearing surface

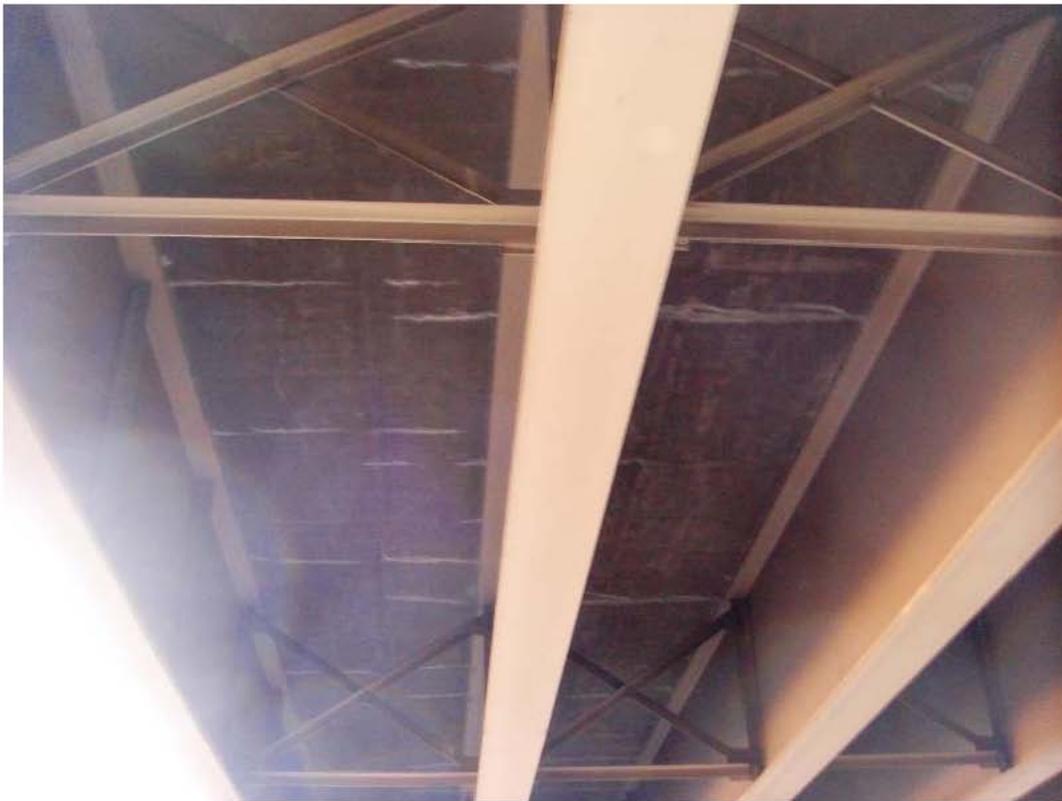
**Photo No.:** 4  
**File Name:** 0219009B.jpg  
**Descriptions:** General underside (looking south in span 3)

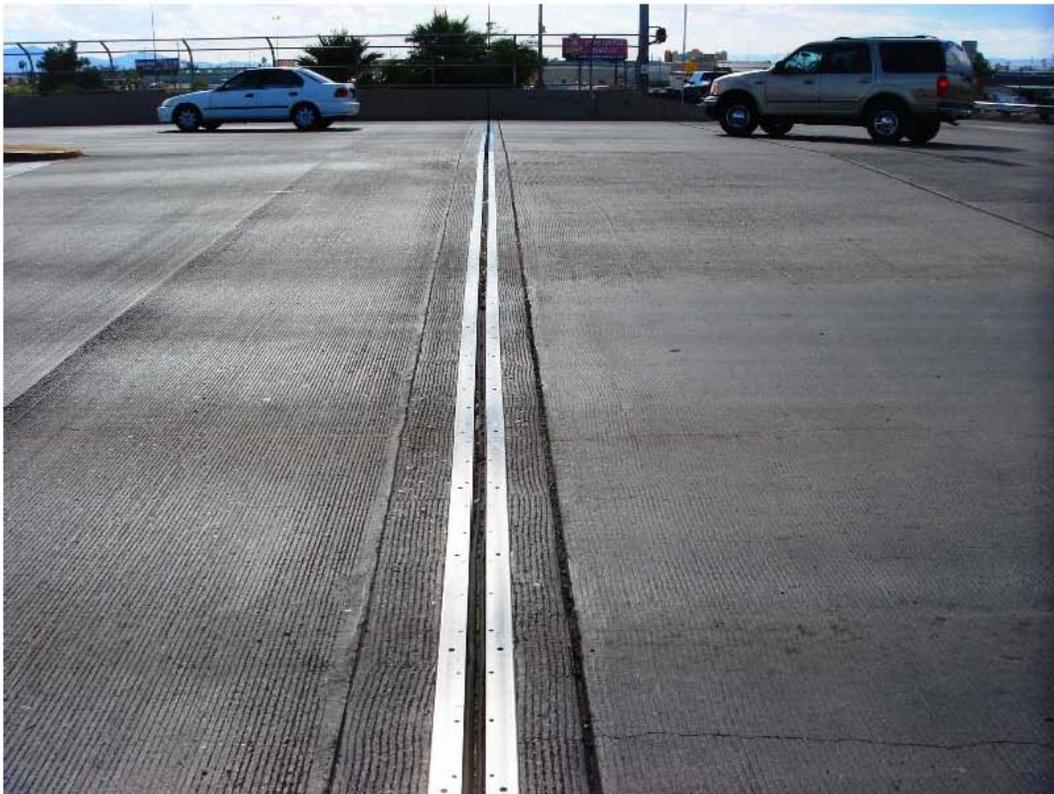
**Photo No.:** 5  
**File Name:** 0219009D.jpg  
**Descriptions:** Typical expansion joint (at north abutment)

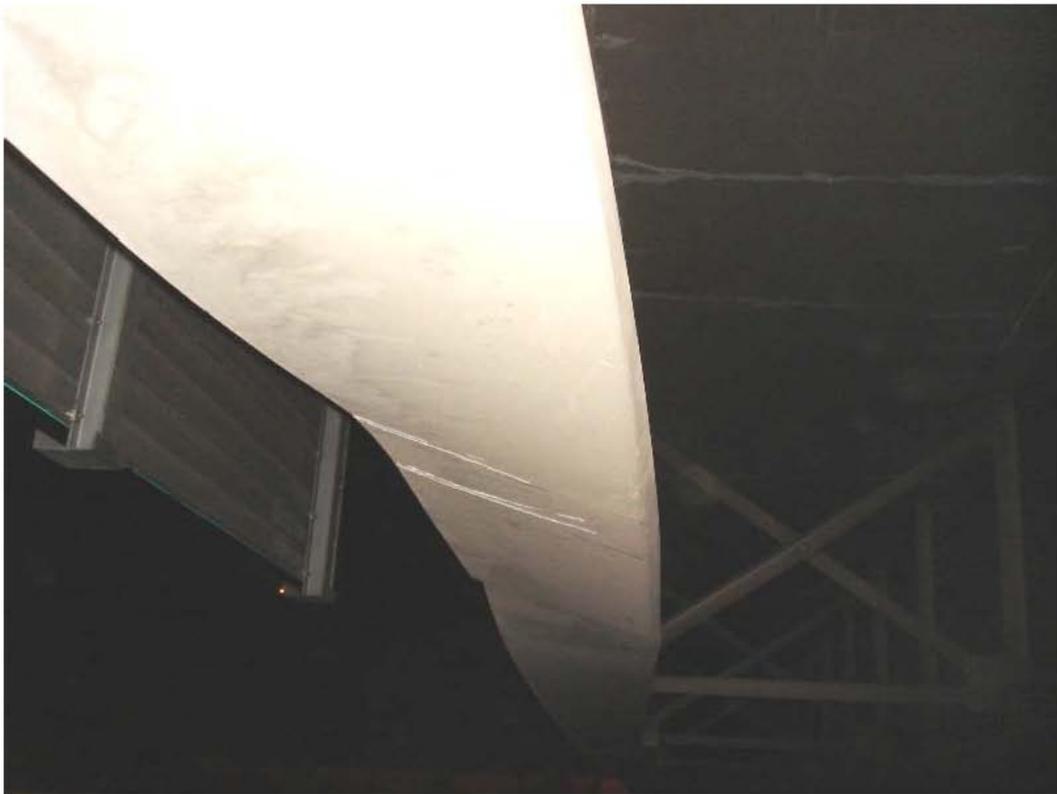
**Photo No.:** 6  
**File Name:** 0219009S.jpg  
**Descriptions:** Bottom flange of girder #1, span #1, bent to the east by collision damage

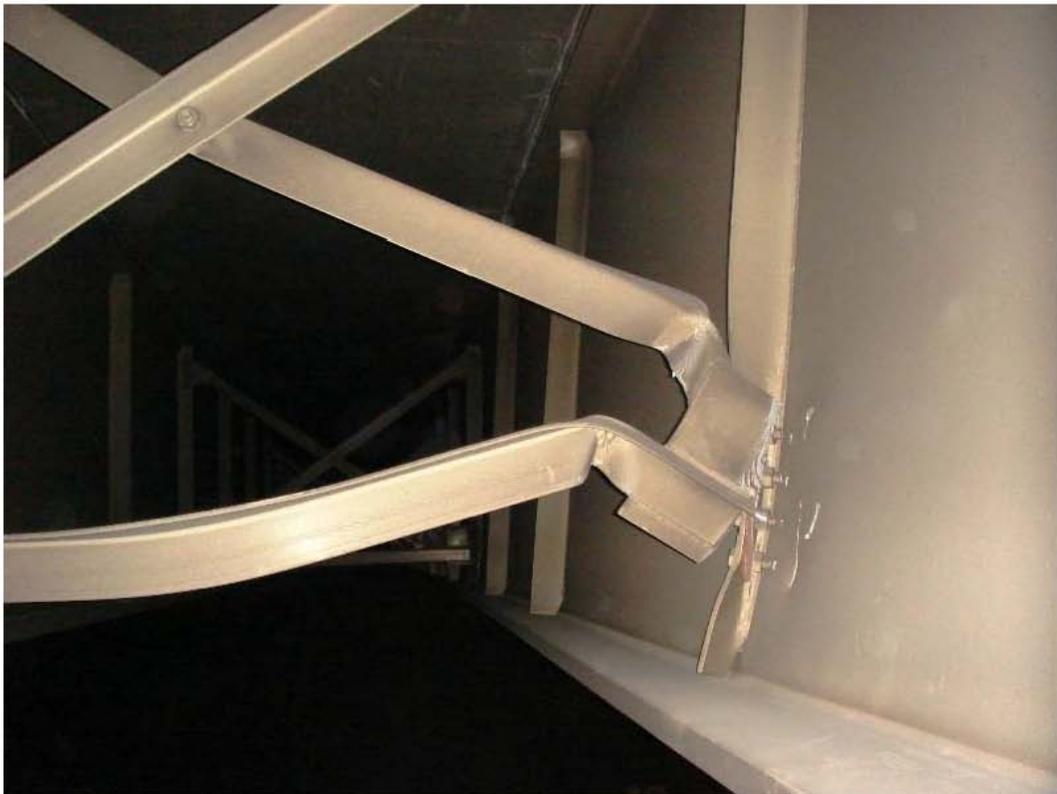
**Photo No.:** 7  
**File Name:** 0219009N.jpg  
**Descriptions:** Fourth cross-frame from pier in span #1, between girders #1 and #2; crushed by collision damage, with gusset plate sheared

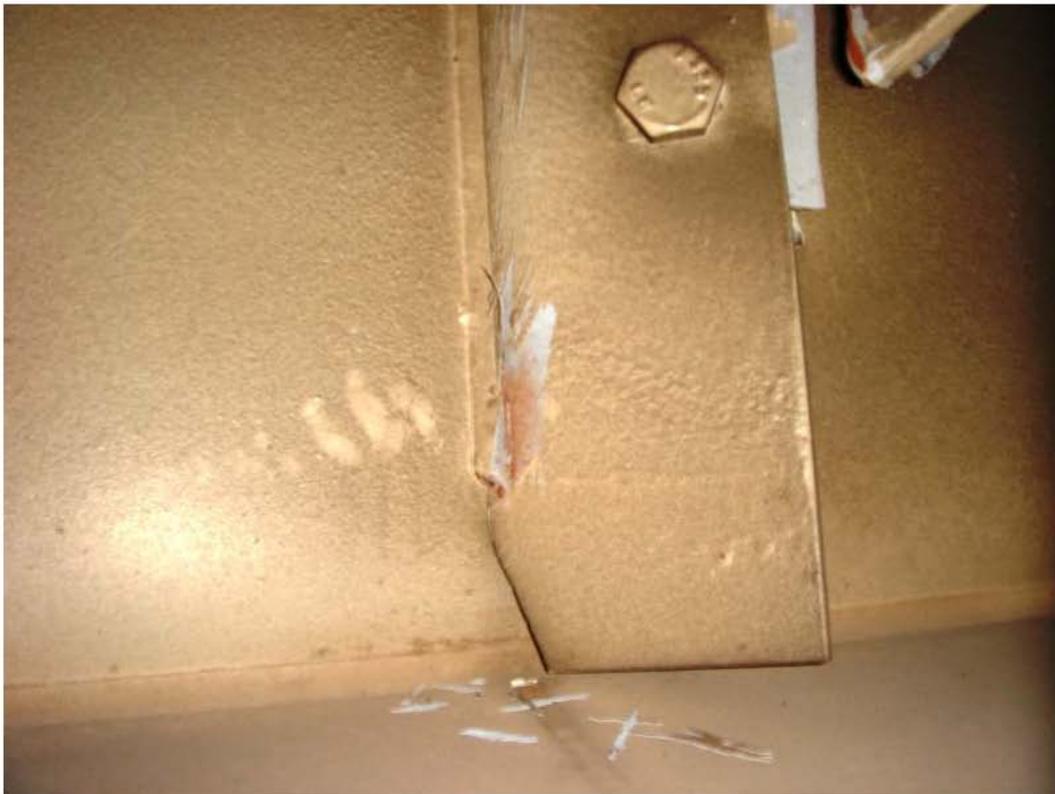
**Photo No.:** 8  
**File Name:** 02190090.jpg  
**Descriptions:** Crack initiated by collision damage in stiffener weld at 4th cross-frame from pier at girder #1, span #1.

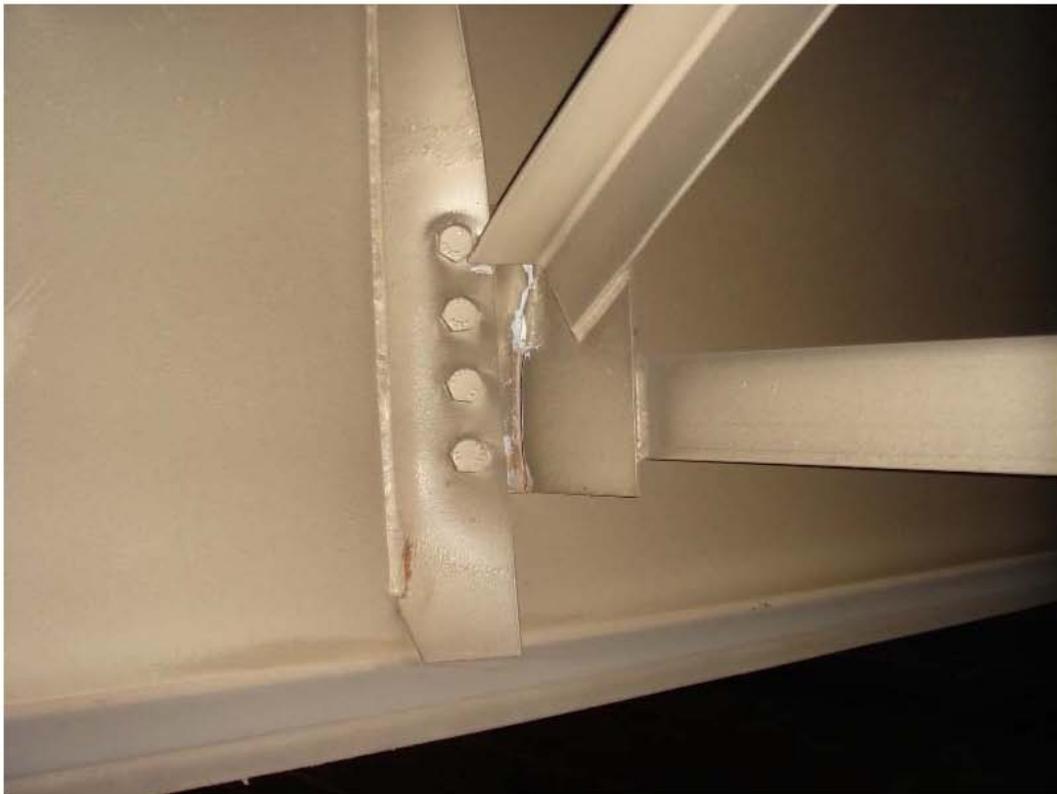
**Photo No.:** 9  
**File Name:** 0219009F.jpg  
**Descriptions:** Collision damage to third cross-frame from pier at girder #1; bent and cracked gusset plate; bent girder stiffener

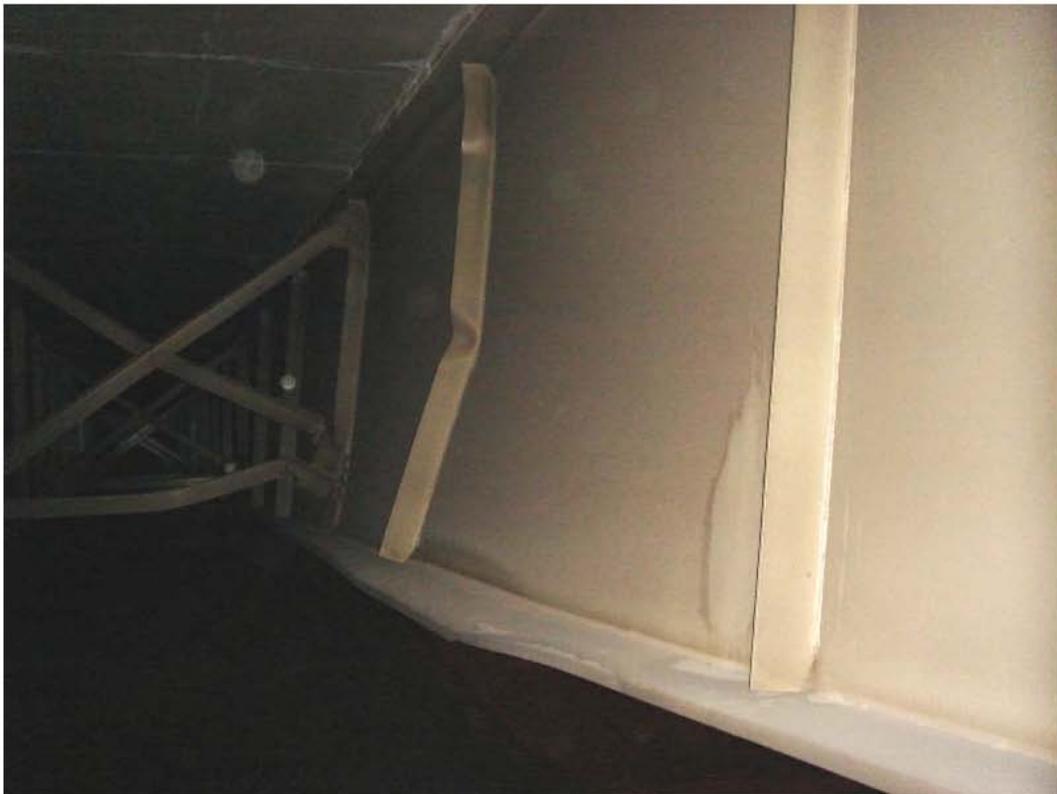
**Photo No.:** 10  
**File Name:** 0219009G.jpg  
**Descriptions:** Distortion of girder #1 and buckled stiffeners due to collision damage
